Aztec Property Inspections
2719 Mission Blvd
San Diego, CA 92109
(858) 245-9329

6352 Some Road
San Diego, CA 92114

Defective Summary

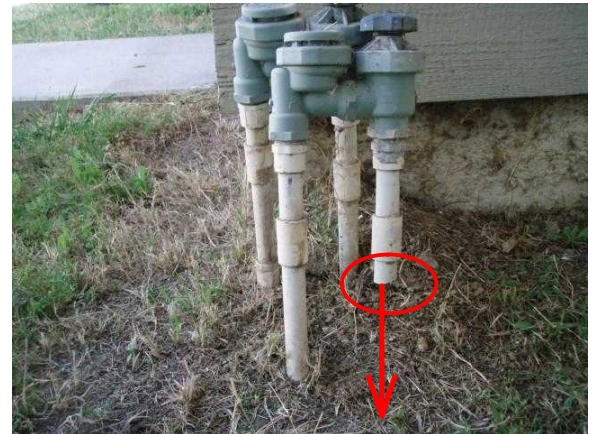
Marginal	Grading: The grading is not proper in one of more areas. This can result is water accumulating around the structure and it's foundation. Accumulated water is a conducive condition for wood destroying insects and organisms. Wet soil may also cause the foundation to settle and possible fail over time. Recommend grading the soil properly and or adding drainage.
Not Inspected	Exterior Surface Drain: Not tested. Beyond the scope of this inspection.
Not Inspected	Lawn Sprinklers: Not tested. Beyond the scope of this inspection. One or more water lines appear to be damaged. Correction is recommended.
Acceptable	Fences: Wood, Chain link Soil to wood contact was noted in one or more areas. This is a condition that is conducive to wood destroying organisms. Unfinished wood was noted in one or more areas. Stain and or finish is recommended. Gate needs adjustment in one or more areas. Correction is recommended. Damage and deterioration was noted in one or more areas. Correction is recommended.

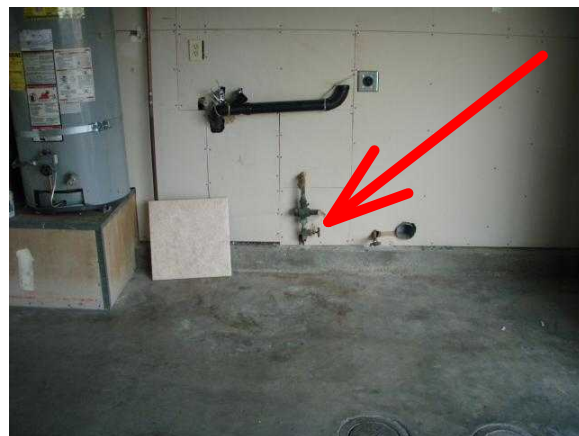
Water Main Shutoff: Garage The water shut off could not be viewed in utility box at the street. This could be the responsibility of the water utility company. Correction is recommended.

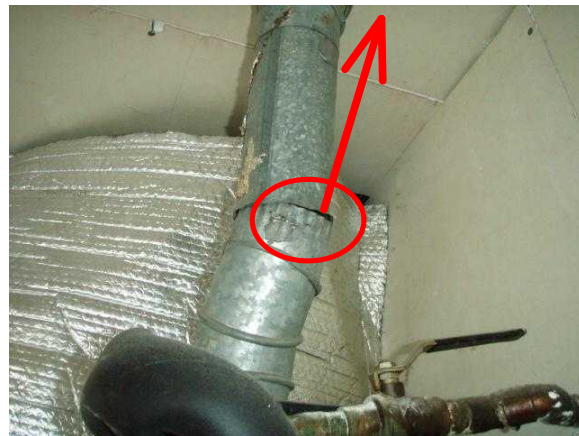
1. Garage Water Heater Flue Pipe: Disconnected vent pipe was noted. Correction is recommended.

Defective, Safety Upgrade Flue Pipe: Disconnected vent pipe was noted. Correction is recommended.

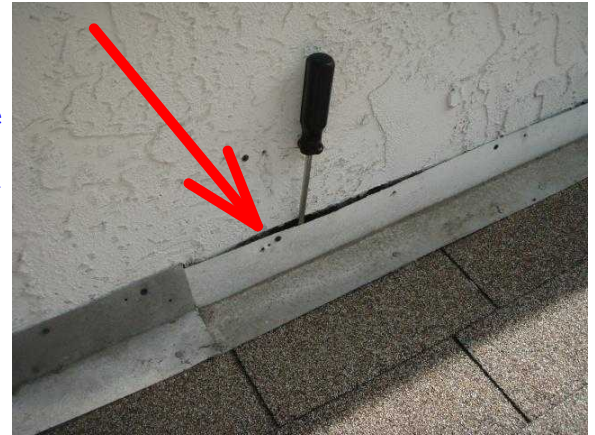
Flashing: Exposed fasteners were noted without mastic. These are possible moisture intrusion areas. Mastic is recommended on each nail head to ensure the water tightness of the roofing system. Improper roof flashing material noted. Improper installation of roof flashing noted. Further evaluation is recommended by a licensed roofer.

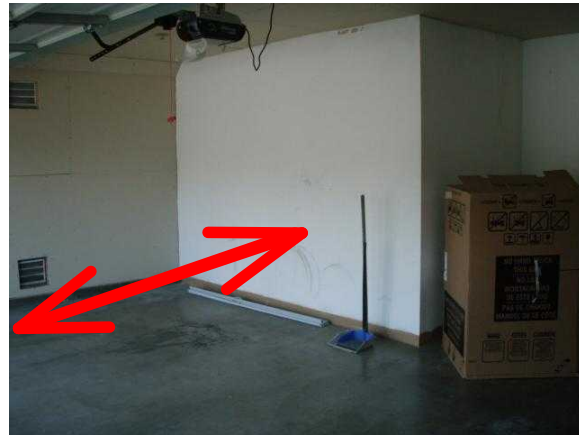
Vehicle Door(s) and Operation: The dept of the garage does not appear to be adequate for an average sized car due to an addition.
