Aztec Property Inspections
3655 Cowley Way
San Diego, CA 92117
(858) 245-9329

Client: Investor Group

888 San Diego Street
San Diego, CA 92104

Investor Group
Commercial Sample Report.inspx

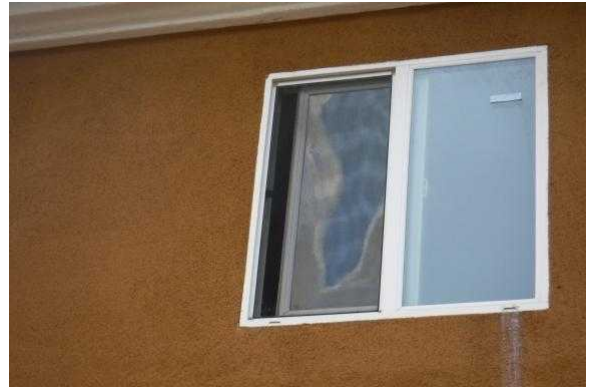
Windows: Moisture and or discoloration was noted to one or more windows. This is usually due to a damaged seal. A qualified licensed contractor is recommended to evaluate and estimate repairs.

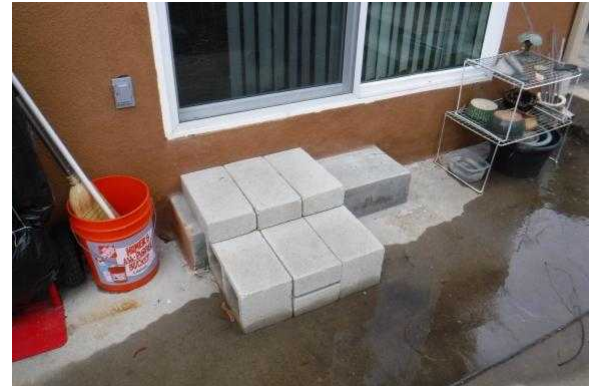
7. Safety Upgrade **Exterior Door(s):** Landings were improper at one door. Correction is recommended.

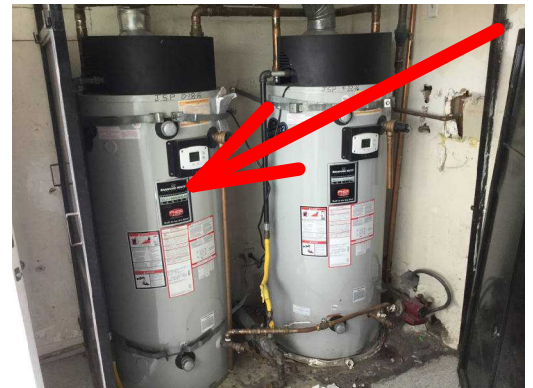
Operation: The local utility company is recommended for a complimentary safety inspection before the close of the contingency period. A gas line drip leg (sediment trap) is recommended. The local utility company is recommended for a complimentary safety inspection. Recommend raising the unit so the flame is at least 18" off the floor. This is required in the garage or any other area where flammables are kept. It is recommended in all other areas.

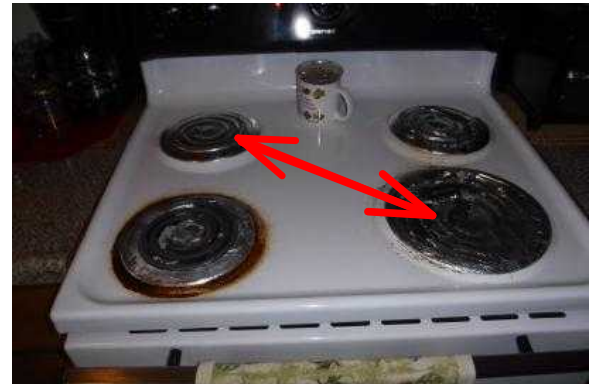
4. Defective **Cooking Appliances:** (Electric) - One or more burners did not operate properly. Correction is recommended.

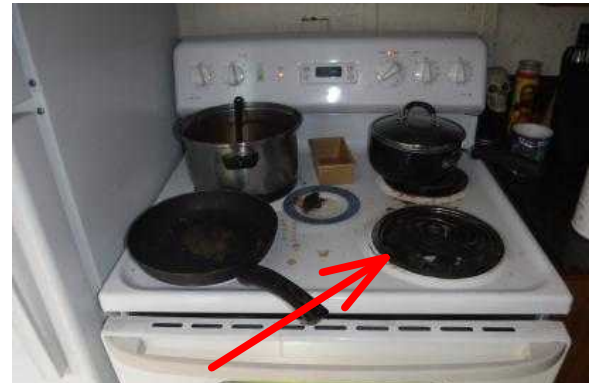
(Unit 4) Kitchen

5. Defective **Cooking Appliances:** (Electric) - One or more burners did not operate properly. Correction is recommended.

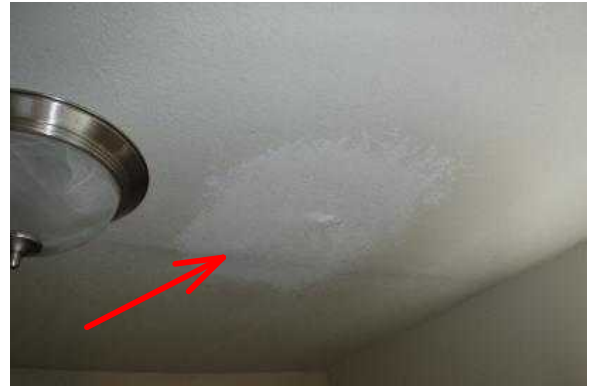
Ceiling: Patch and repair noted.
Inquire with seller.

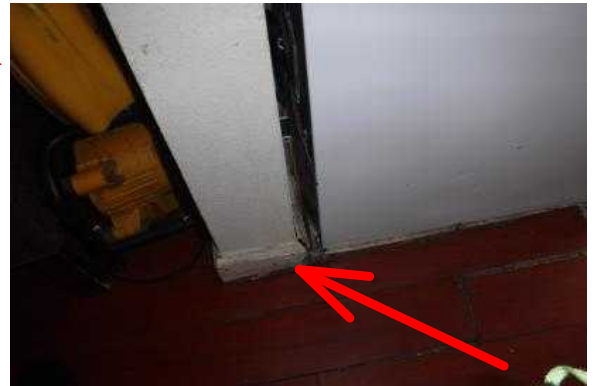
Floor: Water damage noted in one or more locations. Further evaluation is recommended.

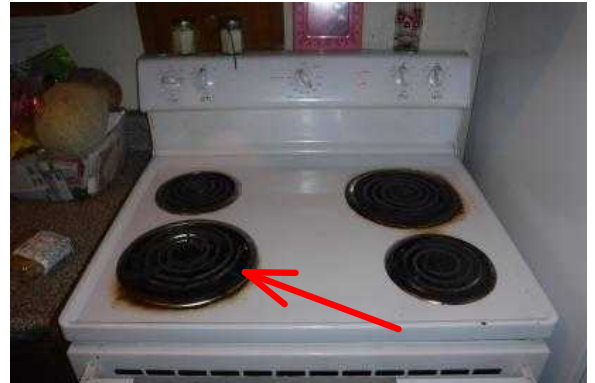
(Unit 5) Kitchen

Cooking Appliances: (Electric) -
One or more burners did not
operate properly. Correction is
recommended.

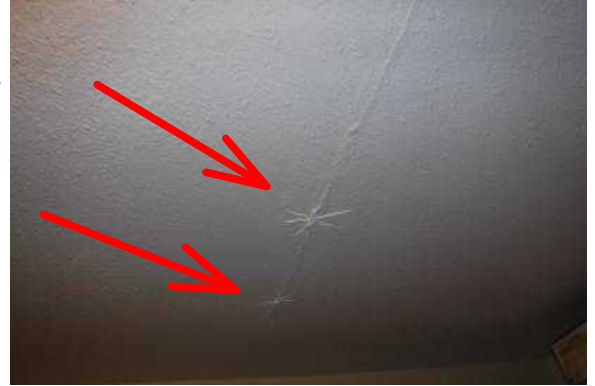
Ceiling: Bubbled paint noted. No active moisture penetration noted at the time of inspection. Further evaluation may be desired.

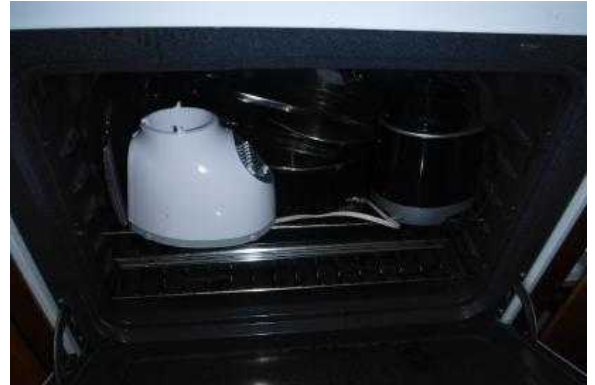
Cooking Appliances: Not inspected due to personal belongings inside. Further evaluation is recommended.

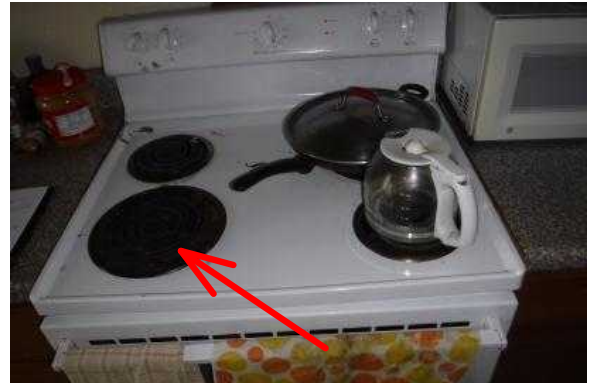
(Unit 23) Kitchen

Cooking Appliances: One or more burners did not operate properly. Correction is recommended.

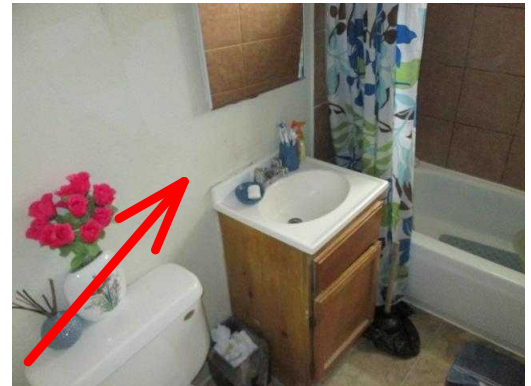
Electrical: No outlets were noted in the bathrooms.

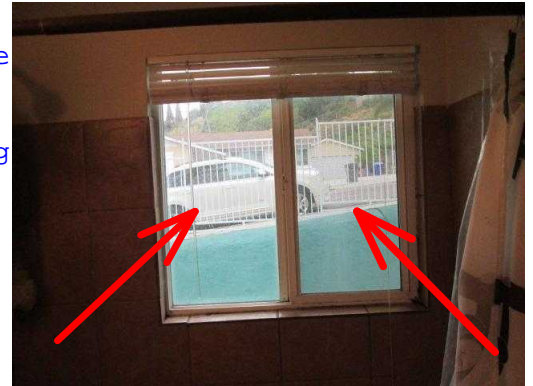
6. Safety Upgrade, Marginal **Windows:** Tempered glass could not be verified at one or more windows (this is sometimes difficult to view). Recommend confirming that the glass is tempered. If not then upgrades are recommended for added safety.

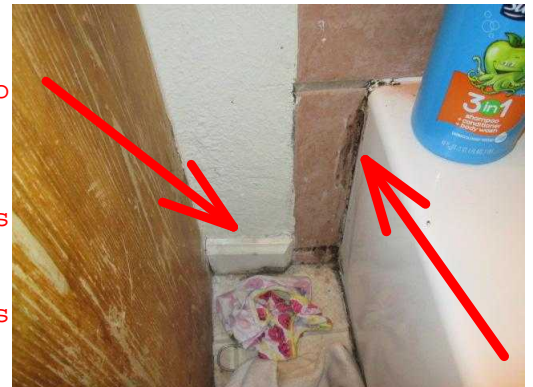
Unit #4 Bathroom

Walls: Water stains and damage were present in one or more areas. It is beyond the scope of this inspection to determine if the moisture penetration is active. Inquire with seller and licensed specialist if necessary. Unidentifiable biological substance is present and is a potential health concern (probably a mold or mildew). Further evaluation of the substance is recommended by a specialist. A moisture intrusion expert is also recommended.

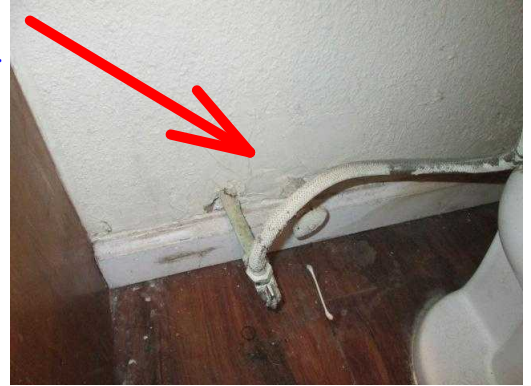
Walls: Patch and or repair noted. Soft spots were noted in one or more areas.

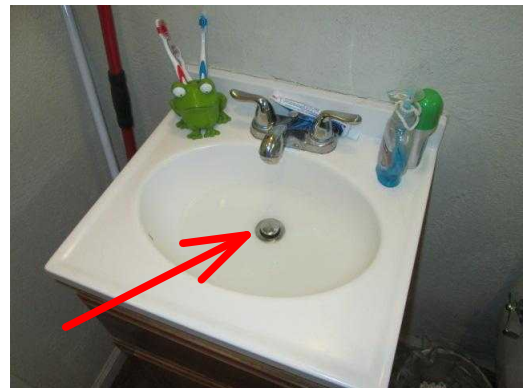
Faucets/Traps: A slow drain was noted at the sink. Correction is recommended.

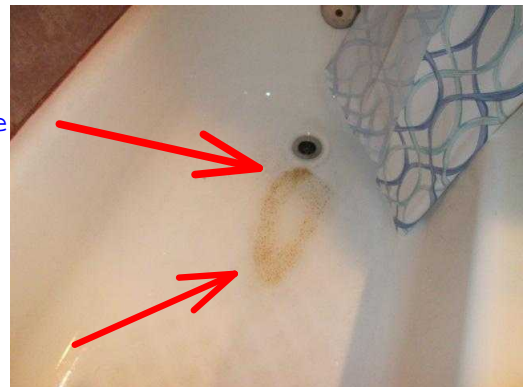
Tub/Surround: Tub does not slope properly to the drain in one or more areas. This is not a proper installation and water will sit in the tub. Rust and or damage is noted in the tub. A qualified and licensed contractor is recommended to evaluate and estimate repairs.

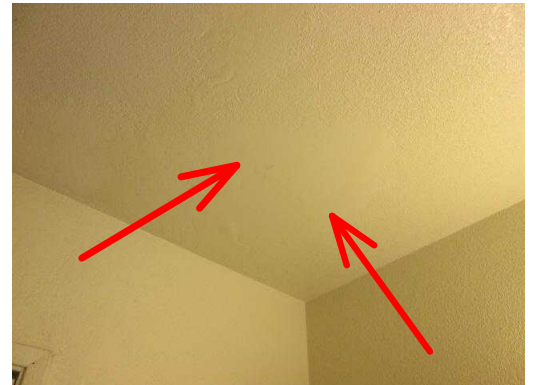
Ceiling: Patch and repair noted.

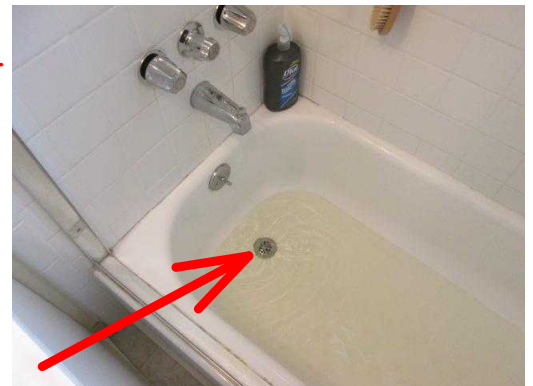
Faucets/Traps: A slow drain was noted at the tub. Correction is recommended.

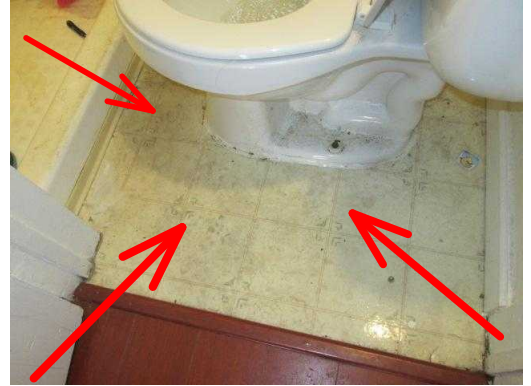
Floor: Discoloration was noted in one or more areas.

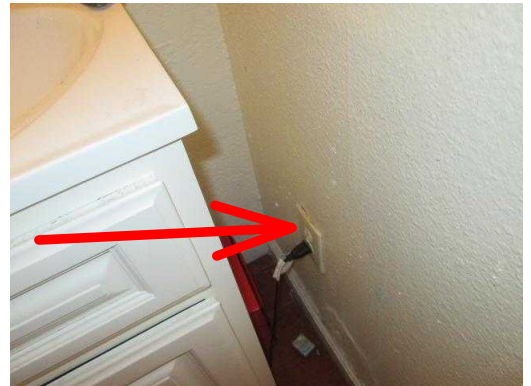
Electrical: Non-GFCI circuit noted. Recommend GFCI circuit be installed for added safety.

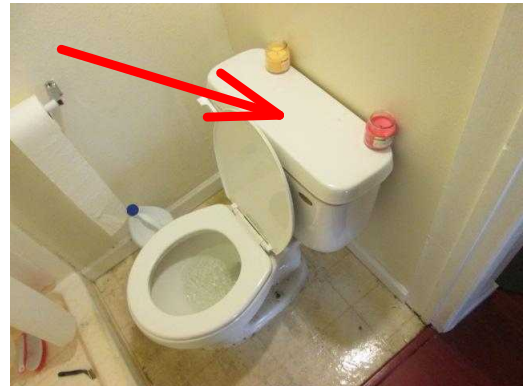
Toilets: The toilet was not properly operational. Clearances were not proper in the bathroom or around the toilet. A qualified licensed contractor is recommended to evaluate and estimate repairs.

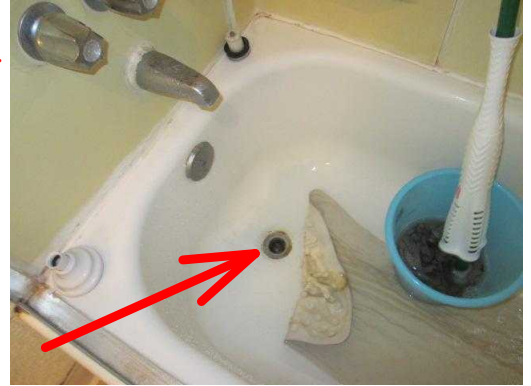
Faucets/Traps: A slow drain was noted at the tub. Correction is recommended.

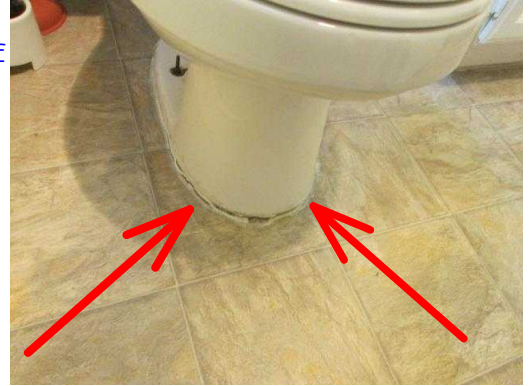
Toilets: The toilet was loose at the floor. This may require replacement of the wax seal. Correction is recommended.

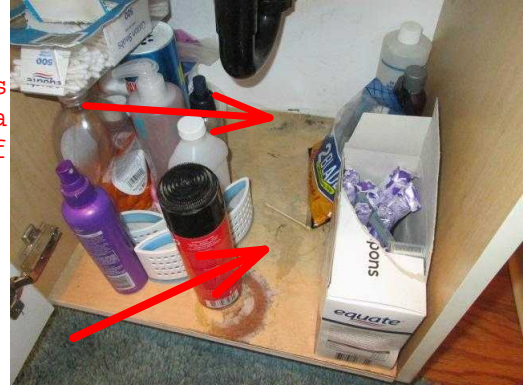
Counter/Cabinet: Water damage present under the counter. Unidentifiable biological substance is present and is a potential health concern (probably a mold or mildew). Further evaluation of the substance is recommended by a specialist. A moisture intrusion expert is also recommended.

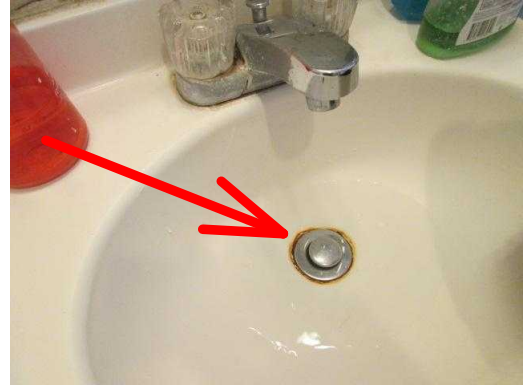
Faucets/Traps: A slow drain was noted at the sink. Correction is recommended.

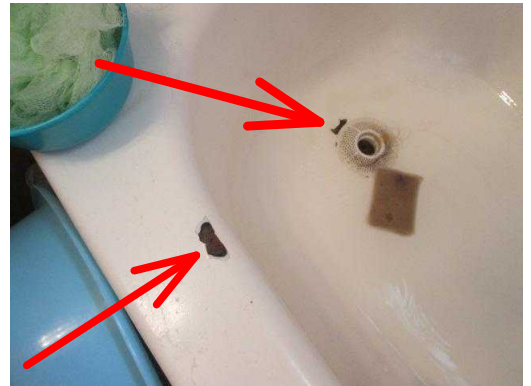
Tub/Surround: Chipped or damaged tub. A qualified contractor is recommended to evaluate and estimate repairs.

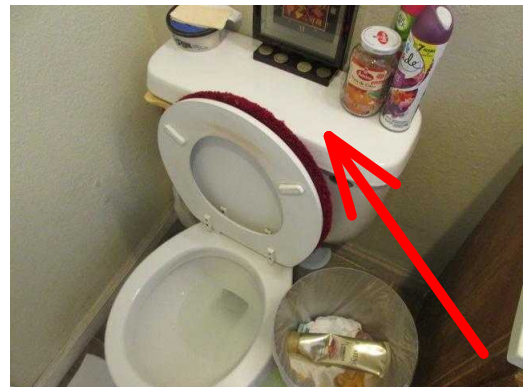
Toilets: The toilet was not properly operational. A qualified licensed contractor is recommended to evaluate and estimate repairs.

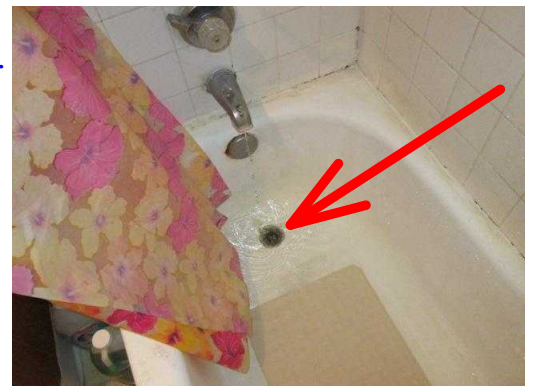
Faucets/Traps: A slow drain was noted at the tub. Correction is recommended.

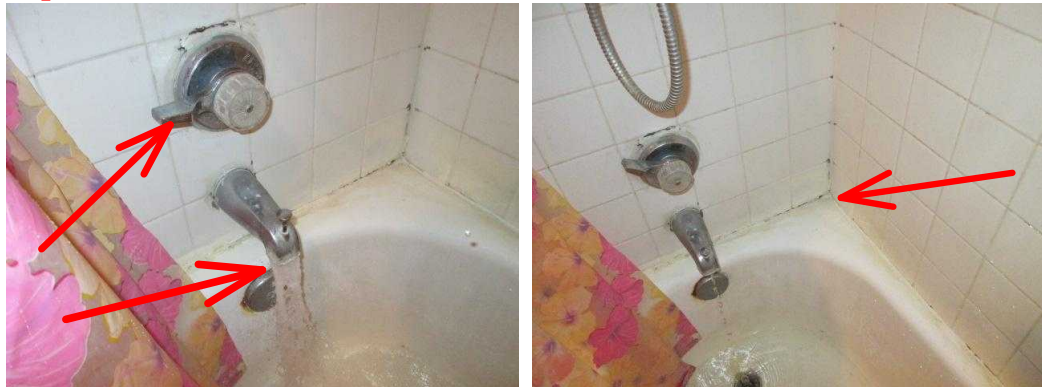
Tub/Surround: Damaged tiles were noted at the tub surround. The tub diverter was not functional. Water comes out the tub spout when the shower is activated. Replacement may be needed. A qualified licensed contractor is recommended to evaluate and estimate repairs.

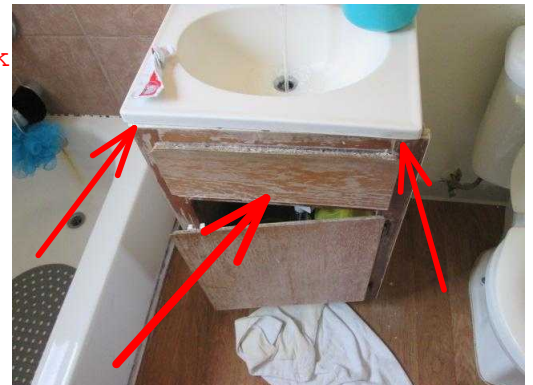
Counter/Cabinet: Cabinets have excessive moisture damage and the sink is loose at the countertop. A qualified licensed contractor is recommended to evaluate and estimate repairs.

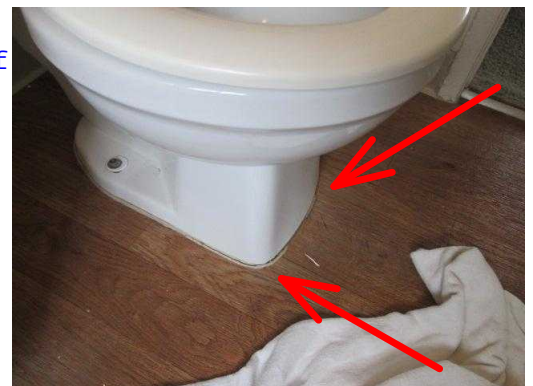
Toilets: The toilet was loose at the floor. This may require replacement of the wax seal. Correction is recommended.

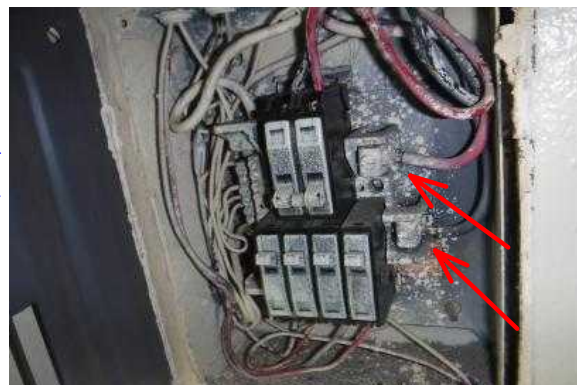
Condition: Paint and or texture was noted inside the panel. This is a potential fire hazard and correction is highly recommended. A qualified licensed contractor is recommended to evaluate the entire electrical system and estimate repairs.

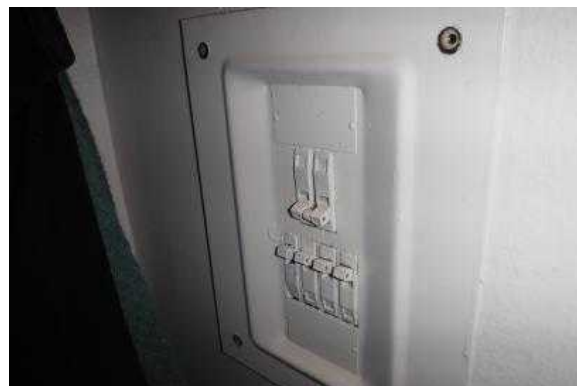
Condition: Unable to access due to the cover being painted shut. Further evaluation may be desired.

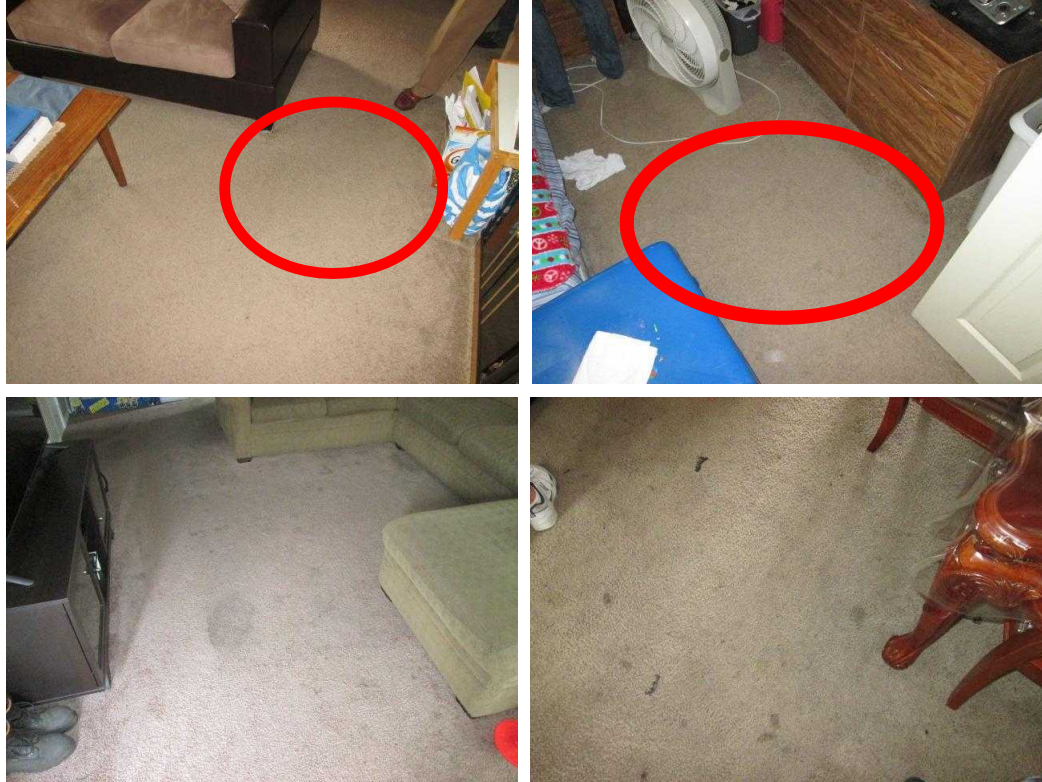
Floor: Floor squeaks were noted in one or more units. Uneven floors noted in one or more units. Stained and soiled carpet was noted in one or more units. Corrections are recommended.

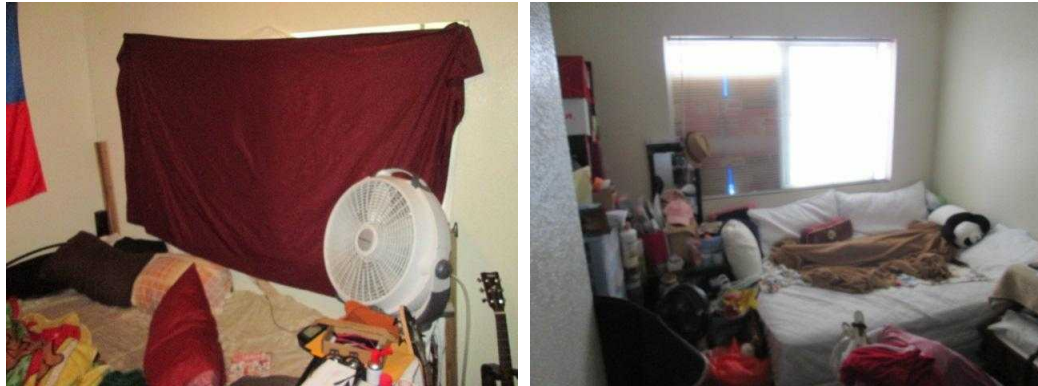
Windows: Unable to access all the windows due to personal belongings and or furniture.

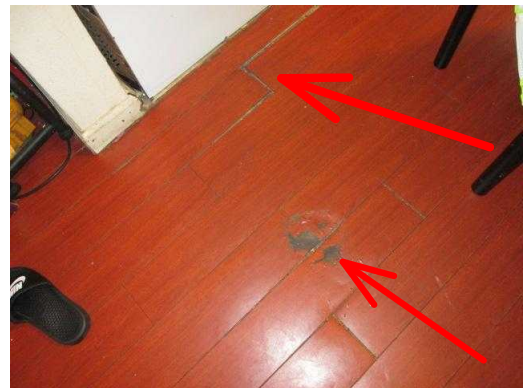
9. Defective **Floor:** Loose flooring was noted in one or more areas. Moisture damaged was noted in one or more areas. Hidden damage and or mold/mildew may be present. A qualified licensed contractor is recommended to evaluate and estimate repairs.

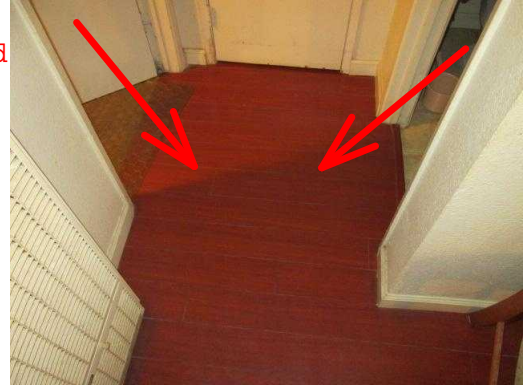
Floor: Bubbling and loose floorboards were noted at the hallway. A qualified licensed contractor is recommended to evaluate and estimate repairs.

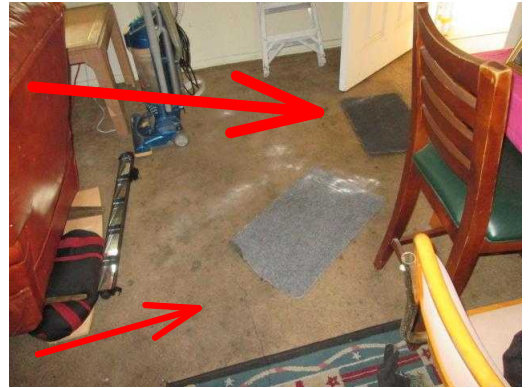
18. Marginal **Floor:** Carpet is stained and soiled. Replacement is recommended.

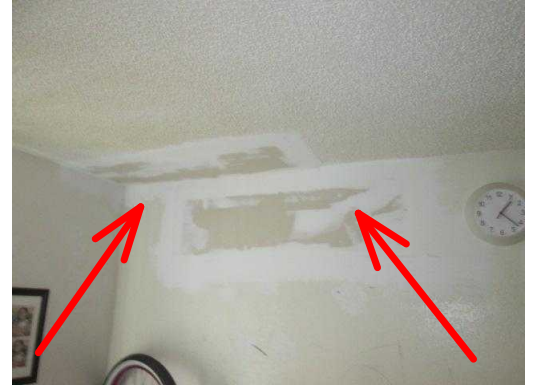
Ceiling: Patch and repair noted.
Recommend inquiring with the seller.

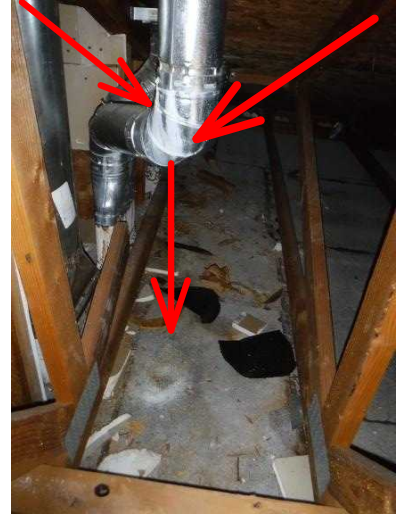
Moisture Penetration: Minor water intrusion was noted. Correction is recommended.
