Aztec Property Inspections
3655 Cowley Way
San Diego, CA 92117
(858) 245-9329

777 Clairemont Ave
San Diego, CA 92111

Jeff Smith
Home Inspection Sample.inspx

Definitions

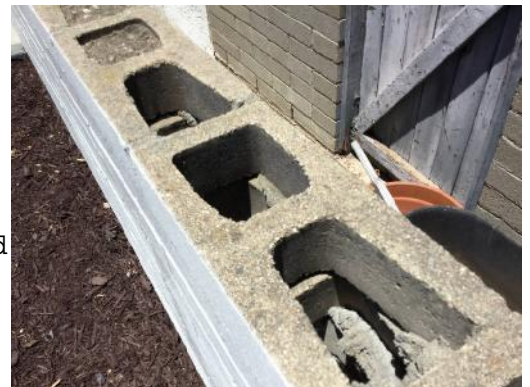
Retaining Walls: No rebar and or concrete were noted in one or more areas of the block walls. This is an improper installation. Caps were missing on top of the walls in one or more areas. No surface drains or drainage openings were visible in one or more areas. This condition can lead to damage to the wall and eventually failure. Recommend further evaluation and repairs as necessary by a qualified contractor.

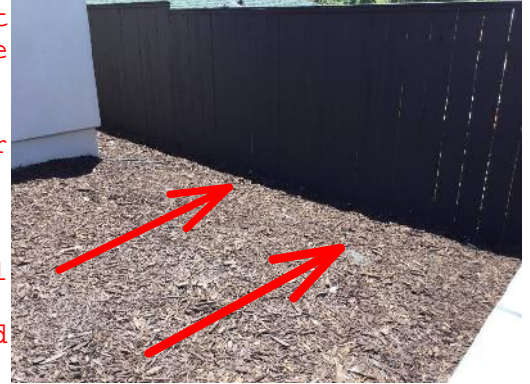
6. Defective

Grading: The perimeter grading does not slope down and away from the structure in one or more areas. No drainage was visible. This could trap water near the structure. Inquire with the seller to verify that drainage has been installed that is not visible or underground. Wet soil may cause the foundation to settle and possibly fail over time. Recommend having all soil and or hardscape so it slopes down and away from the structure properly or adding drainage as necessary using standard building practices. A qualified licensed contractor is recommended to evaluate and estimate repairs.

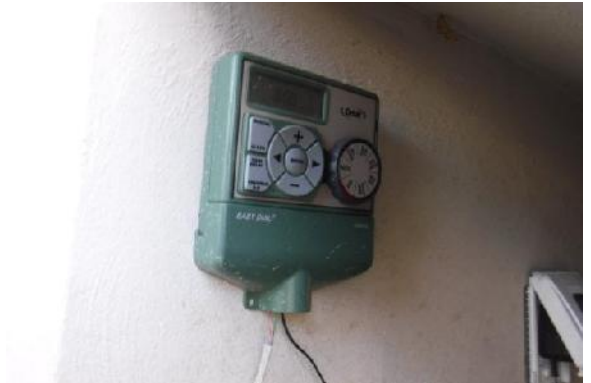
8. Not Inspected

Lawn Sprinklers: Not tested. Beyond the scope of this inspection. Adjustment is recommend away from the house, walkways and or fencing. Recommend verifying that the timer box is rated for exterior use.

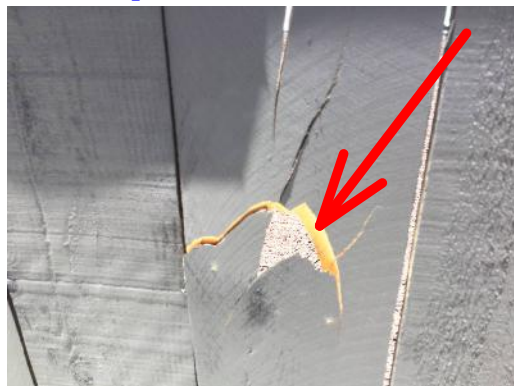
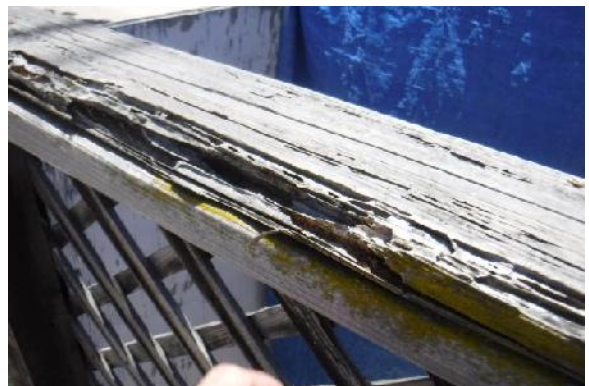
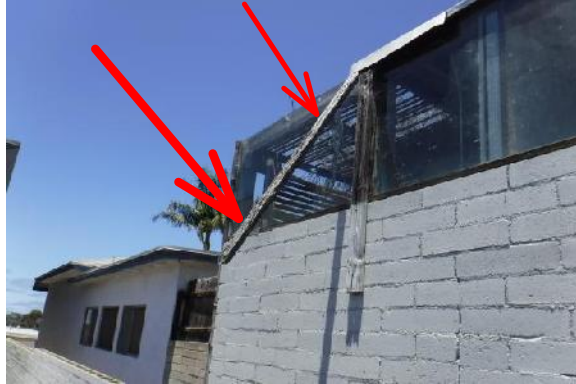
9. Marginal

Fences: A broken board or two were noted. Damaged, soft and or deteriorated wood was noted in one or more areas. Further evaluation is recommended by a qualified and licensed pest control specialist. Damage and deterioration was noted in one or more areas. Loose wood was noted at the upper neighbor's cover which is a safety hazard. Correction is recommended.

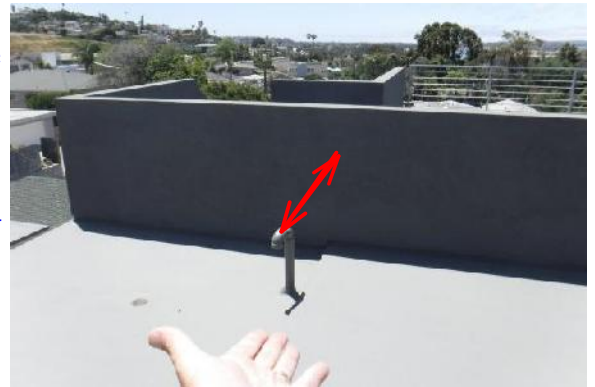
10. Safety Upgrade, Marginal **Deck:** (Rooftop) - Upper deck was unusually close to the laundry heater vent. This could cause the inhalation of toxic gases (carbon monoxide). Usually these are routed above the surface or farther away. Each city can choose to adopt different codes or can adopt a variance for specific items. If more information is desired then please contact the city's building department. Further evaluation may be desired by a licensed specialist. The guardrails comply with code but could be considered a safety hazard because kids tend to climb horizontal guardrails.

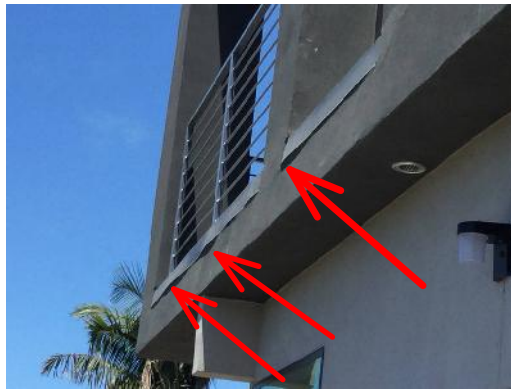
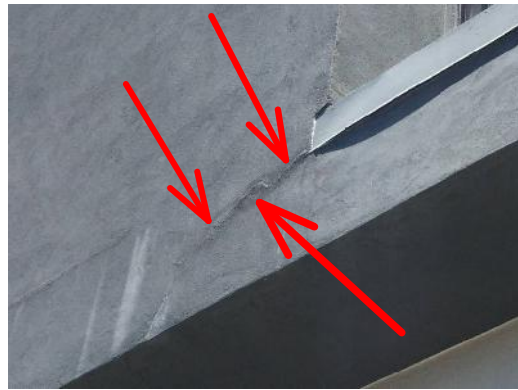
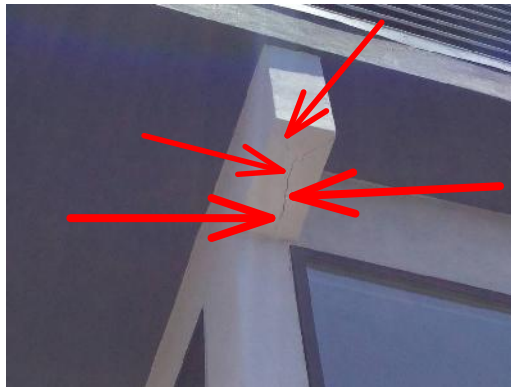
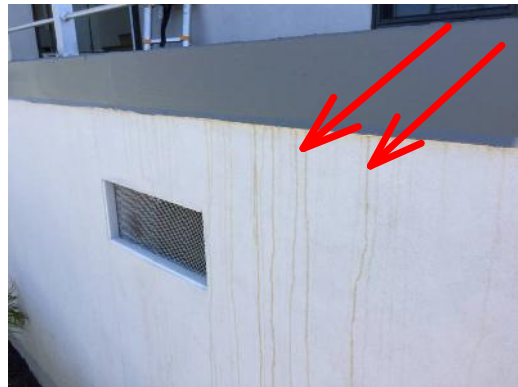
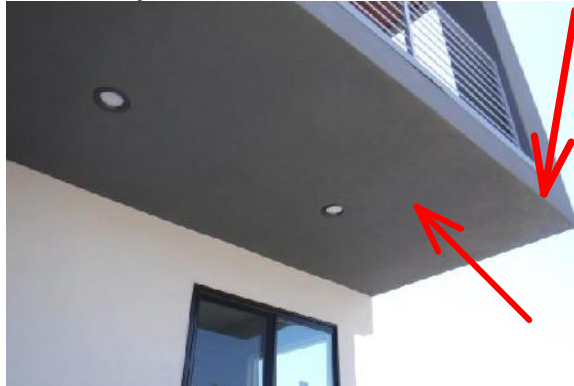
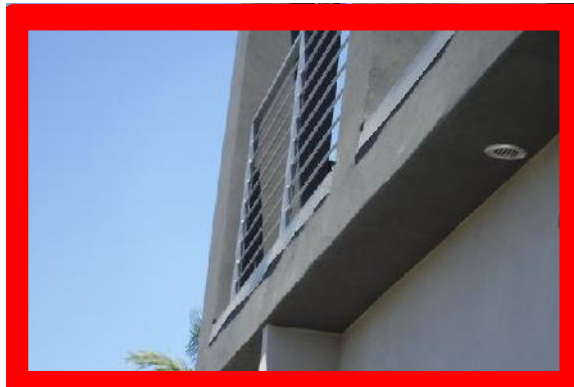
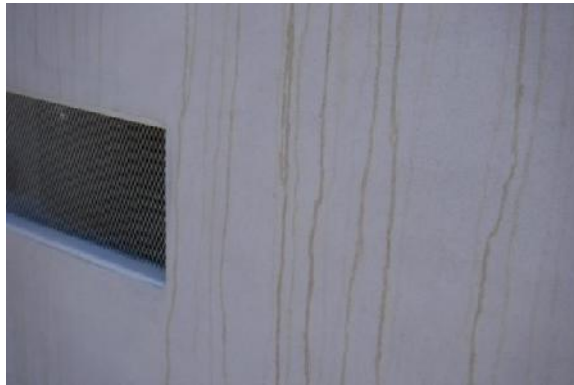
1. Marginal

Exterior Walls: (Stucco) - Discoloration was noted at the front of the house. No metal flashing was noted at the bottom of several vertical surfaces. Unable to view ventilation in one or more areas. This is frequently seen at stucco eaves or under decks/balconies. Ventilation is typically to allow any enclosed ventilation to breath properly which lessens the possibility of mold related issues. Title 24 (adopted as of construction permitted after 7/1/2014) has allowed for tighter construction which has eliminated ventilation in some areas. Determining if what is present meet the Title 24 requirements or determining if what is present will function properly in the long run is beyond the scope of this inspection and further evaluation maybe desired. Loose and rippled drip edge was noted. Some drip edge appears to be flush or embedded in the stucco. Correction is recommended. Common to moderate cracks noted. Correction is recommended.

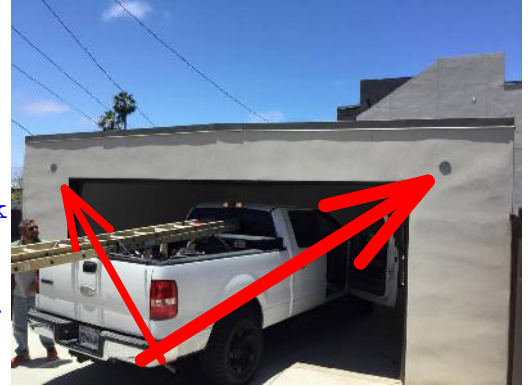
4. Safety Upgrade, Marginal **Exterior Lighting:** One or more missing fixtures were noted (garage). Lights were not operational at one or more locations which could just be a burned out bulb or be due to a motion sensor (back stairs). Inquire with seller. No lights have been installed on the upper deck. Correction is recommended.

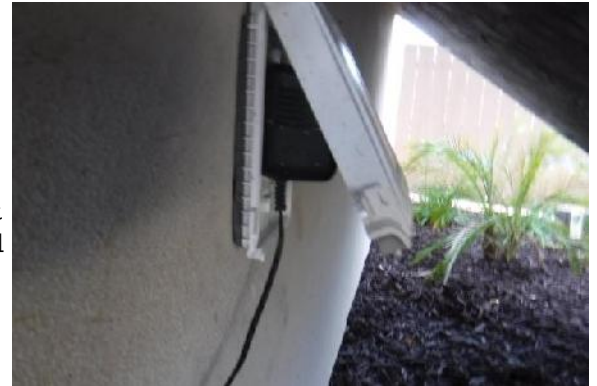
5. Acceptable **Exterior Electric Outlets:** (120 VAC GFCI) - One or more exterior receptacles are being used for appliances or systems that are constantly in use and aren't equipped with a properly sized "in-use" receptacle covers for wet locations. This is a safety hazard and poses a risk of both fire and shock. Recommend installing "in use" covers where necessary.

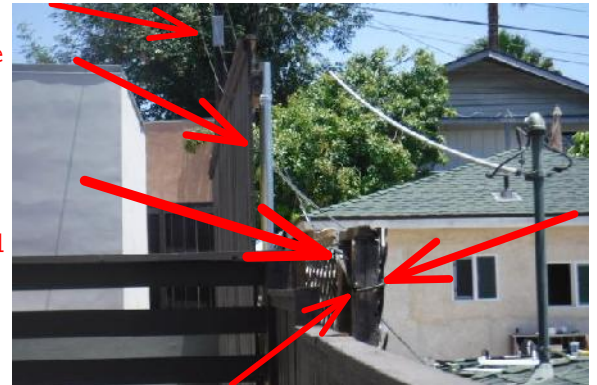
6. Defective **Low Voltage Utilities:** Boxes have not been installed for the low voltage utilities (cable, TV and television). These are typically separate metal boxes. The wires have been disconnected and were hanging on the fence. A qualified licensed contractor is recommended to evaluate and estimate repairs.

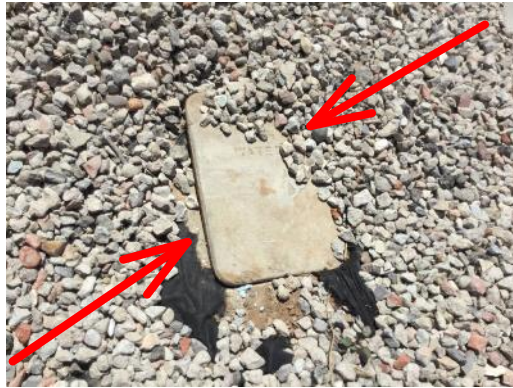
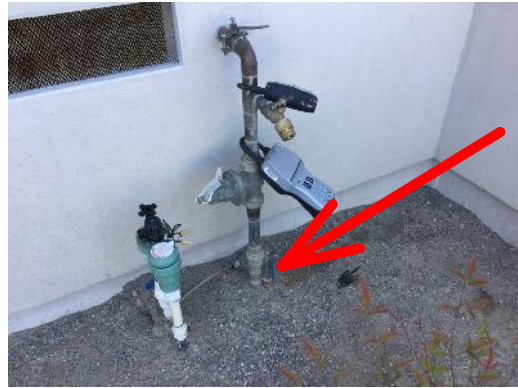
1. Marginal

Water Main Shutoff: (Front of house) - Clearing the rock is recommended from the street utility box. The shut off handle was in the soil at the street utility box. Correction is recommended.

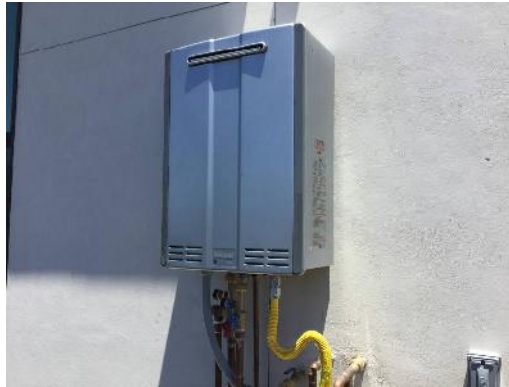
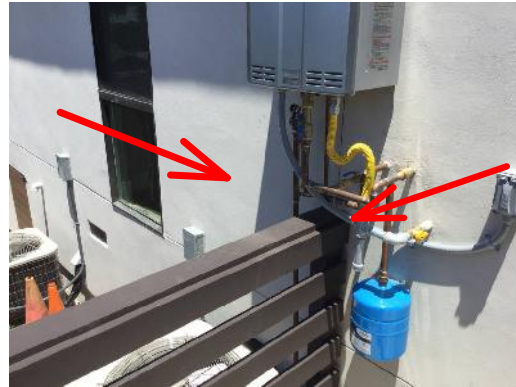
11. Acceptable

Operation: The local utility company is recommended for a complimentary safety inspection. Tankless water heaters are limited on how much water they can heat at one time. The unit may not be sufficient for multiple fixtures going at the same time. This flow was not inspected. Inquire with seller. Improper work space noted. The unit is going to be difficult to service. Expansion tanks are beyond the scope of this inspection.

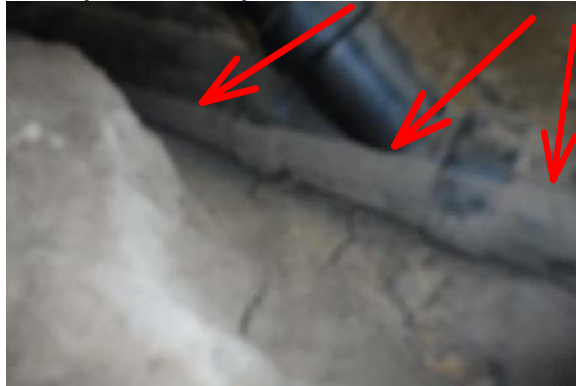
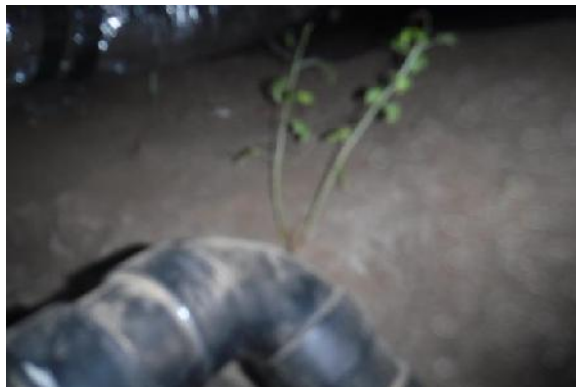
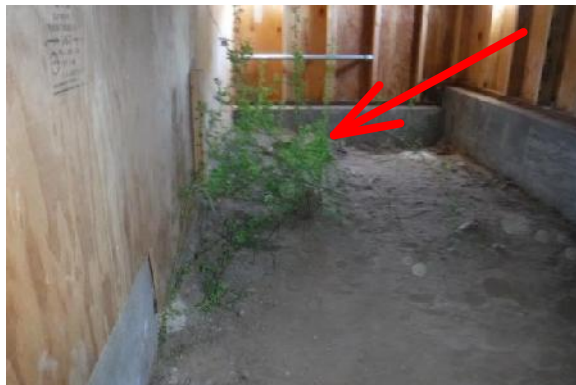
5. Marginal Moisture Penetration: Vegetation was growing under the house. Removal is recommended. A water stain was noted on the water main (near vegetation). It is unknown if any water intrusion is active or if this was happened during construction.

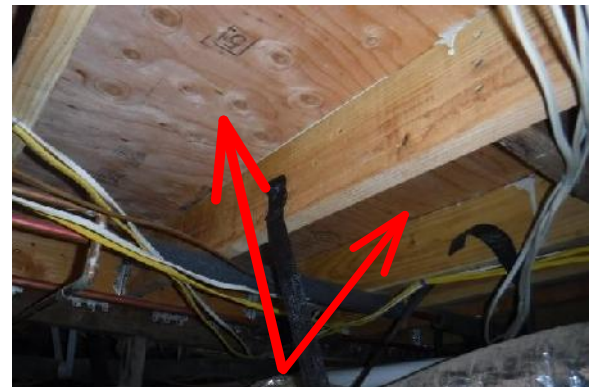
11. Defective

Insulation: No insulation has been installed in some areas. Correction is recommended.

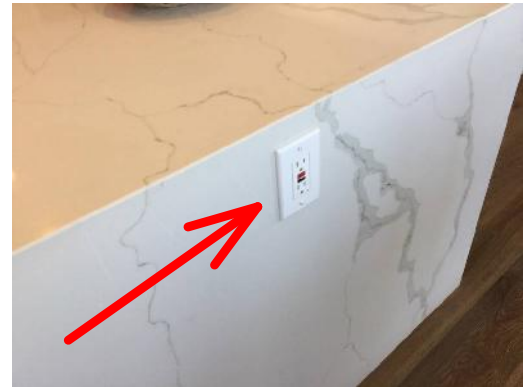
Electrical: (120 Volt GFCI) - The island GFCI outlets must be reset at the countertop. Correction is recommended.

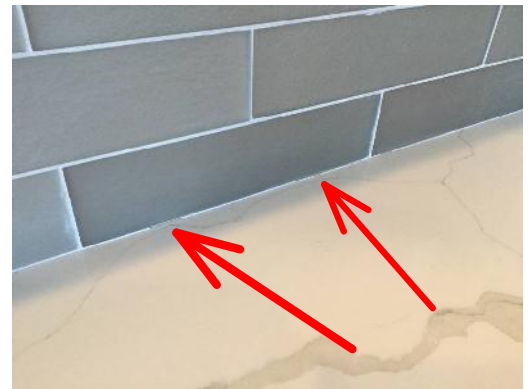
Counter Tops: Grout is missing in several areas. Correction is recommended.

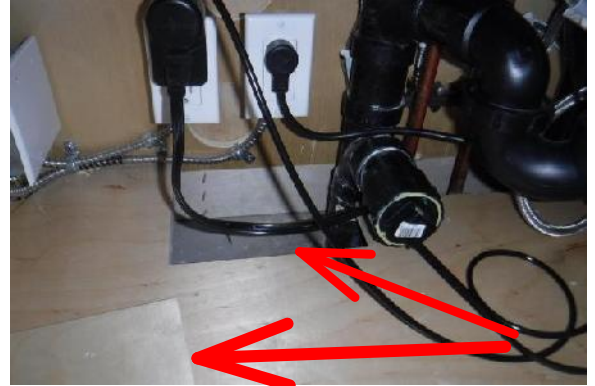
9. Marginal

Cabinets: A crude cut out was noted for the plumbing. Correction may be desired.

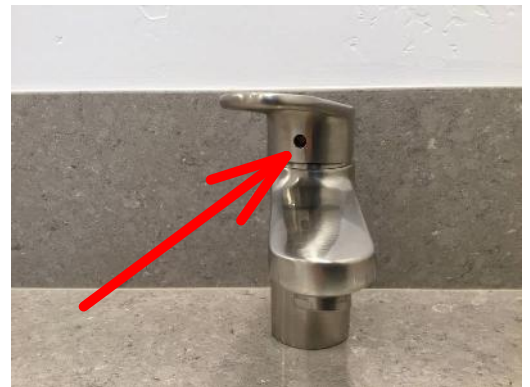
4. Marginal

Faucets/Traps: The rubber cap is missing at the right side faucet. Correction is recommended.

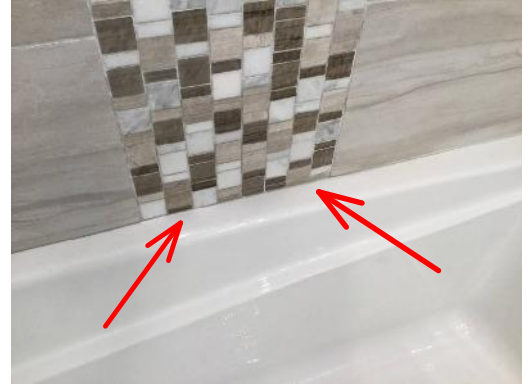
5. Marginal

Tub/Surround: Bench, ledges, and/or soap dishes do not slope properly to drain. This could lead to moisture intrusion. Regular maintenance of the caulking will be required.

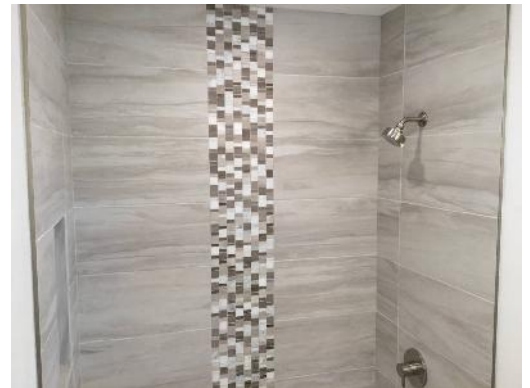
6. Marginal

Shower/Surround: No shower enclosure has been installed. Correction is recommended.

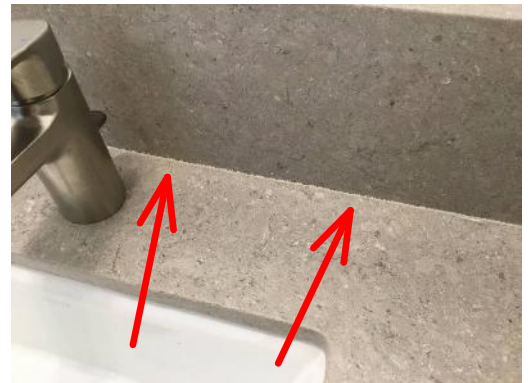
Counter/Cabinet: Caulking is needed at the backsplash. Correction is recommended.

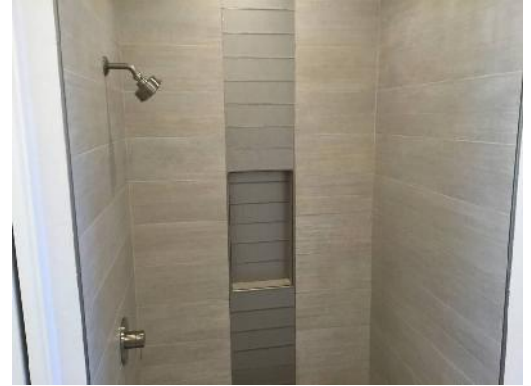
13. Marginal

Shower/Surround: No shower enclosure has been installed. Correction is recommended.

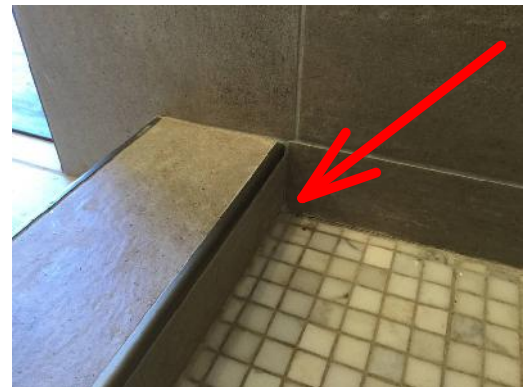
20. Marginal

Shower/Surround: No shower enclosure has been installed. Grout is cracked and/or missing in one or more locations. Corrections are recommended.

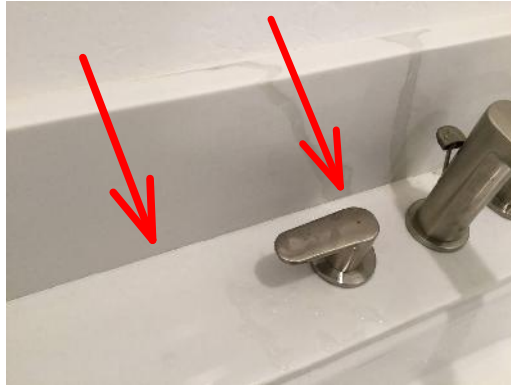
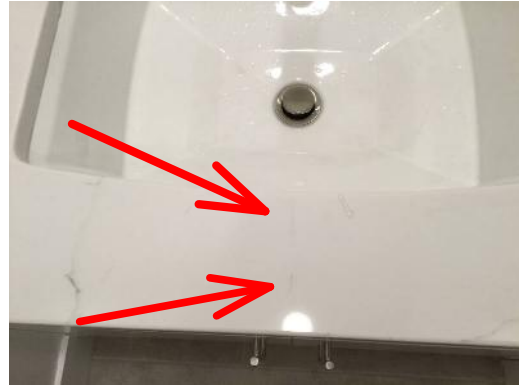
Counter/Cabinet: Caulking is needed at the backsplash. Scratches were noted at the countertop. Correction is recommended.

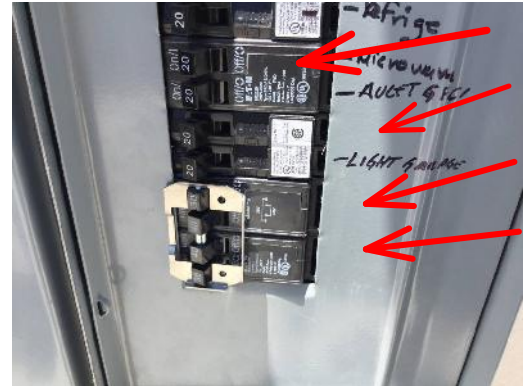
6. Safety Upgrade, Marginal **Breakers:** One or more breakers were not labeled. The breakers are loose at the panel. A qualified licensed contractor is recommended to evaluate and estimate repairs.

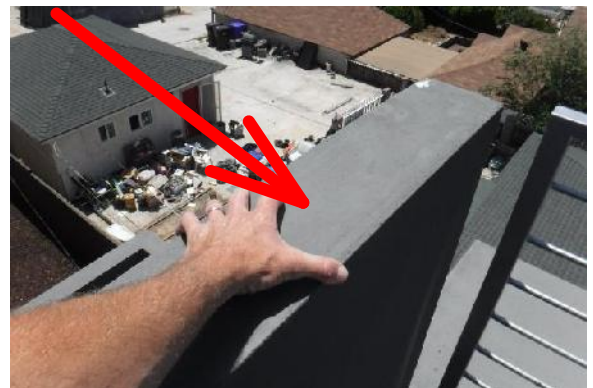
1. **Method of Inspection:** Walked on roof
2. Acceptable **General Condition:** (Unknown Material) - Inquire with the seller as to what product was used and for the warranty information. Recommend verifying that the roof does not drain onto any of the exterior doors or stairs.
3. Acceptable **Flashing:** No hard caps were noted on the tops of the parapet walls. This is typically a metal cap and not stucco. Correction is recommended.

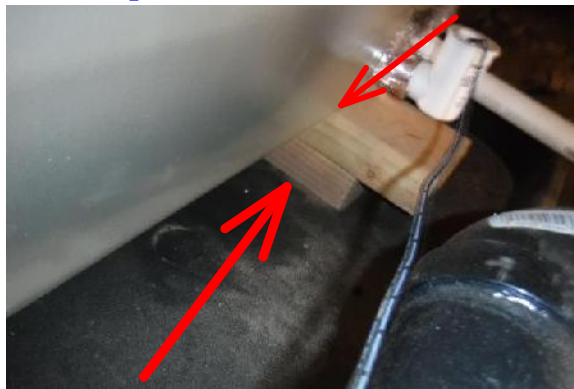
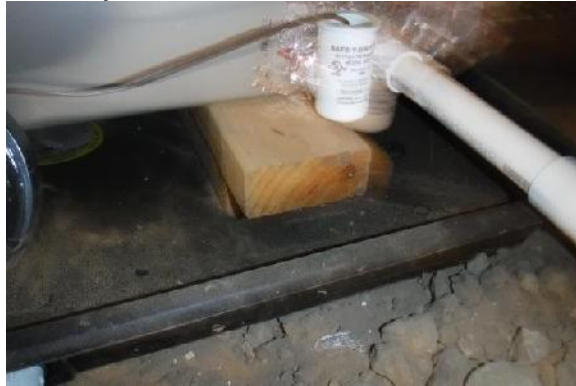
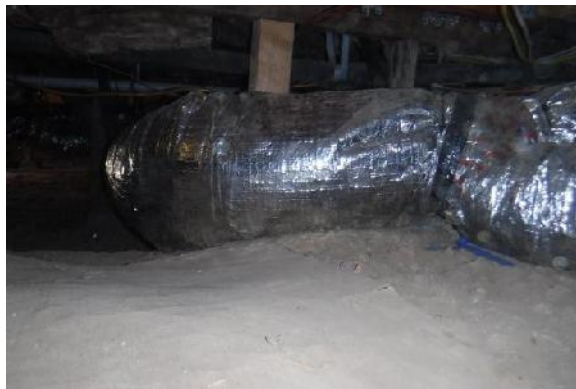
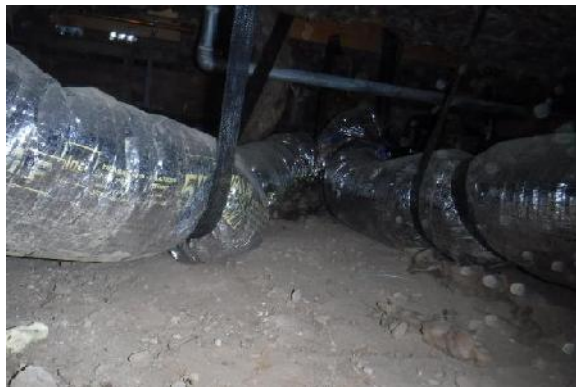
Distribution: A plenum was improperly supported by wood inside the catch pan which is designed to catch water. Correction is recommended. One or more ducts were in contact with the dirt in the crawl space. Correction is recommended.

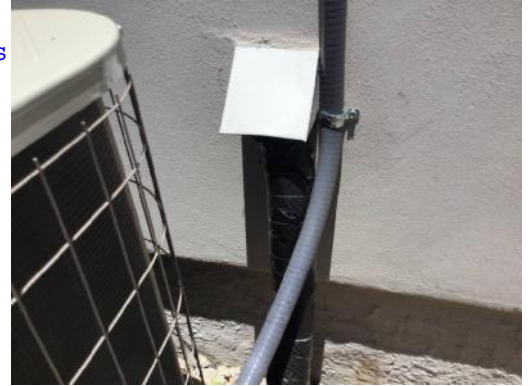
Refrigerant Lines: Recommend sealing the connection where the refrigerant lines penetrate the wall to prevent rodent intrusion.

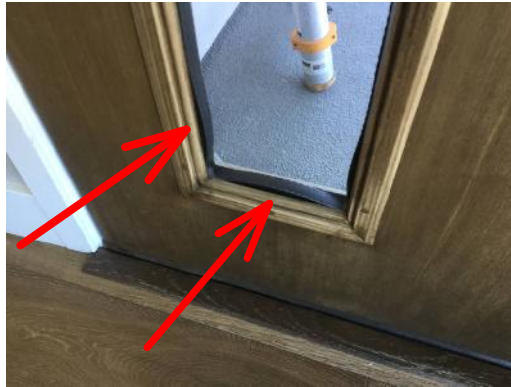
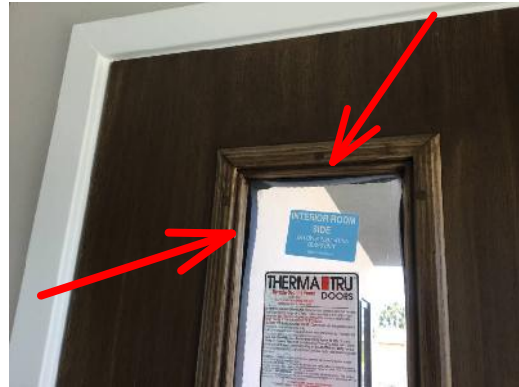
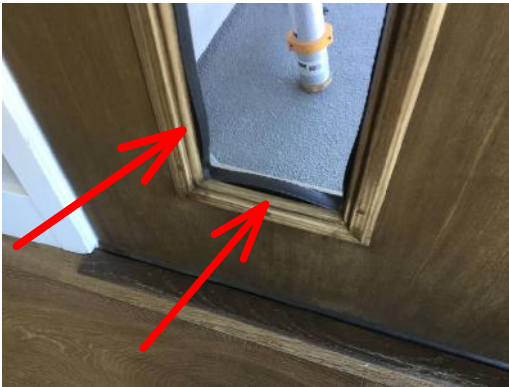
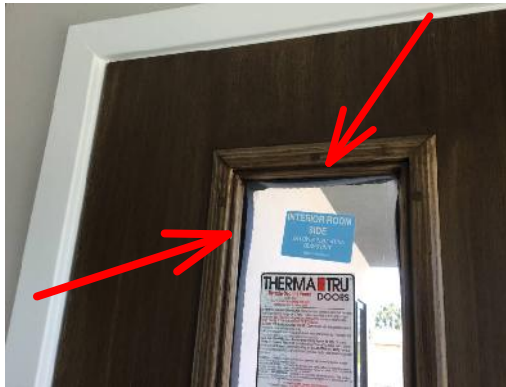
1. Defective

Entry Door: The inner window seal appears to be damaged at one or more areas. A qualified licensed contractor is recommended to evaluate and estimate repairs.

6. **Living Space Entry Door:** The inner window seal appears to be damaged at one or more areas. A qualified licensed contractor is recommended to evaluate and estimate repairs.

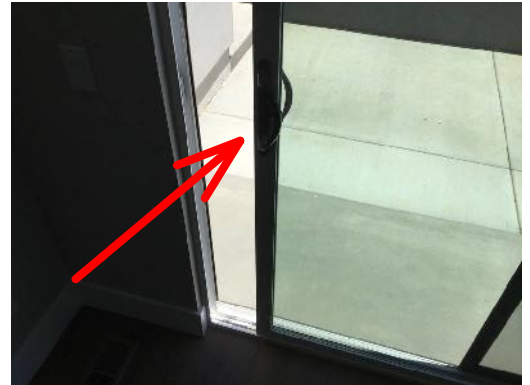
2. Safety Upgrade, Marginal

Exterior Door(s): Latching hardware was loose and not properly operational at one or more areas (Master bedroom glass slider). Correction is recommended for added safety.

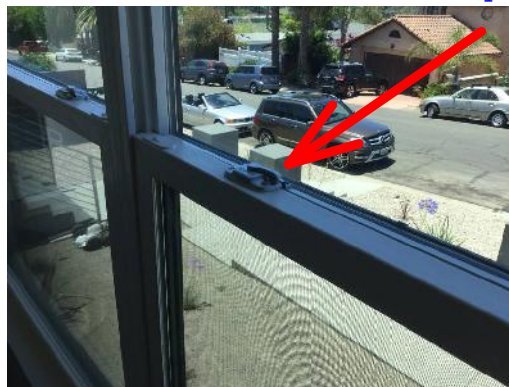
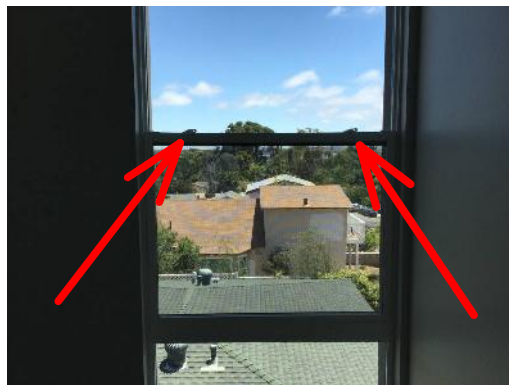
Windows: A tint has been installed on one or more windows. This could cause damage if improperly installed. Determining if the installation is proper is beyond the scope of this inspection. One or more windows are difficult to latch or lock properly. Correction is recommended for added safety.

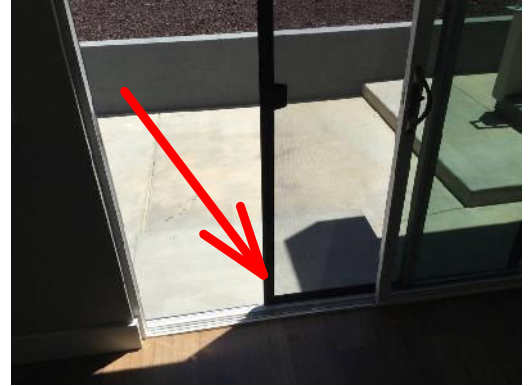
Window Screens: Screen doors slide with difficulty in one or more locations. Correction is recommended.

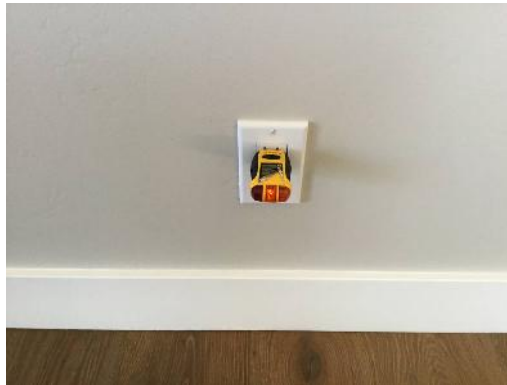
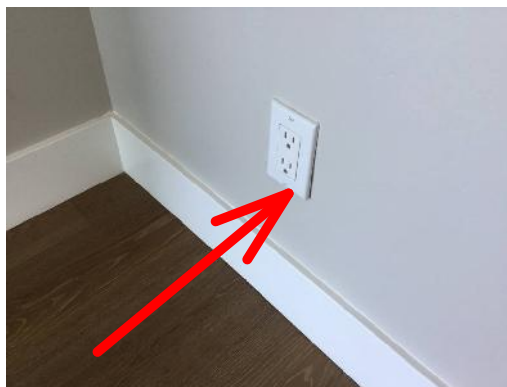
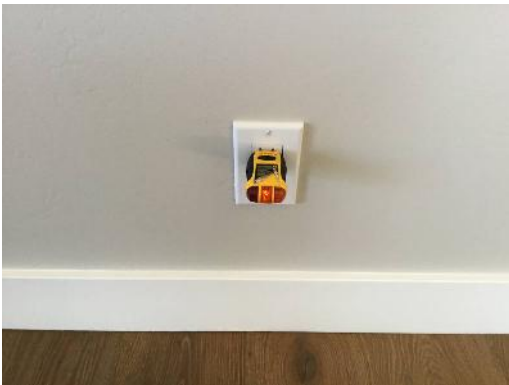
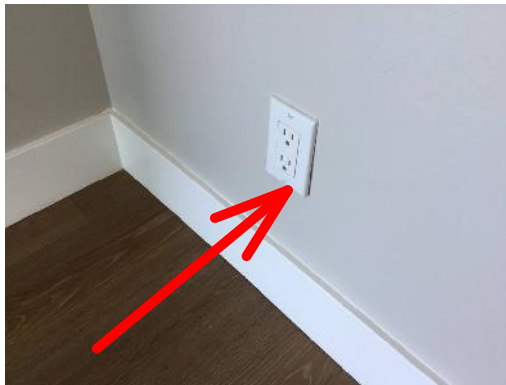
10. Defective, Safety Upgrade

Electrical: Low voltage wiring, security system, cable TV and/or telephone are all beyond the scope of this inspection. One or more outlets has three prong outlets which were not properly grounded at the second floor living room. Loose outlets were noted. A qualified licensed electrical contractor is recommended to evaluate and estimate repairs.

7. **Living Space Electrical:** Low voltage wiring, security system, cable TV and/or telephone are all beyond the scope of this inspection. One or more outlets has three prong outlets which were not properly grounded at the second floor living room. Loose outlets were noted. A qualified licensed electrical contractor is recommended to evaluate and estimate repairs.

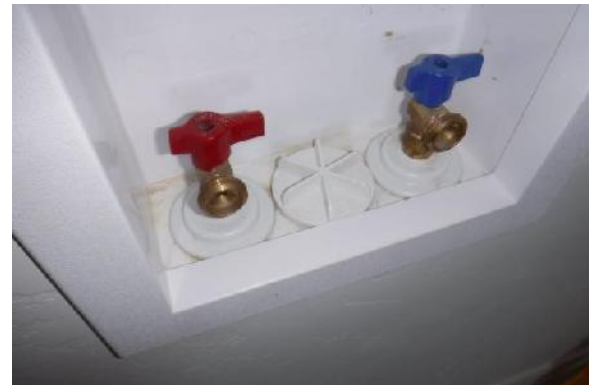
Washer Drain: Drain is still capped. Correction is recommended.

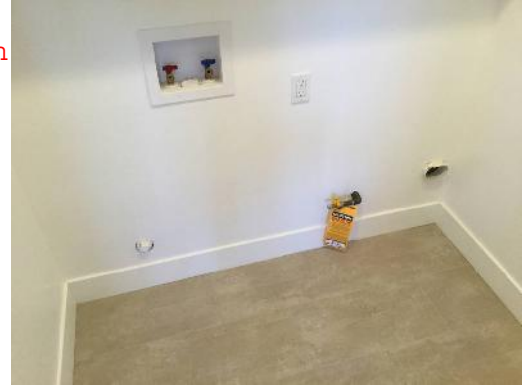
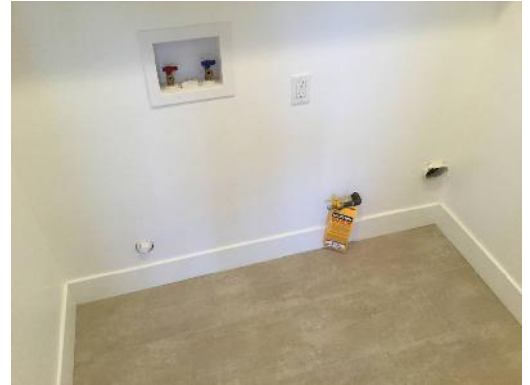
8. Defective

Floor Drain: No floor drain has been installed. We recommend adding a catch pan with a drain to the exterior. A qualified licensed contractor is recommended to evaluate and estimate repairs.

9. **Laundry Room/Area Floor Drain:** No floor drain has been installed. We recommend adding a catch pan with a drain to the exterior. A qualified licensed contractor is recommended to evaluate and estimate repairs.

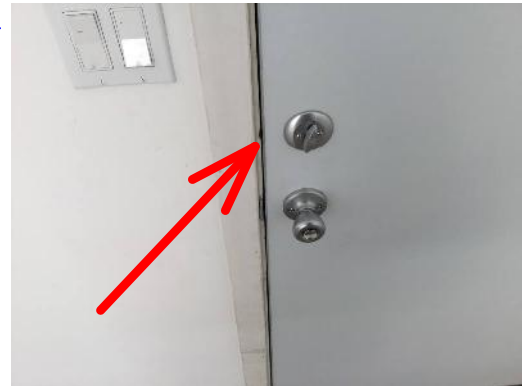
Exterior Door: Latching hardware was not properly operational at one or more areas. Corrections are recommended.

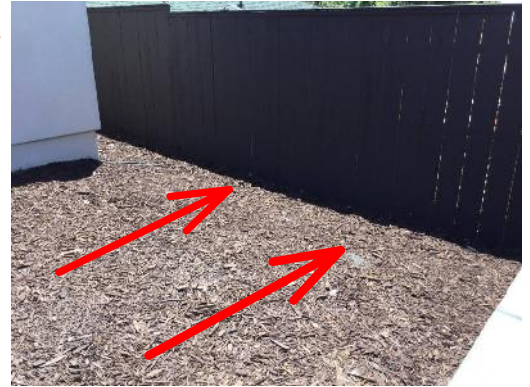
- 1. Grading:** The perimeter grading does not slope down and away from the structure in one or more areas. No drainage was visible. This could trap water near the structure. Inquire with the seller to verify that drainage has been installed that is not visible or underground. Wet soil may cause the foundation to settle and possibly fail over time. Recommend having all soil and or hardscape so it slopes down and away from the structure properly or adding drainage as necessary using standard building practices. A qualified licensed contractor is recommended to evaluate and estimate repairs.

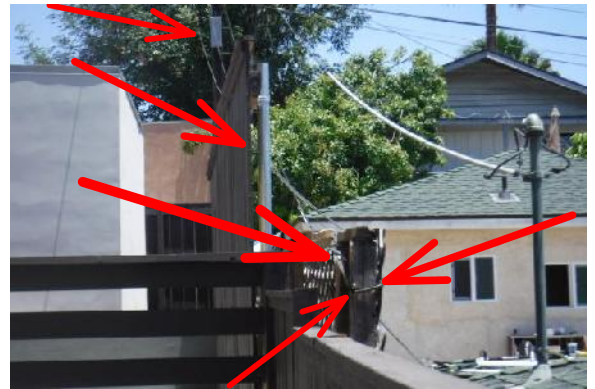
- 2. Exterior Surface Low Voltage Utilities:** Boxes have not been installed for the low voltage utilities (cable, TV and television). These are typically separate metal boxes. The wires have been disconnected and were hanging on the fence. A qualified licensed contractor is recommended to evaluate and estimate repairs.

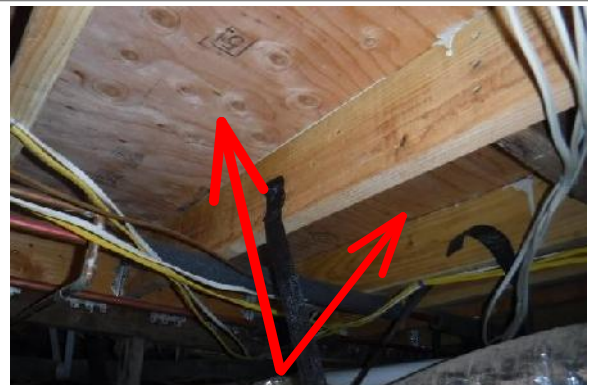
- 3. Crawl Space Insulation:** No insulation has been installed in some areas. Correction is recommended.
