Aztec Property Inspections
3655 Cowley Way
San Diego, CA 92117
(858) 245-9329

Client: Investor Group

888 San Diego Street
San Diego, CA 92104

Investor Group
Commercial Sample Report.inspx

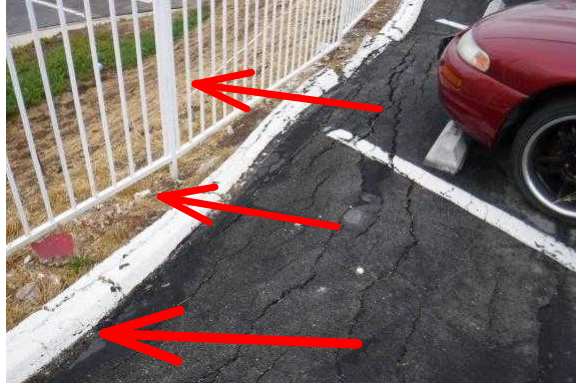
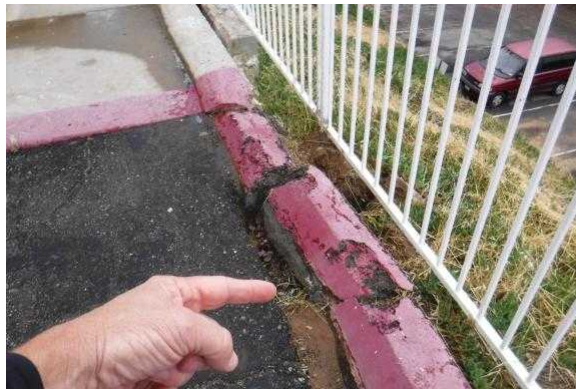
1. Not Inspected **Vehicle Gate:** Beyond the scope of this inspection as per the Standards of Practice set forth by CREIA (California Real Estate Inspection Association).
2. Safety Upgrade, Marginal **Walkways:** Damaged and or deteriorated in one or more areas. A raised or settled surface was noted thus creating a trip hazard noted in one or more areas. Headroom was unconventionally low in one or more areas (pool gate). Correction is recommended.
3. Marginal **Driveway:** Damaged or deterioration noted in one or more areas. Settlement was noted towards the hillside. A qualified licensed contractor is recommended to evaluate and estimate repairs.

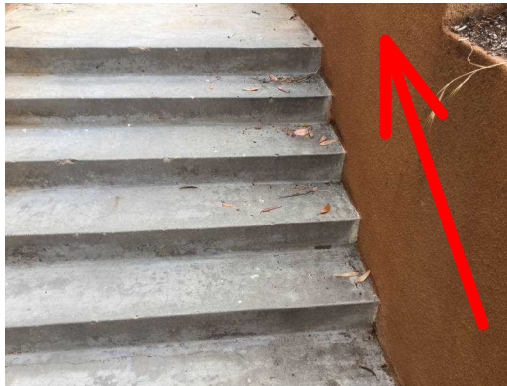
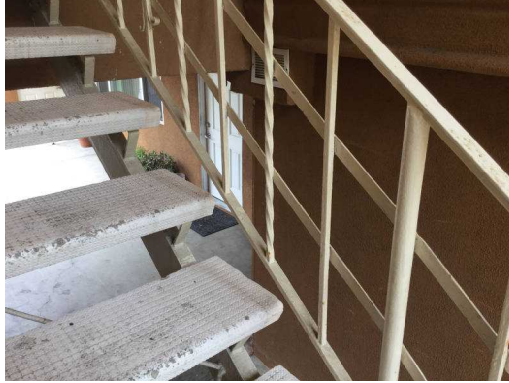
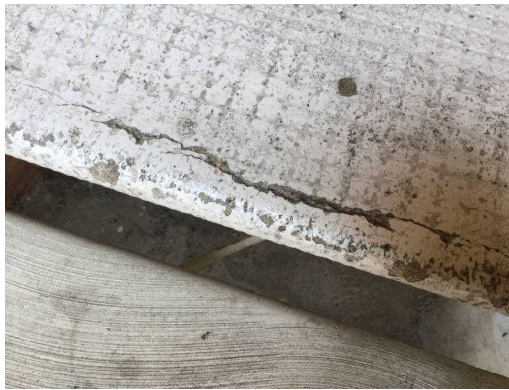
4. Safety Upgrade, Marginal **Stairs and Railings:** Handrails and or guardrails do not appear to be tall enough to meet the current building standards in one or more areas. Correction may be desired for safety. The guardrails comply with code but could be considered a safety hazard because kids tend to climb horizontal guardrails. Loose guardrail was noted to 17. Correction is recommended.

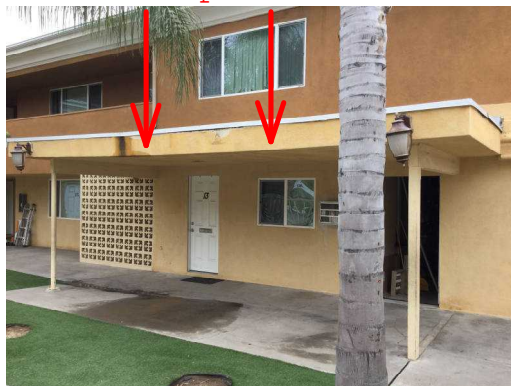
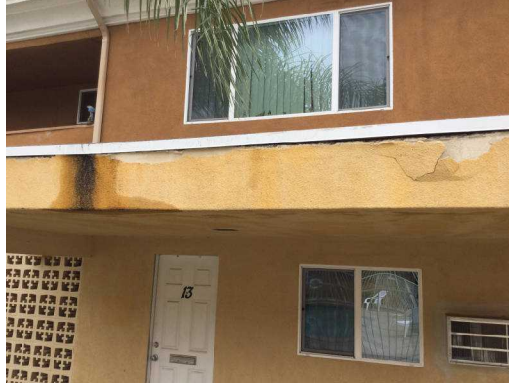
6. Defective, Safety Upgrade **Patio Cover:** Damage and settlement was noted. A qualified licensed contractor is recommended to evaluate and estimate repairs.

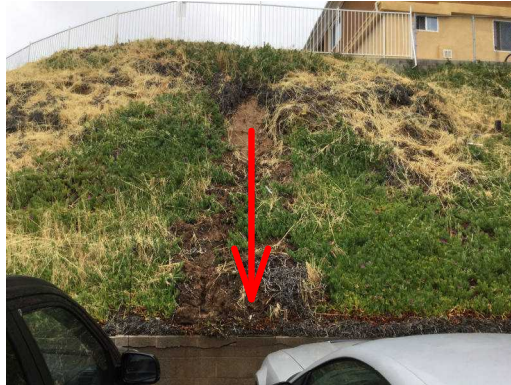
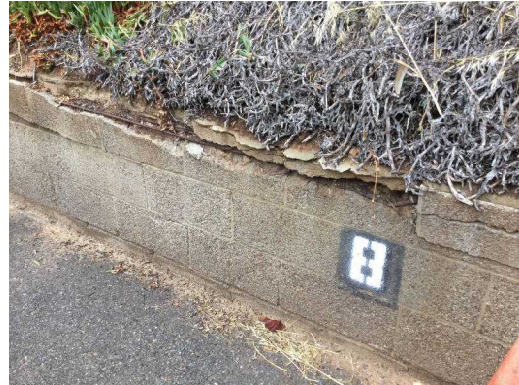
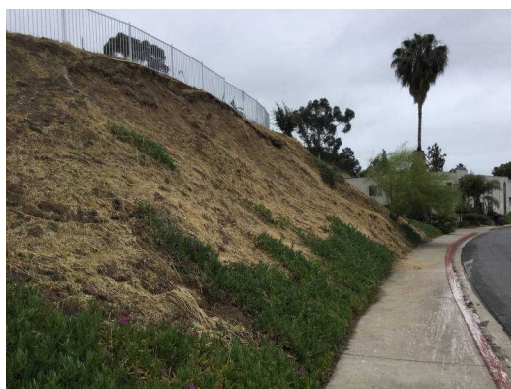
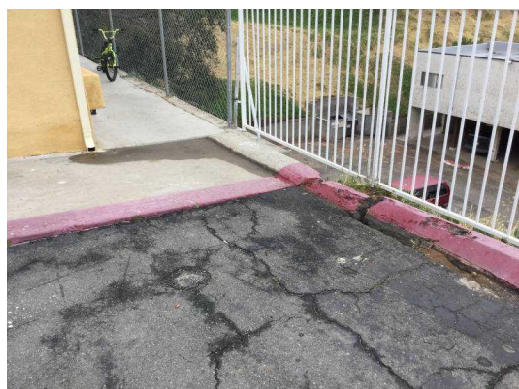
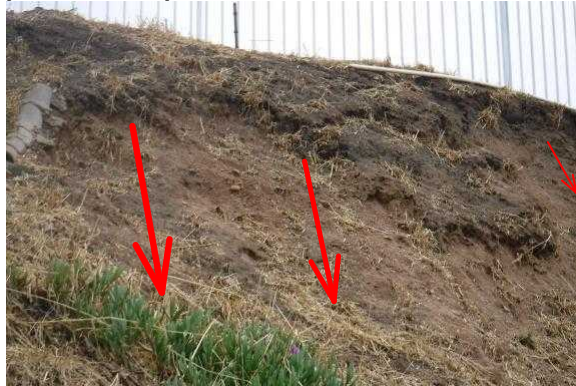
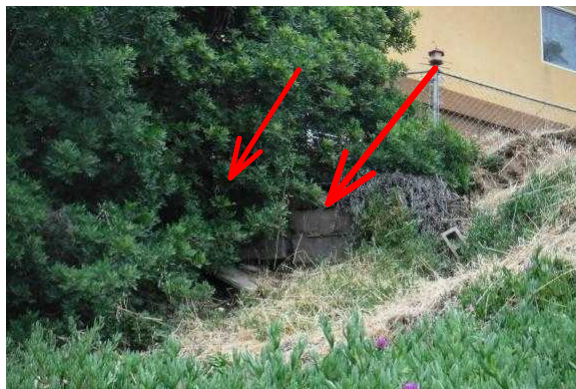
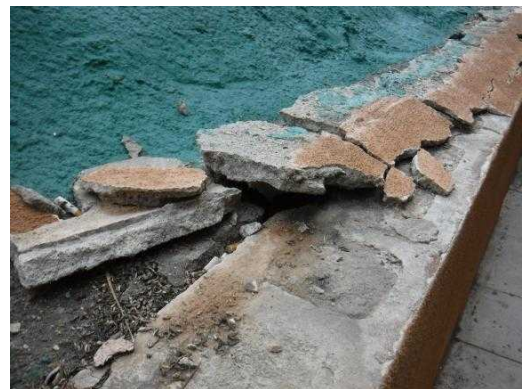
Retaining Walls: A walk off or drop off hazard noted in one or more areas. Recommend installing guard rails for added safety. Soil in one or more areas was not supported. This may be acceptable if the soil/rock is deemed as stable enough by a licensed professional. Determining this is beyond the scope of this inspection. Further evaluation may be desired. Soil was coming over the walls in one or more areas. Soil has given way and or eroded in one or more areas. It is unknown which property owns the wall and or walls. Leaning walls and or damage were noted in one or more areas (lower property). A qualified licensed civil and or geo technical engineer is recommended.

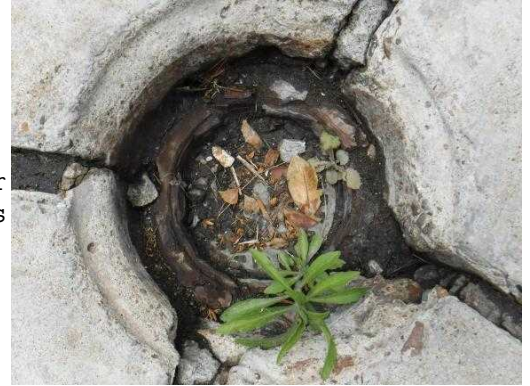
Exterior Surface Drain: Beyond the scope of this inspection as per the Standards of Practice set forth by CREIA (California Real Estate Inspection Association). Clogged and or blocked drains were noted in one or more areas. Inquire with the seller as to the termination point(s) of the surface drains. The perimeter grading does not slope down and away from the structure in one or more areas. No drainage was visible. This could trap water near the structure. Inquire with the seller to verify that drainage has been installed that is not visible or underground. Wet soil may cause the foundation to settle and possibly fail over time. Recommend having all soil and or hardscape so it slopes down and away from the structure properly or adding drainage as necessary using standard building practices. The property drains onto the neighbor's yard. Correction is recommended.

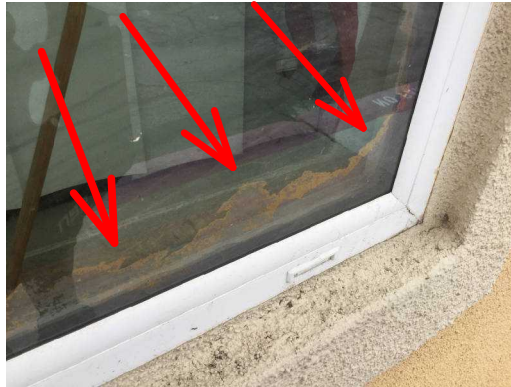
Windows: Moisture and or discoloration was noted to one or more windows. This is usually due to a damaged seal. A qualified licensed contractor is recommended to evaluate and estimate repairs.

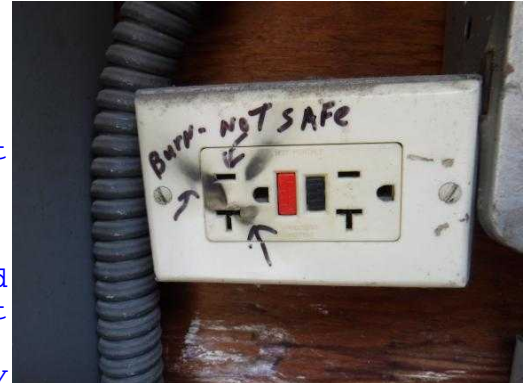
Exterior Electric Outlets: (120 VAC GFCI) - Minimal outlets were visible on the exterior of the property. Recommend adding more outlet for improved functionality. Water proof covers are recommended in one or more areas. Scorched outlet noted in one or more areas (closet by pool equipment). Further evaluation is recommended by a licensed electrician. A qualified licensed contractor is recommended to evaluate and estimate repairs.

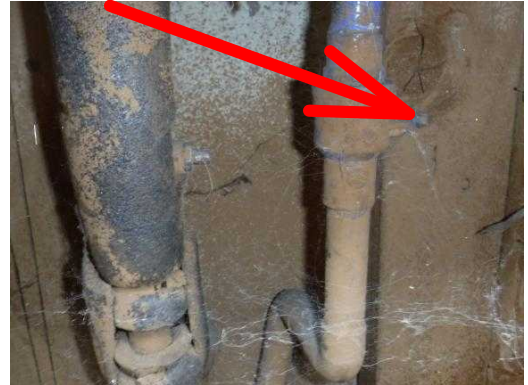
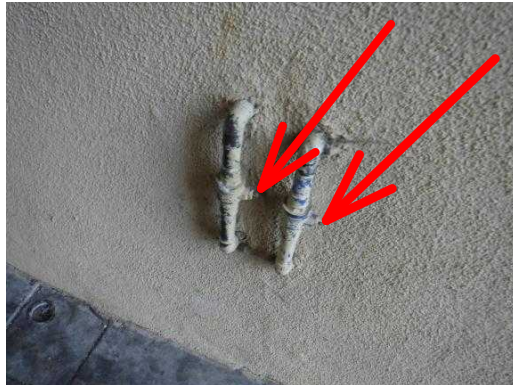
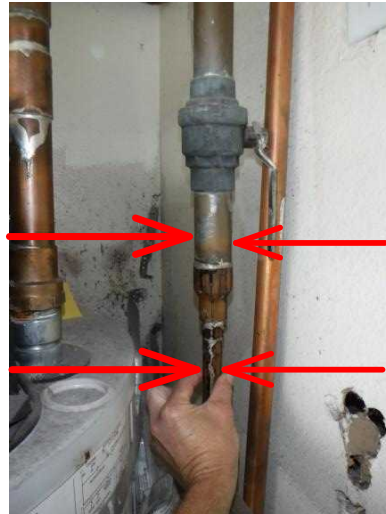
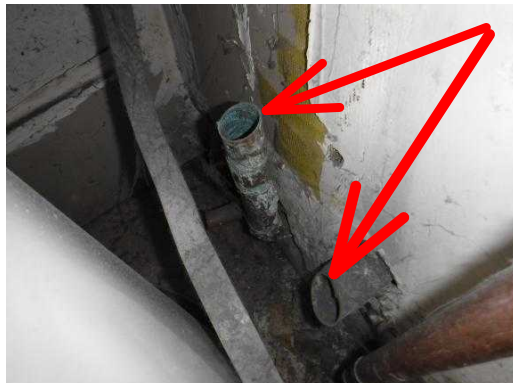
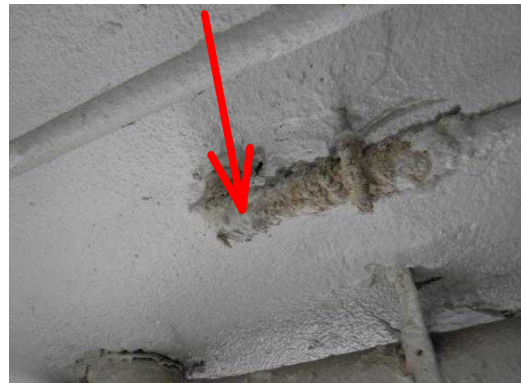
Water Lines: (Copper and Unknown) - Water shut off valves have been removed in several areas. Correction is recommended. The supply lines have been re piped with copper in several areas. Inquire with the seller as to why and what was done. The much larger water lines have been terminated. The water line in the laundry reduces from 1 1/2" to 3/4". This is very unusual and further evaluation is needed. A leak was noted in one or more areas (laundry ceiling). Further evaluation is recommended by a licensed plumber.

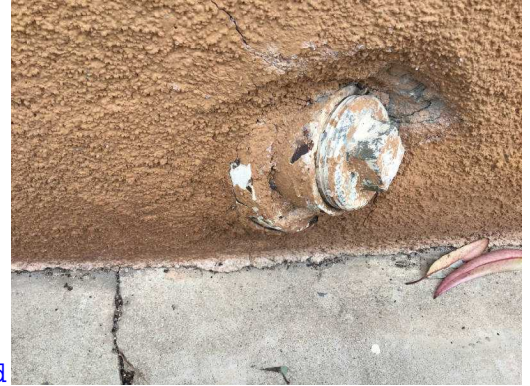
Waste Lines (ABS and Cast Iron) - A clean out cover was missing in one or more areas (under the electrical panel). This could allow sewer gases to come up through the pipe and correction is recommended. Cast iron waste lines rust from the inside out and generally last 50-70 years before needing to be replaced. However, any home over 35 years of age has an increased risk of failure due to aging. We recommend having a qualified licensed professional come out to scope (run a camera in the waste lines) and to perform a visual inspection. Only the visible portions of the waste system were inspected. A slow drain was noted. A qualified licensed plumbing contractor is recommended to evaluate and estimate repairs.

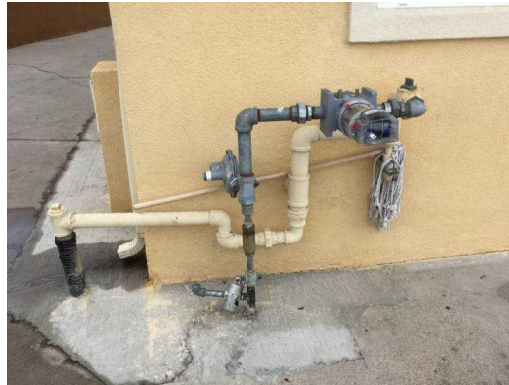
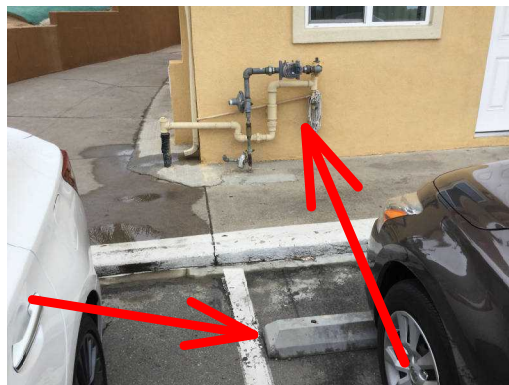
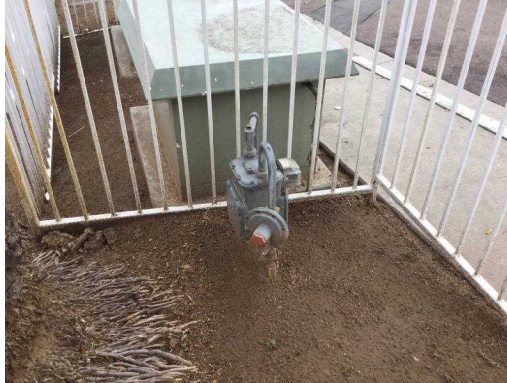
Gas Meter: Recommend protecting the unit from physical damage (car). Inquire with the seller to see the purpose of the small gas meter by the fence. Correction is recommended.

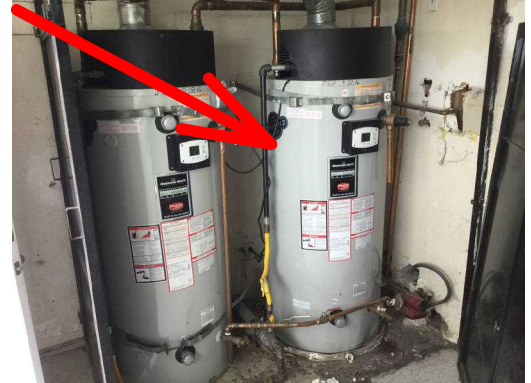
15. Acceptable, Safety Upgrade **Operation:** The local utility company is recommended for a complimentary safety inspection before the close of the contingency period. A gas line drip leg (sediment trap) is recommended. The local utility company is recommended for a complimentary safety inspection. Recommend raising the unit so the flame is at least 18" off the floor. This is required in the garage or any other area where flammables are kept. It is recommended in all other areas.

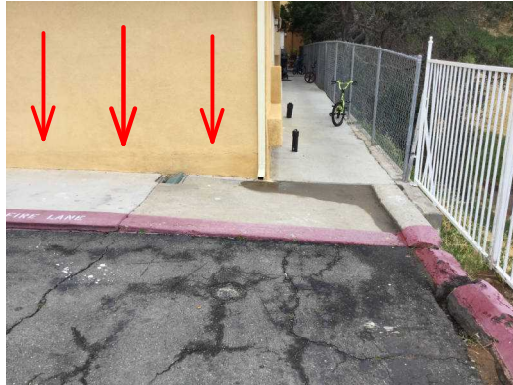
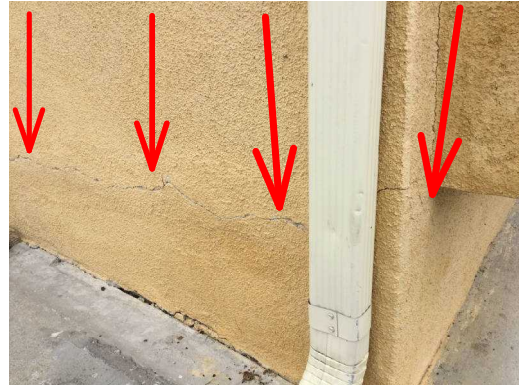
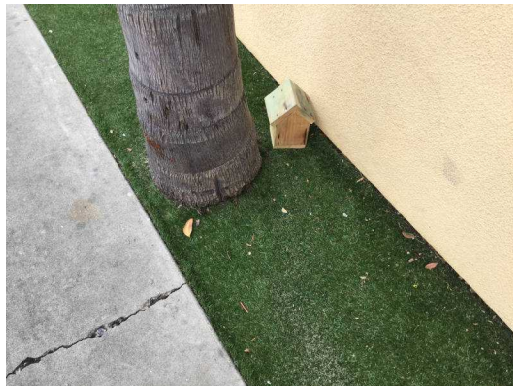
Floor/Slab: A tree was noted close to the structure. Removal is recommended to prevent future damage. One or more buildings were unusually close to the hillside based on today's standards. Cracks were noted and building has been recently stuccoed. A qualified licensed foundation contractor is recommended to evaluate and estimate repairs.

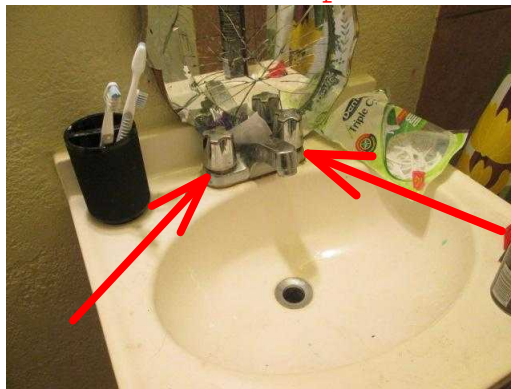
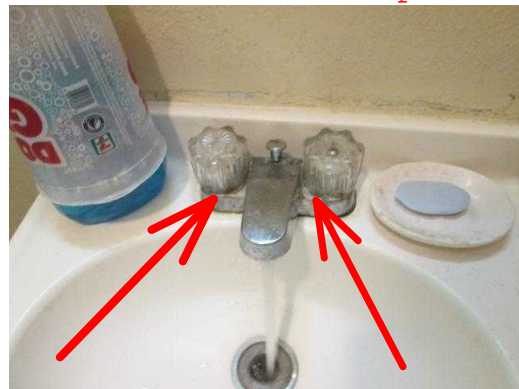
Faucets/Traps: Leaking faucet handles were noted at one or more units. A licensed plumber recommended to estimate repairs.

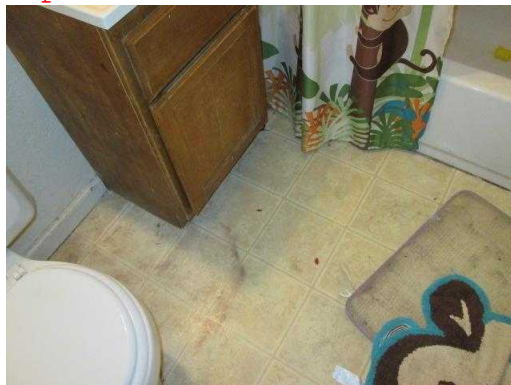
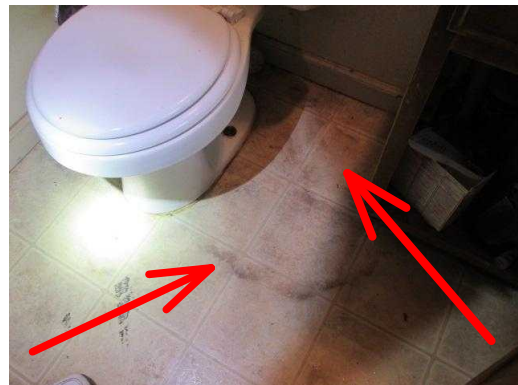
Floor: Standing water and moisture damage noted at the flooring. Unidentifiable biological substance is present and is a potential health concern (probably a mold or mildew). Further evaluation of the substance is recommended by a specialist. A moisture intrusion expert is also recommended.

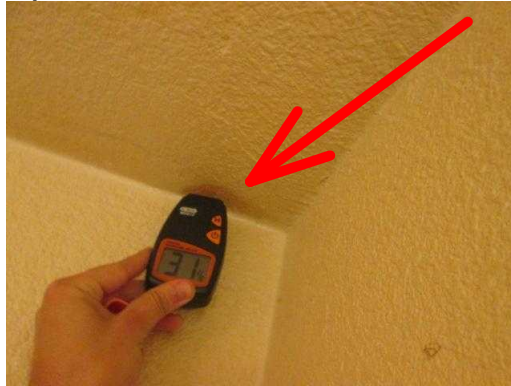
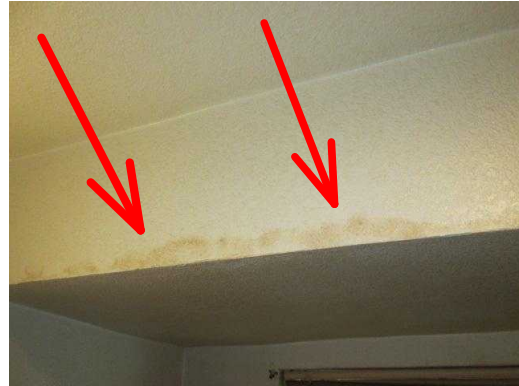
Ceiling: Water stains and or damage were present in one or more areas. Evidence of water intrusion was noted. Hidden damage and or mold/mildew may be present. A qualified licensed contractor is recommended to evaluate and estimate repairs.

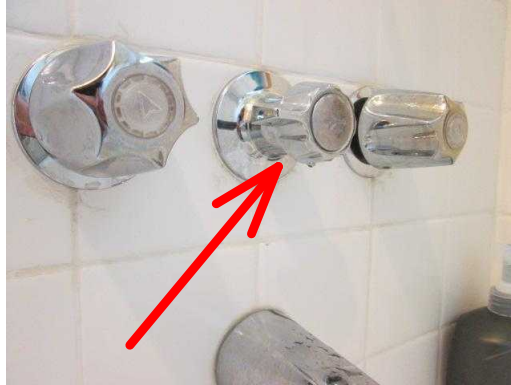
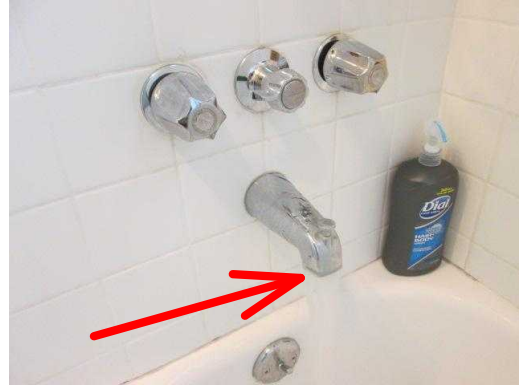
Tub/Surround: Tub diverter was not functional and is leaking at the handle. Water comes out the tub spout when the shower is activated. A qualified and licensed contractor is recommended to evaluate and estimate repairs.

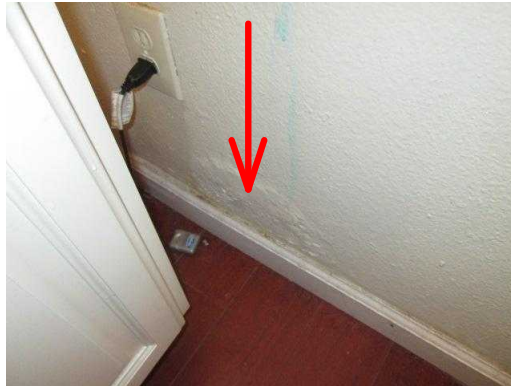
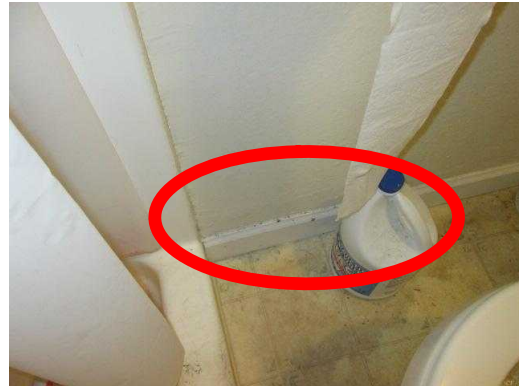
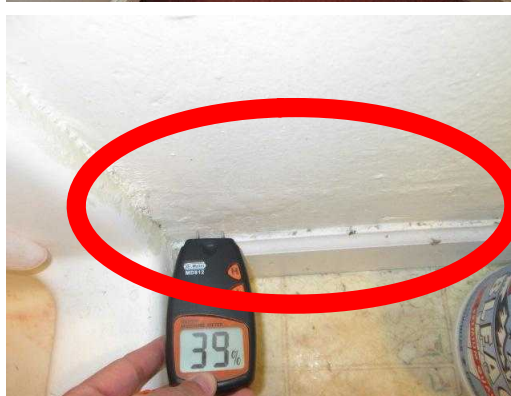
Unit #13 Bathroom

Walls: Patching or repairs were noted. Water stains and damage were present in one or more areas. It is beyond the scope of this inspection to determine if the moisture penetration is active. Inquire with seller and licensed specialist if necessary.

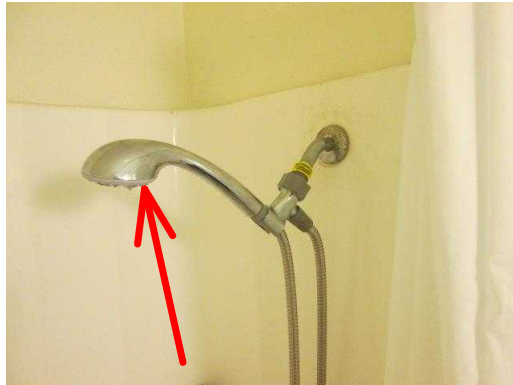
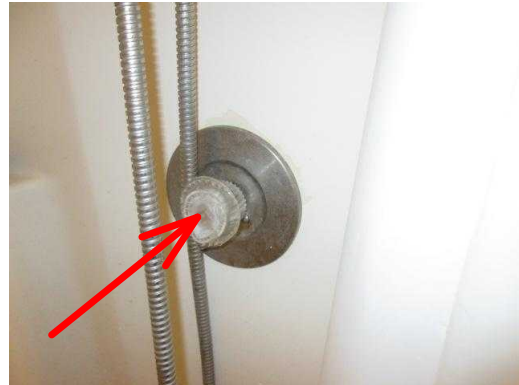
Faucets/Traps: A leaking shower faucet was noted. The shower faucet handle rotates 360 degrees. A licensed plumber recommended to estimate repairs.

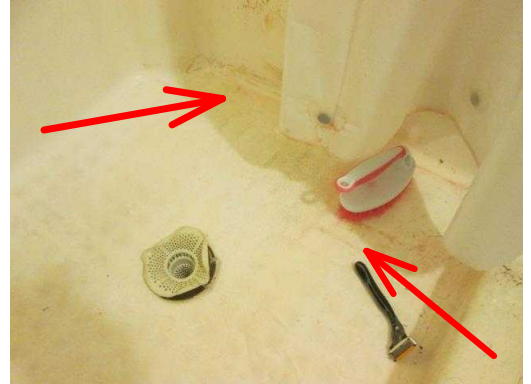
Shower/Surround: Cracks were noted at the shower pan.

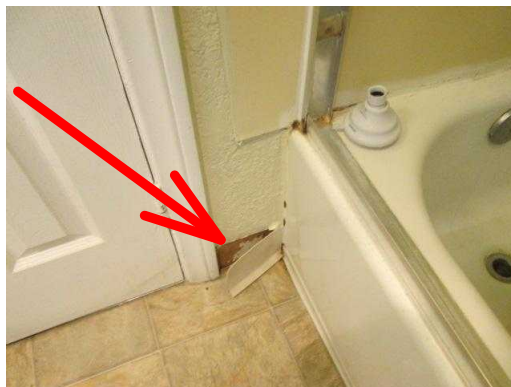
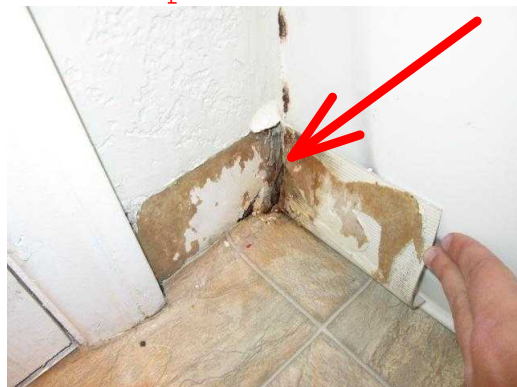
Walls: Water stains and or damage were present in one or more areas. Evidence of water intrusion was noted. Hidden damage and or mold/mildew may be present. A qualified licensed contractor is recommended to evaluate and estimate repairs.

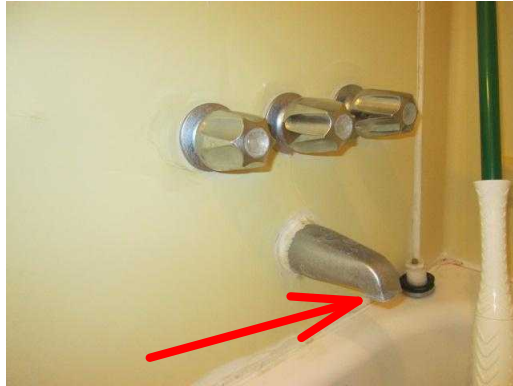
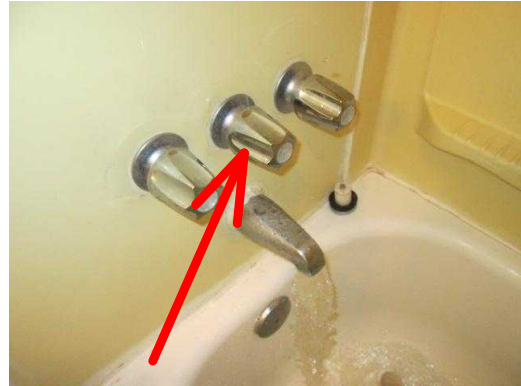
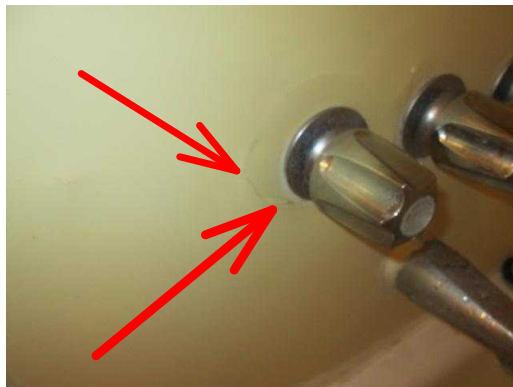
Tub/Surround: Tub faucet was actively drip leaking. Tub diverter was not 100 % functional. Some water comes out the shower spout when the tub is activated. Cracking was noted at the shower surround. A qualified and licensed contractor is recommended to evaluate and estimate repairs.

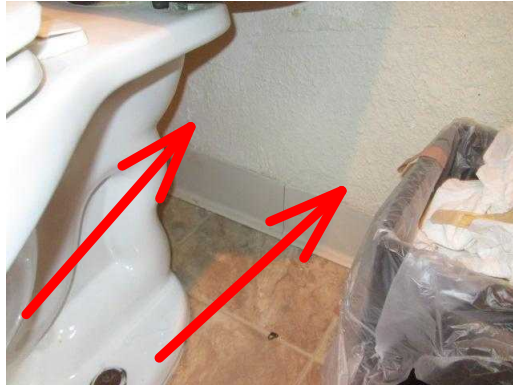
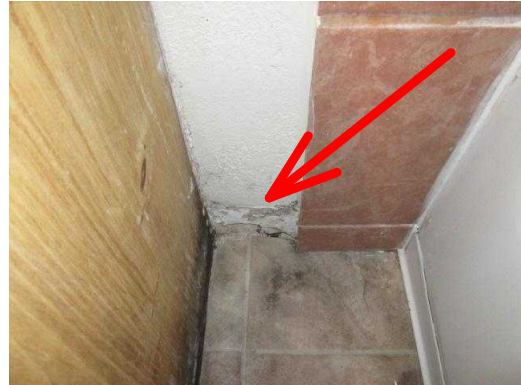
Walls: Water stains and damage were present in one or more areas. It is beyond the scope of this inspection to determine if the moisture penetration is active. Inquire with seller and licensed specialist if necessary.

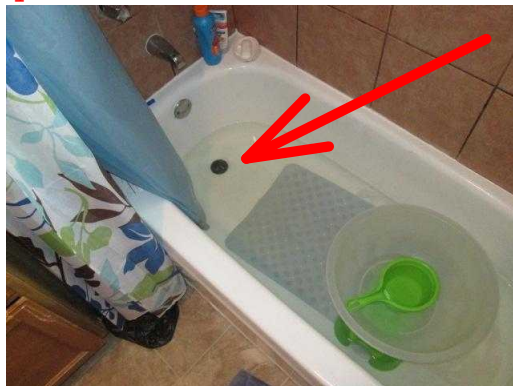
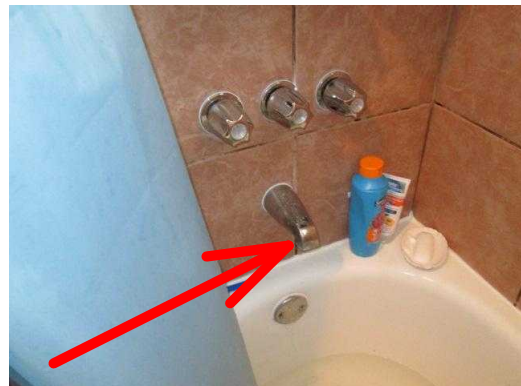
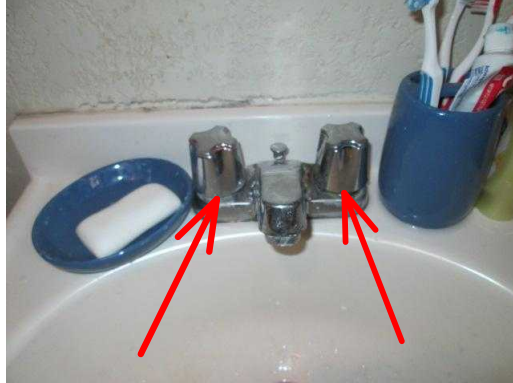
Faucets/Traps: A slow drain was noted at the tub. Leaking fixtures were noted in one or more areas (shower and sink faucet). A qualified licensed contractor is recommended to estimate repairs.

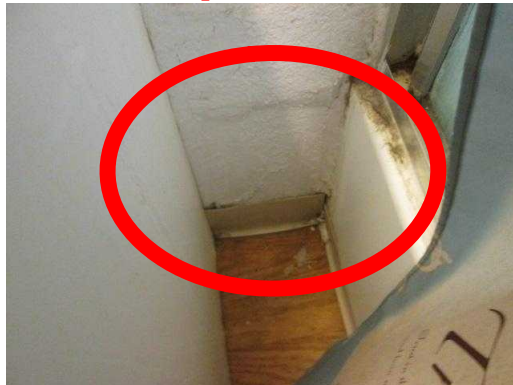
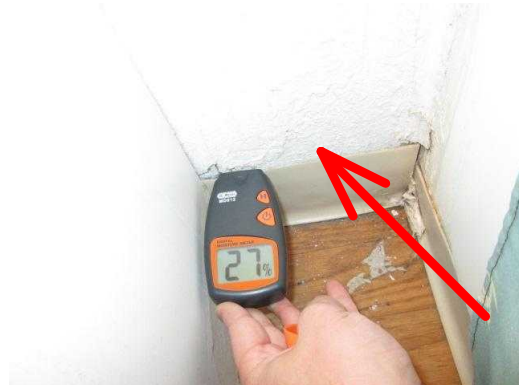
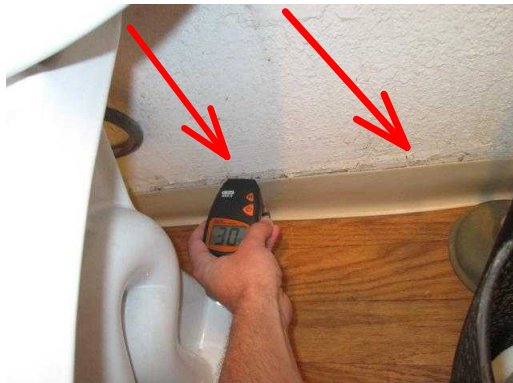
Unit #19 Bathroom

Walls: Water stains and damage were present in one or more areas. It is beyond the scope of this inspection to determine if the moisture penetration is active. Inquire with seller and licensed specialist if necessary.

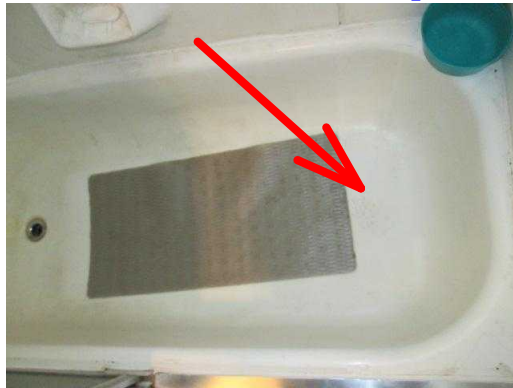
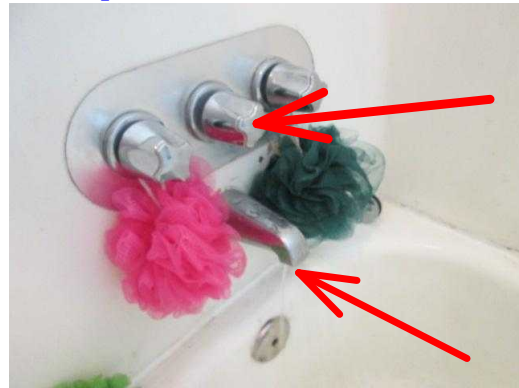
Tub/Surround: Chipped or damaged tub. A qualified contractor is recommended to evaluate and estimate repairs. Tub diverter was not 100 % functional. Some water comes out the tub spout when the shower is activated. Replacement may be needed.

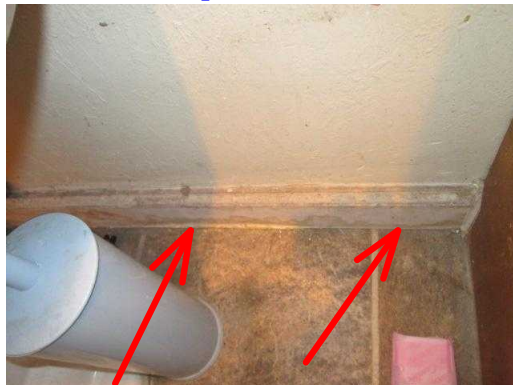
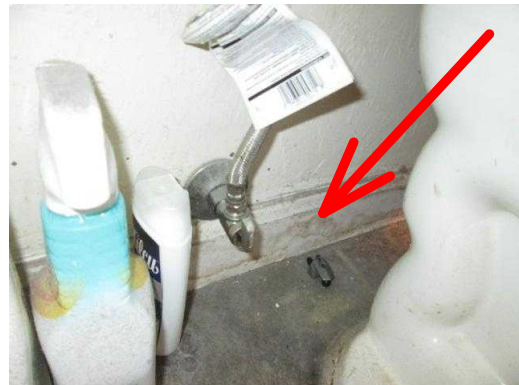
Unit #21 Bathroom

Walls: Water stains were present in one or more areas. It is beyond the scope of this inspection to determine if the moisture penetration is active. Inquire with seller and licensed specialist if necessary.

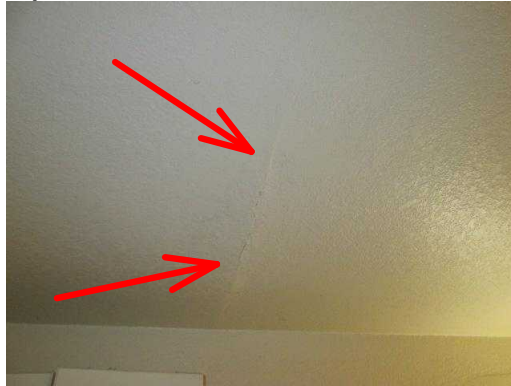
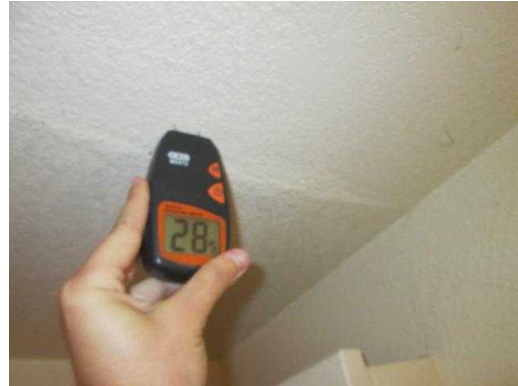
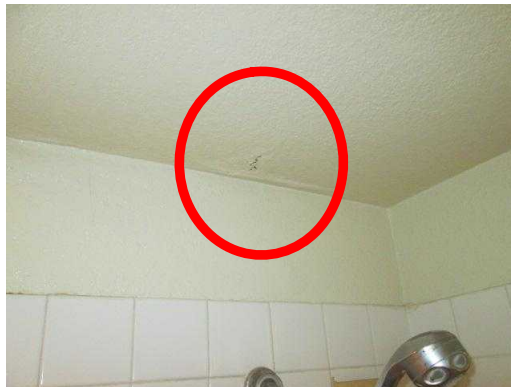
Ceiling: Soft spots and/or moisture damage were noted in one or more areas. Water stains and damage were present in one or more areas. It is beyond the scope of this inspection to determine if the moisture penetration is active. Inquire with seller and licensed specialist if necessary.

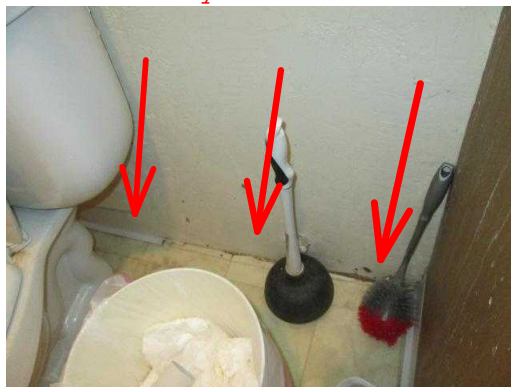
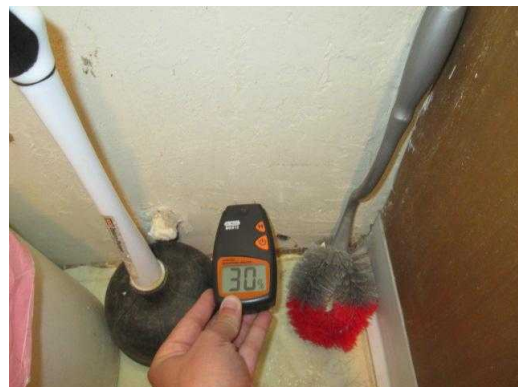
Walls: Water stains and damage were present in one or more areas. It is beyond the scope of this inspection to determine if the moisture penetration is active. Inquire with seller and licensed specialist if necessary.

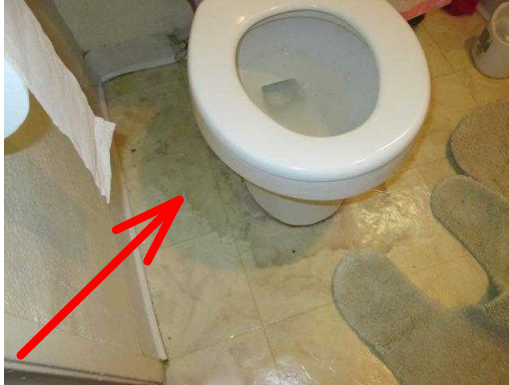
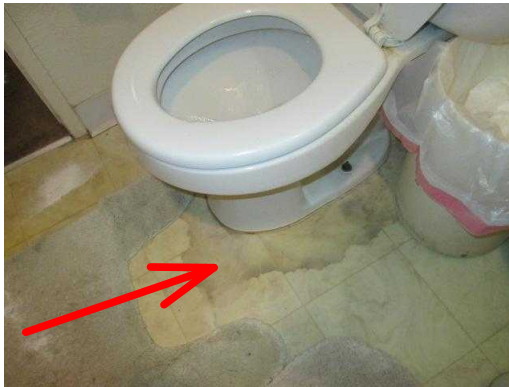
- 39. Defective, Safety Upgrade** **Floor:** Flooring was discolored and or stained in one or more areas. Water stains and or damage were present in one or more areas. Evidence of water intrusion was noted. Hidden damage and or mold/mildew may be present. A qualified licensed contractor is recommended to evaluate and estimate repairs.

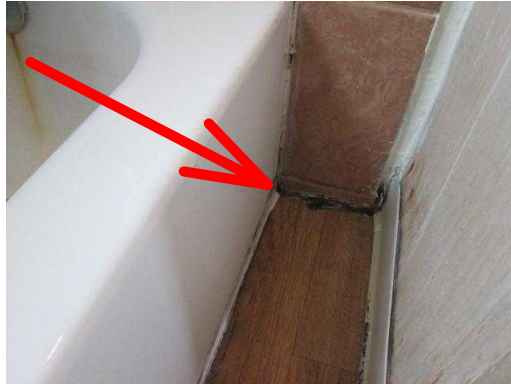
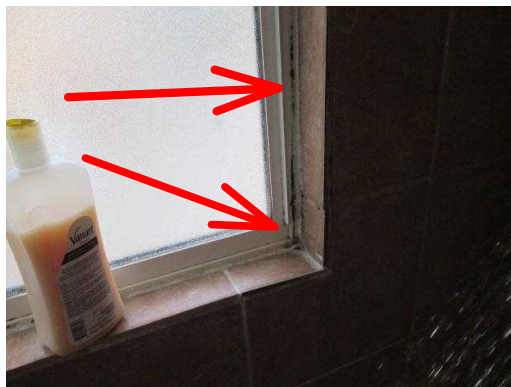
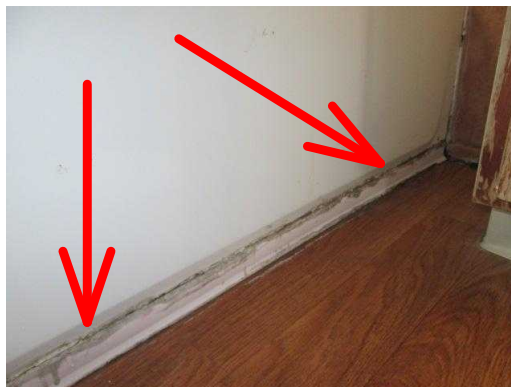
Tub/Surround: Grout was cracked or deteriorated at one or more areas. Correction is recommended. Unidentifiable biological substance is present and is a potential health concern (probably a mold or mildew). Further evaluation of the substance is recommended by a specialist. A moisture intrusion expert is also recommended.

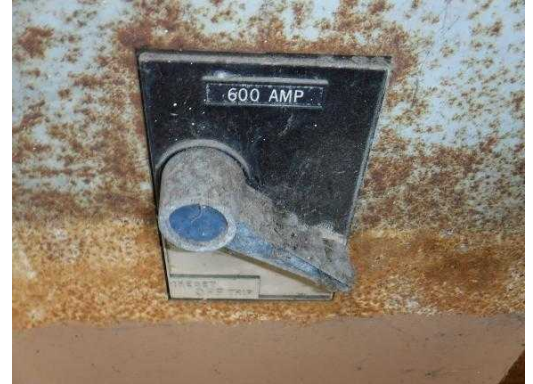
Main Breakers to each Sub Panel: The electrical system appears to be under powered by today's standards (50 amps). A qualified contractor is recommended to evaluate and estimate repairs.

Main Service: (600 Amps)

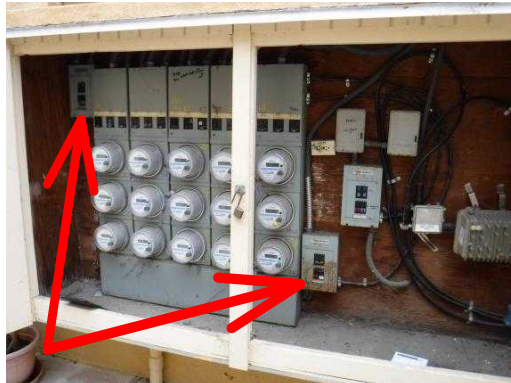
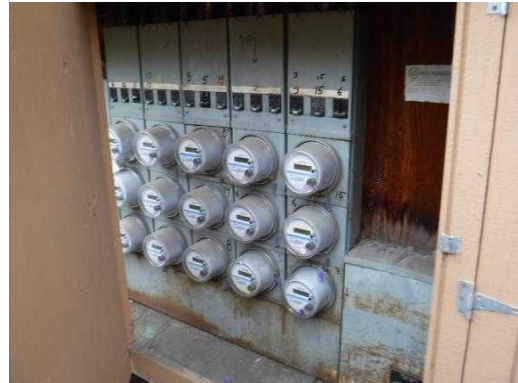
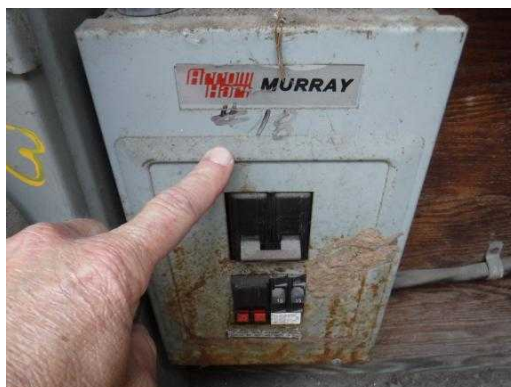
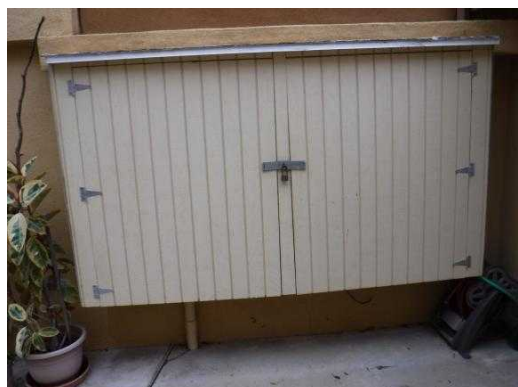
3. Safety Upgrade

Sub Panels: All the sub panels in the units were 100 amps max. The current building practice does not allow electrical panels clothes closets for added safety. This item is not required to be brought up to the current build practice but upgrades may be desired. The breakers were not labeled. Correction is recommended. Units 18 and 19 did not have electrical panels inside the unit. This would be very inconvenient if the breakers were to trip. Unable to locate a panel for 13. Upgrades may be desired.

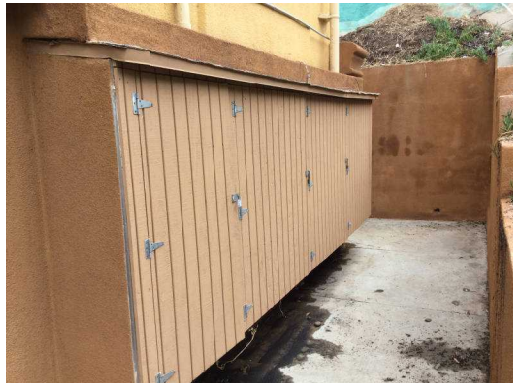
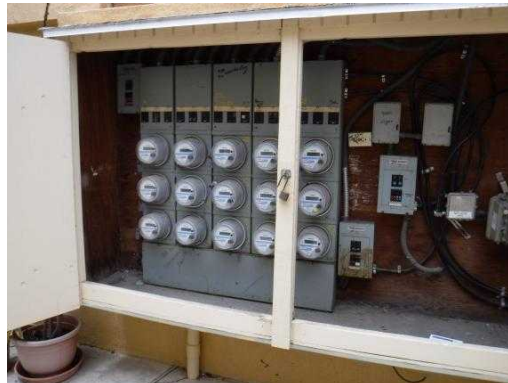
(Unit 17) Electric Panel

Condition: Paint and or texture was noted inside the panel. This is a potential fire hazard and correction is highly recommended. A qualified licensed contractor is recommended to evaluate the entire electrical system and estimate repairs.

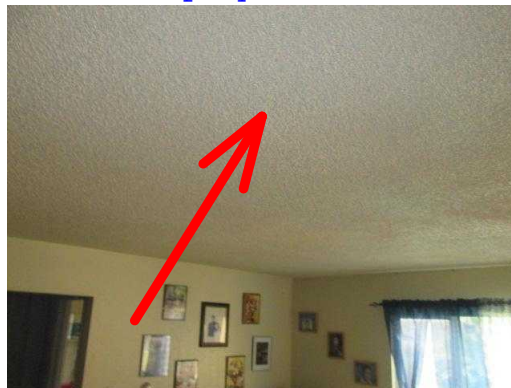
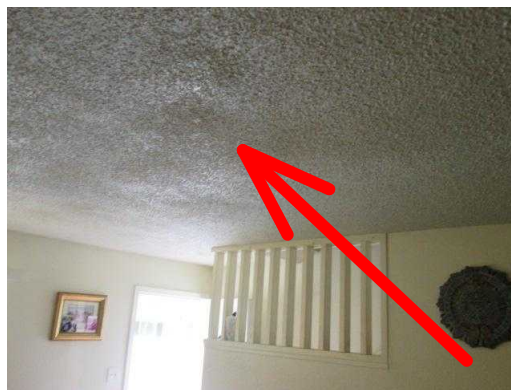
1. Safety Upgrade, Marginal **Ceiling:** Inquire with seller to see if the acoustic spray contains asbestos. If it is unknown then testing the acoustic spray is recommended at one or more units.

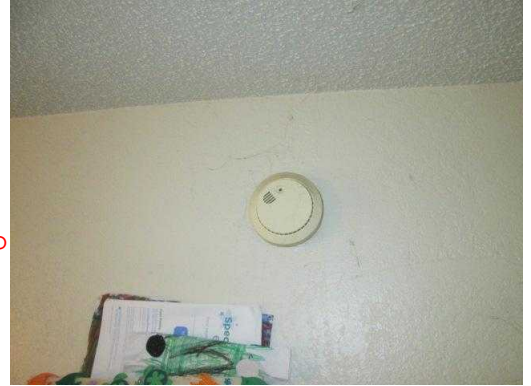
5. Defective, Safety Upgrade No detectors were found at one or more locations. A smoke detector is recommended for each hallway leading to a bedroom and one per bedroom. One or more smoke detectors did not appear to be operational. This is a safety item and correction is needed.

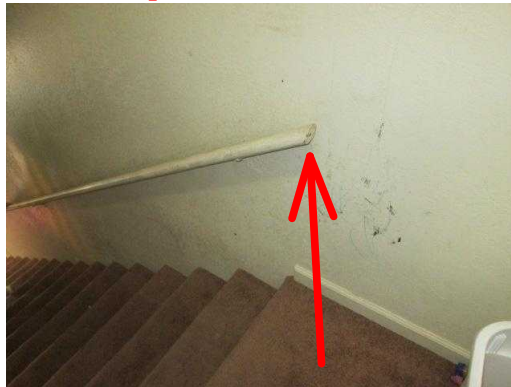
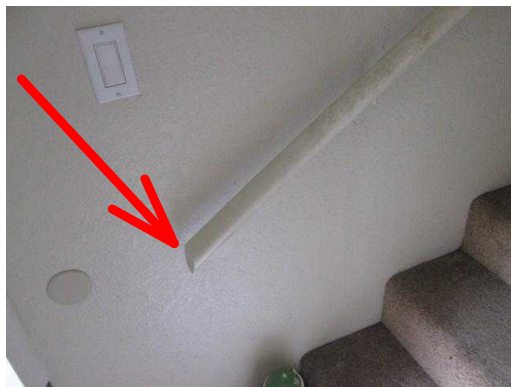
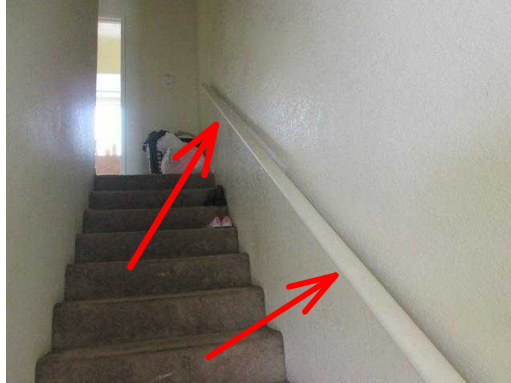
7. Defective, Safety Upgrade **Stairs and Railings:** Handrails were improper in one or more areas. The current building practice is that they should tie back into the wall for added safety. Loose handrails were noted in one or more areas. Recommend having a qualified contractor add proper guardrails where necessary.

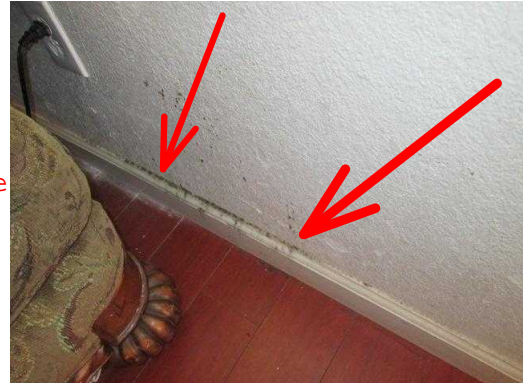
8. Defective, Safety Upgrade **Walls:** Unidentifiable biological substance is present and is a potential health concern (probably a mold or mildew). Further evaluation of the substance is recommended by a specialist. A moisture intrusion expert is also recommended.

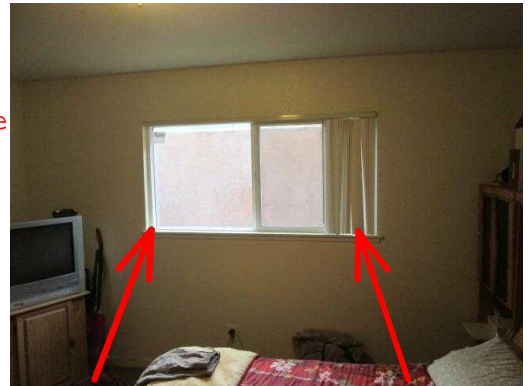
Windows: Windows in the bedrooms do not meet the current fire escape requirements in one or more areas. This is a safety hazard. It could have been acceptable when it was built but upgrades are recommended for added safety.

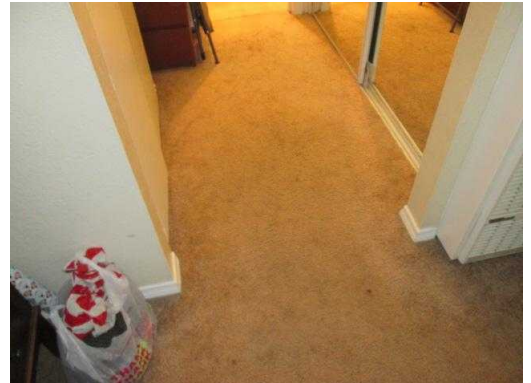
Floor: Uneven floors noted in one or more areas (hallway).

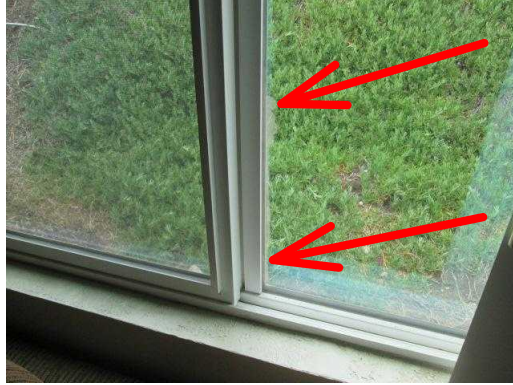
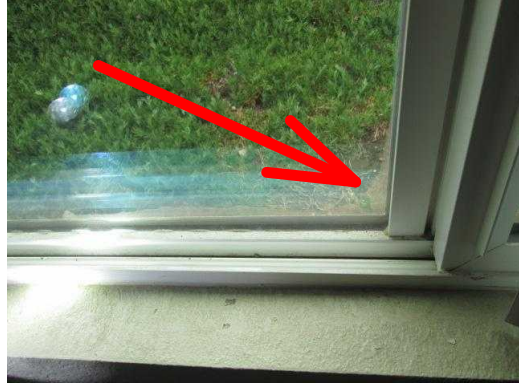
Windows: Moisture and or discoloration was noted to one or more windows. This is usually due to a damaged seal. A qualified licensed contractor is recommended to evaluate and estimate repairs.

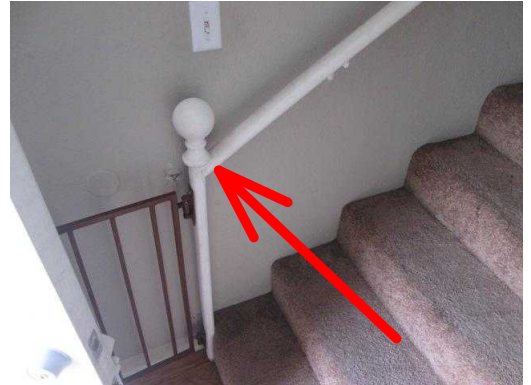
Stairs and Railings: Loose handrails were noted in one or more areas. Recommend having a qualified contractor add proper guardrails where necessary.

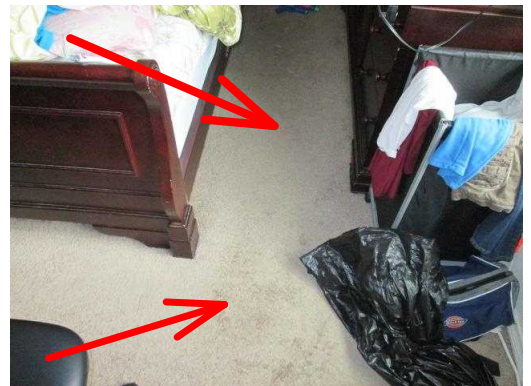
Floor: Uneven floors noted in one or more areas. Floor squeaks were noted in one or more areas.

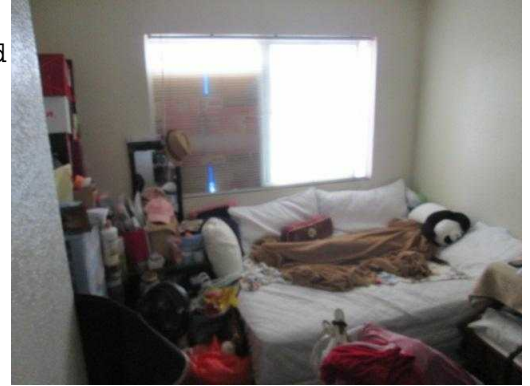
17. Not Inspected **Windows:** Unable to access all the windows due to personal belongings and or furniture.

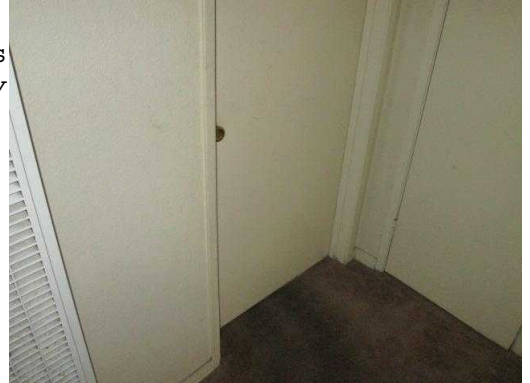
19. Not Inspected **Windows:** Unable to access windows in bedroom to see if they meet the Egress requirements - bedroom was occupied by tenant.

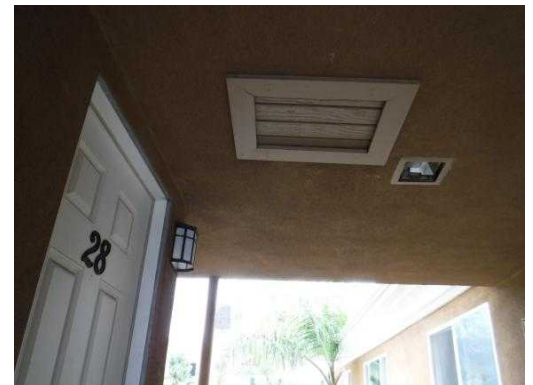
Access: Access is too small based on today's standards. Correction is recommended. No access was noted to one building. Be advised that because we could not enter the attic, hidden problems may exist that are not documented in this report. Access and further evaluation is recommended.
