Aztec Property Inspections
3655 Cowley Way
San Diego, CA 92117
(858) 245-9329

Client: Investor Group

888 San Diego Street
San Diego, CA 92104

Investor Group
Commercial Sample Report.inspx

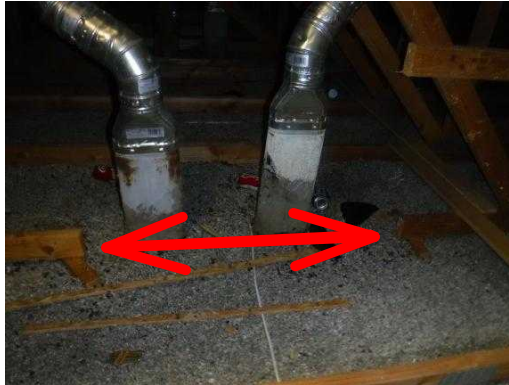
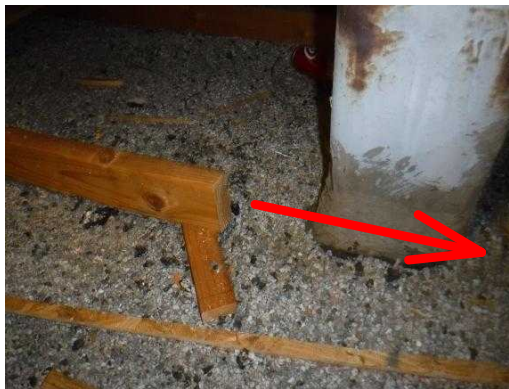
3. Safety Upgrade, Marginal **Roof Framing:** A truss framing system has been added to the original structure. Recommend confirming that the alterations had been engineered (to verify that it could handle the extra weight) and permitted. The truss has been cut and or altered. A qualified civil engineer is recommended for further evaluation. Damaged, soft and or deteriorated wood was noted in one or more areas. Further evaluation is recommended by a qualified and licensed pest control specialist.

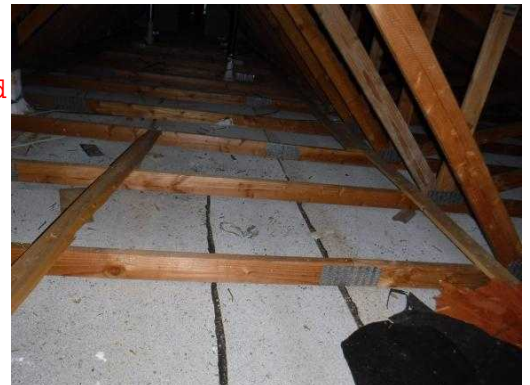
4. Defective, Safety Upgrade **Insulation:** No insulation present in one or more areas. A qualified licensed contractor is recommended to evaluate and estimate repairs.

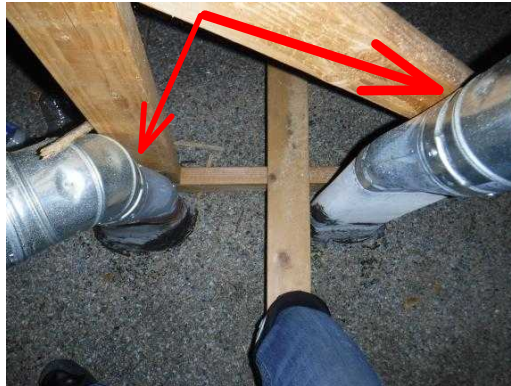
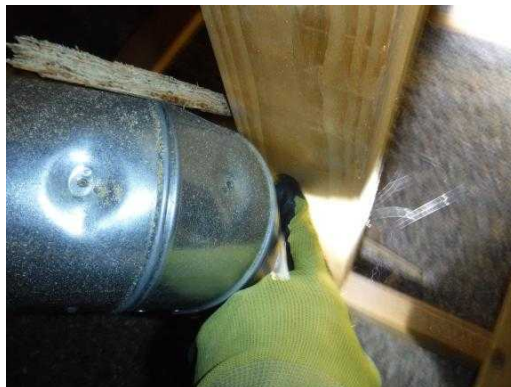
Heater Vents: Improper clearance to combustibles was noted at several vent pipes. This is a fire hazard and correction is recommended.

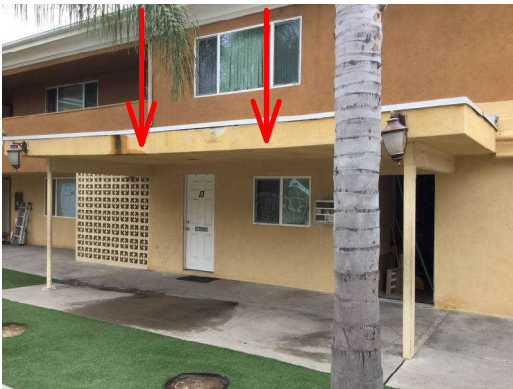
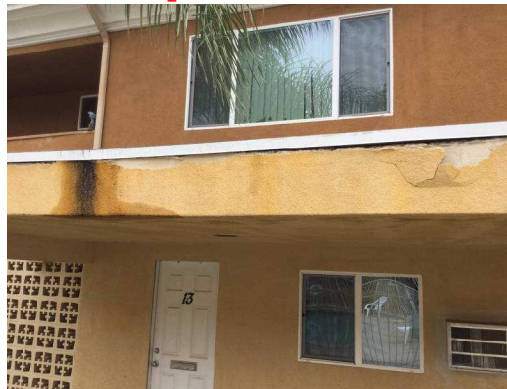
1. **Patio Cover:** Damage and settlement was noted. A qualified licensed contractor is recommended to evaluate and estimate repairs.

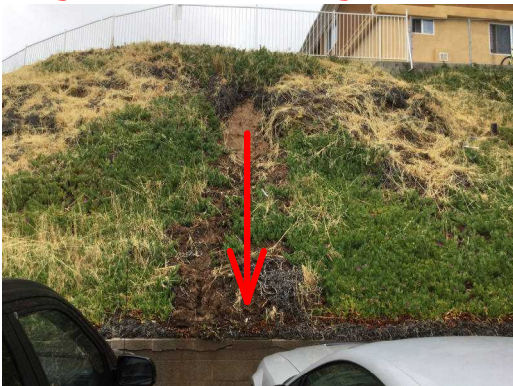
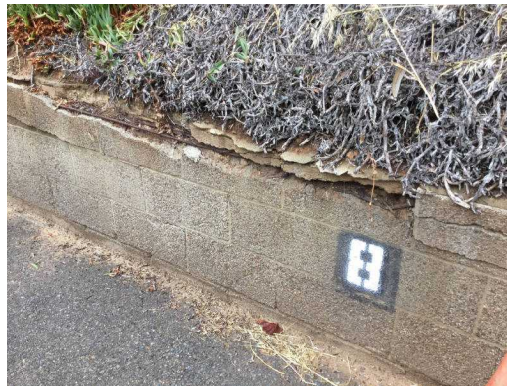
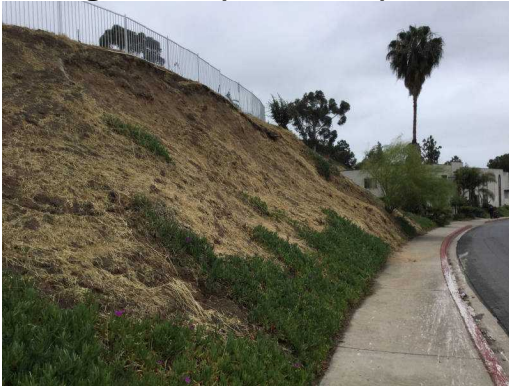
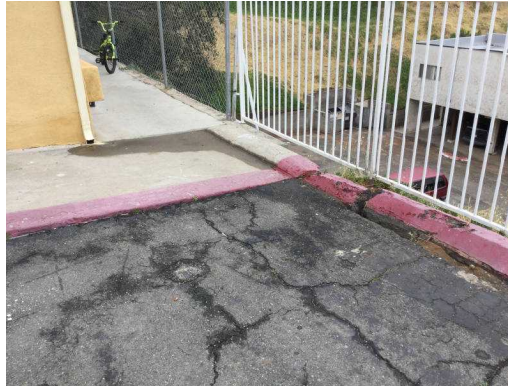
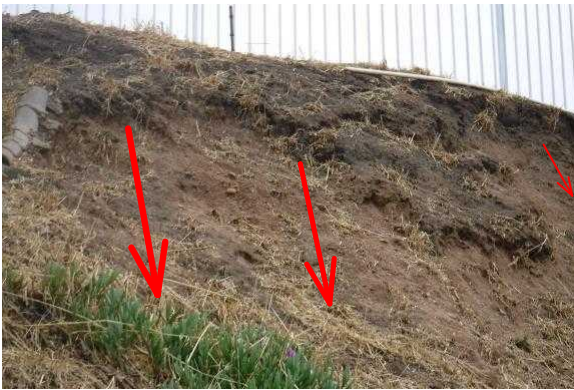
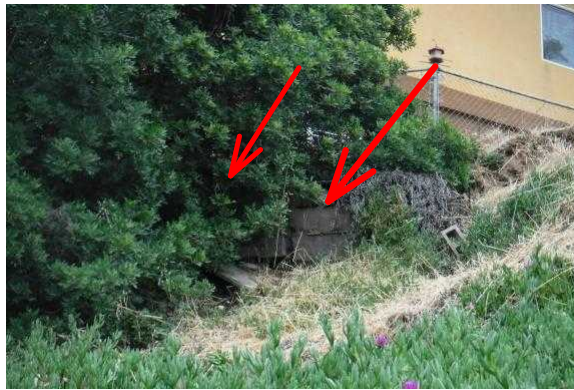
2. **Retaining Walls:** A walk off or drop off hazard noted in one or more areas. Recommend installing guard rails for added safety. Soil in one or more areas was not supported. This may be acceptable if the soil/rock is deemed as stable enough by a licensed professional. Determining this is beyond the scope of this inspection. Further evaluation may be desired. Soil was coming over the walls in one or more areas. Soil has given way and or eroded in one or more areas. It is unknown which property owns the wall and or walls. Leaning walls and or damage were noted in one or more areas (lower property). A qualified licensed civil and or geo technical engineer is recommended.

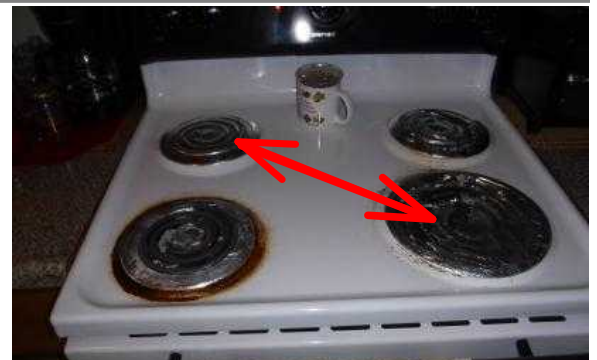
3. (Unit 17) Kitchen Cooking Appliances: (Electric) -
One or more burners did not operate properly.
Correction is recommended.

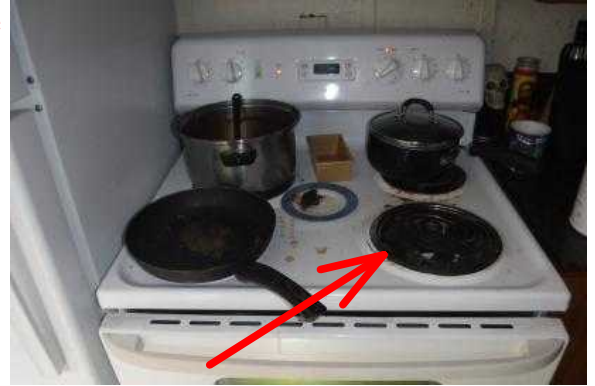
4. **(Unit 4) Kitchen Cooking Appliances:** (Electric) - One or more burners did not operate properly. Correction is recommended.

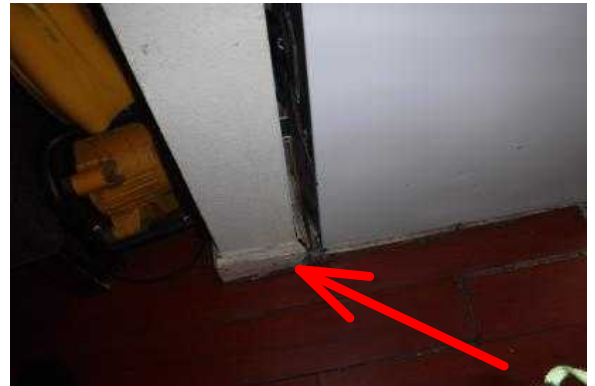
5. **(Unit 4) Kitchen Floor:** Water damage noted in one or more locations. Further evaluation is recommended.

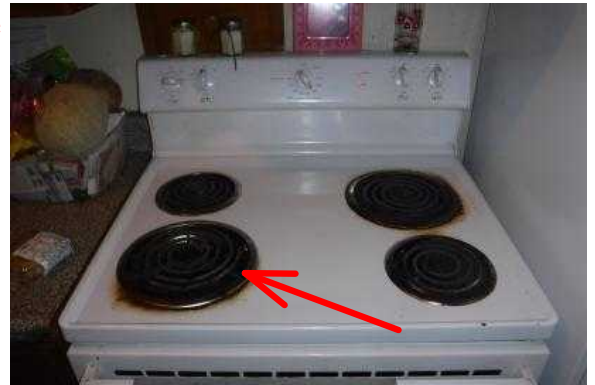
6. **(Unit 5) Kitchen Cooking Appliances:** (Electric) - One or more burners did not operate properly. Correction is recommended.

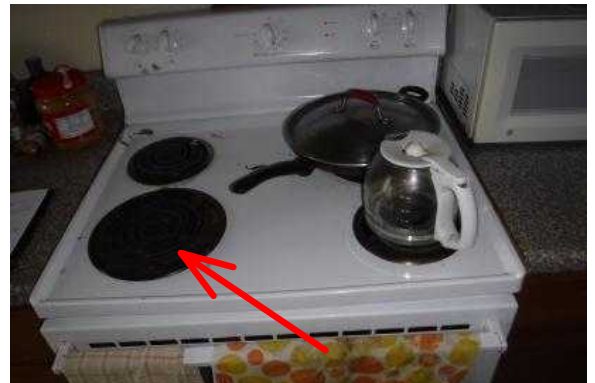
7. **(Unit 23) Kitchen Cooking Appliances:** One or more burners did not operate properly. Correction is recommended.

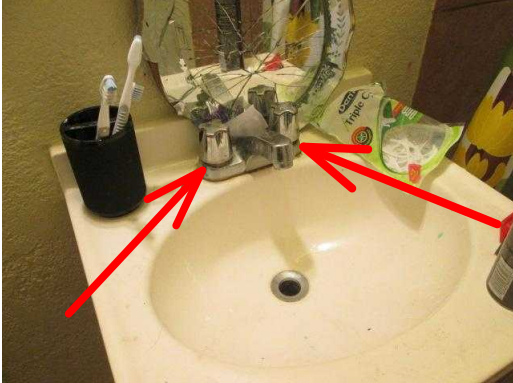
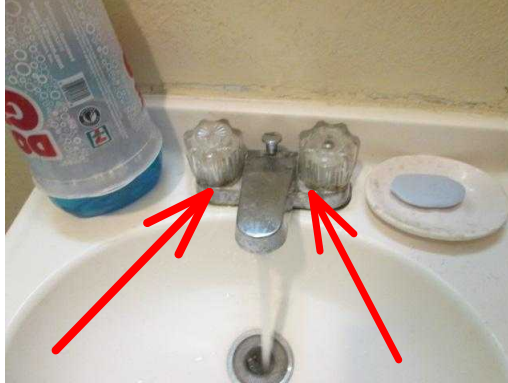
8. **General Bathroom Notes Bathroom Faucets/Traps:** Leaking faucet handles were noted at one or more units. A licensed plumber recommended to estimate repairs.

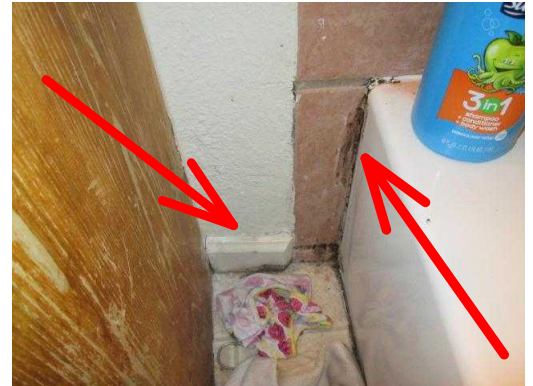
9. **Unit #4 Bathroom Walls:** Water stains and damage were present in one or more areas. It is beyond the scope of this inspection to determine if the moisture penetration is active. Inquire with seller and licensed specialist if necessary. Unidentifiable biological substance is present and is a potential health concern (probably a mold or mildew). Further evaluation of the substance is recommended by a specialist. A moisture intrusion expert is also recommended.

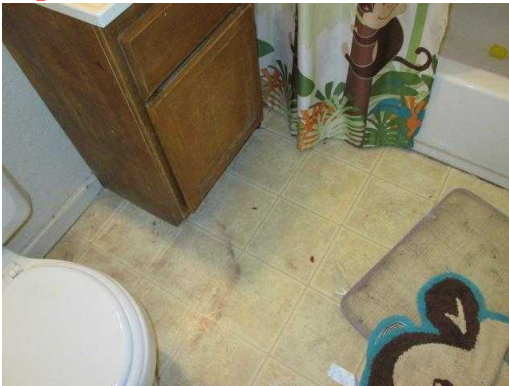
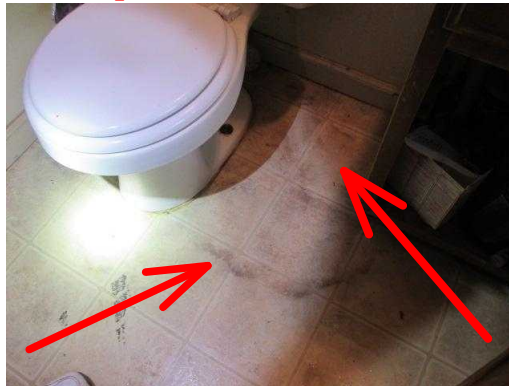
10. **Unit #4 Bathroom Floor:** Standing water and moisture damage noted at the flooring. Unidentifiable biological substance is present and is a potential health concern (probably a mold or mildew). Further evaluation of the substance is recommended by a specialist. A moisture intrusion expert is also recommended.

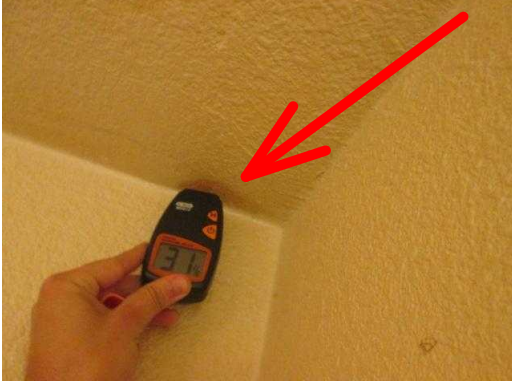
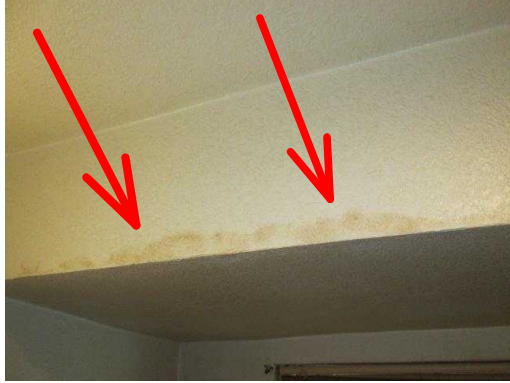
11. **Unit #6 Bathroom Ceiling:** Water stains and or damage were present in one or more areas. Evidence of water intrusion was noted. Hidden damage and or mold/mildew may be present. A qualified licensed contractor is recommended to evaluate and estimate repairs.

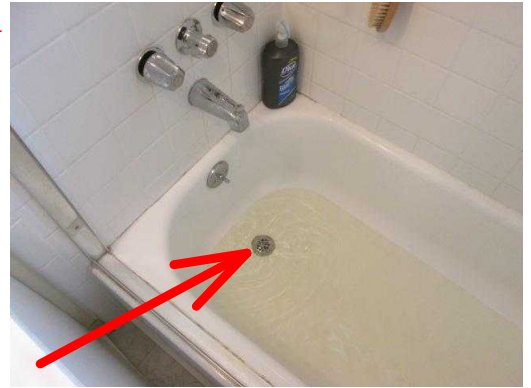
- 12. Unit #12 Bathroom Faucets/Traps:** A slow drain was noted at the tub. Correction is recommended.

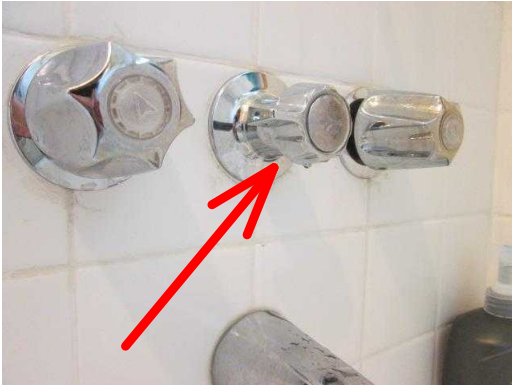
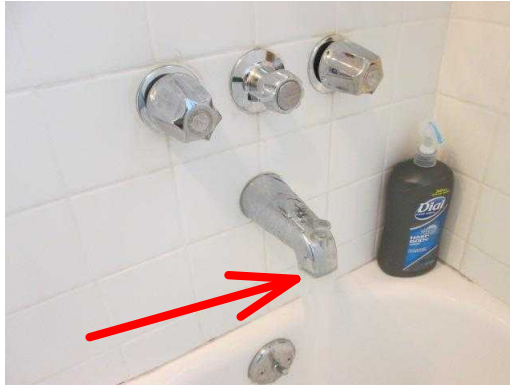
- 13. Unit #12 Bathroom Tub/Surround:** Tub diverter was not functional and is leaking at the handle. Water comes out the tub spout when the shower is activated. A qualified and licensed contractor is recommended to evaluate and estimate repairs.

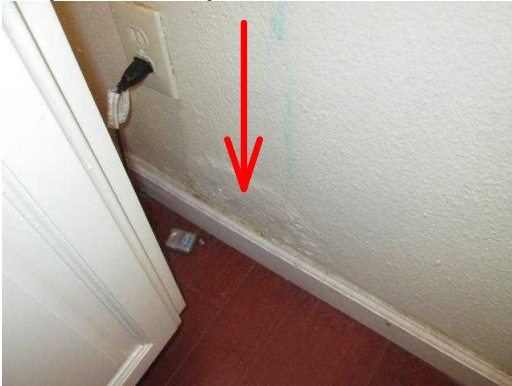
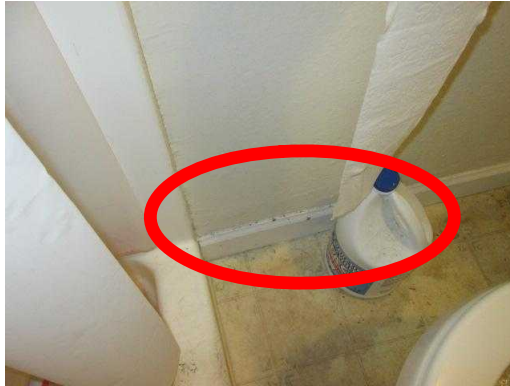
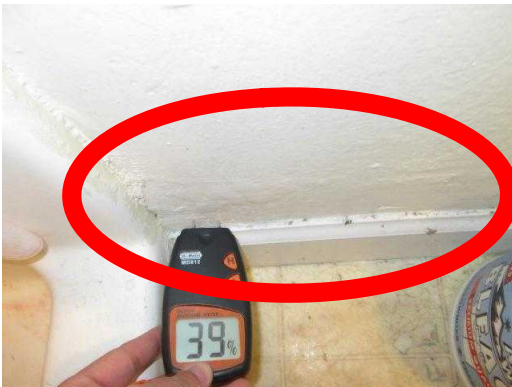
- 14. Unit #13 Bathroom Walls:** Patching or repairs were noted. Water stains and damage were present in one or more areas. It is beyond the scope of this inspection to determine if the moisture penetration is active. Inquire with seller and licensed specialist if necessary.

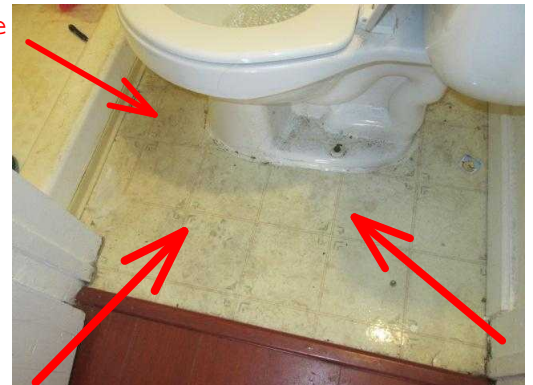
15. Unit #13 Bathroom Floor: Discoloration was noted in one or more areas.

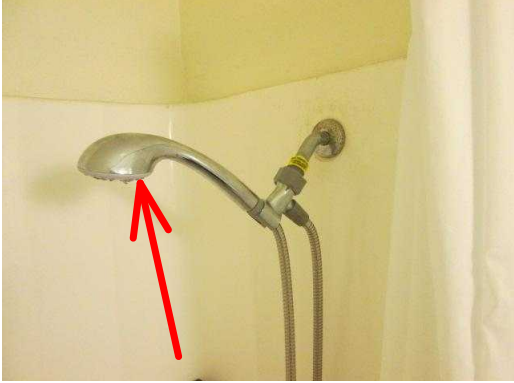
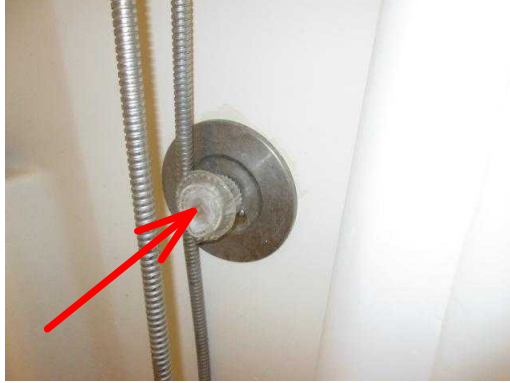
16. Unit #13 Bathroom Faucets/Traps: A leaking shower faucet was noted. The shower faucet handle rotates 360 degrees. A licensed plumber recommended to estimate repairs.

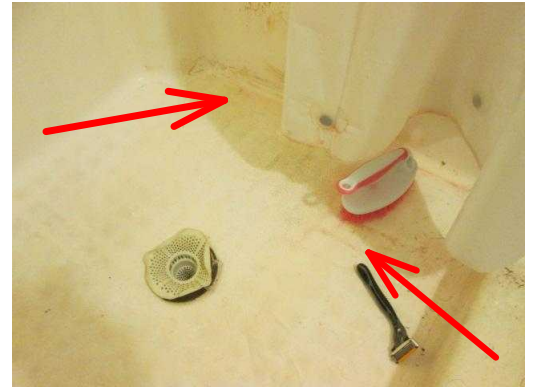
17. **Unit #13 Bathroom Shower/Surround:** Cracks were noted at the shower pan.

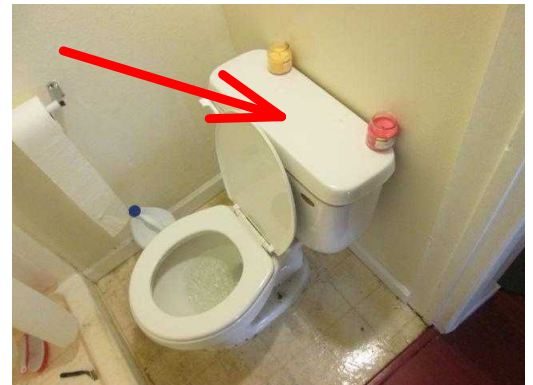
18. **Unit #13 Bathroom Toilets:** The toilet was not properly operational. Clearances were not proper in the bathroom or around the toilet. A qualified licensed contractor is recommended to evaluate and estimate repairs.

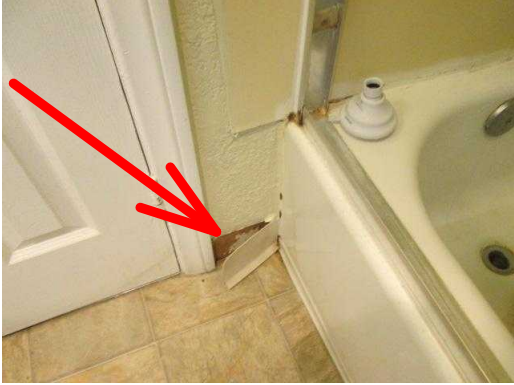
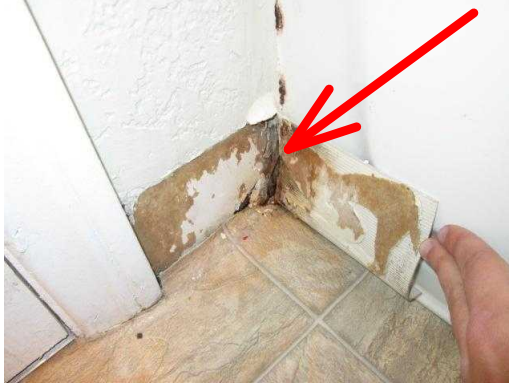
19. **Unit #16 Bathroom Walls:** Water stains and or damage were present in one or more areas. Evidence of water intrusion was noted. Hidden damage and or mold/mildew may be present. A qualified licensed contractor is recommended to evaluate and estimate repairs.

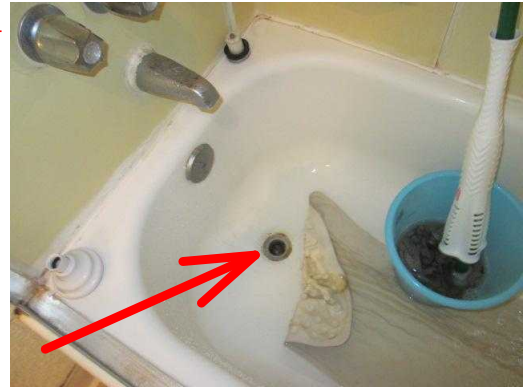
- 20. Unit #16 Bathroom Faucets/Traps:** A slow drain was noted at the tub. Correction is recommended.

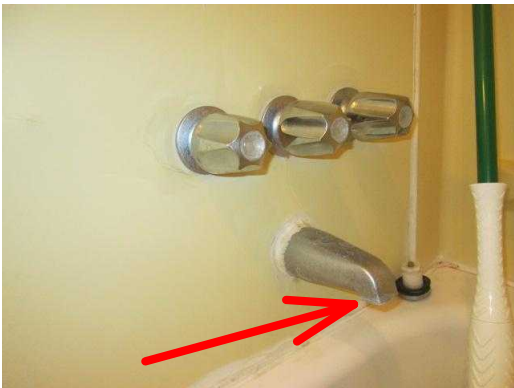
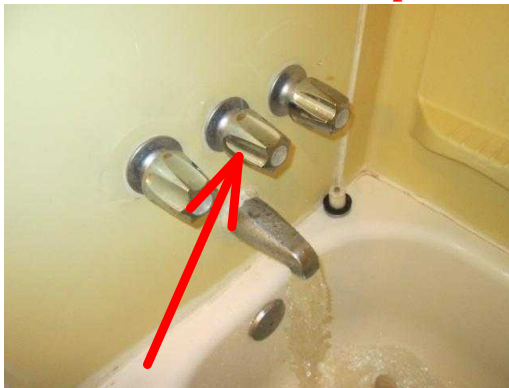
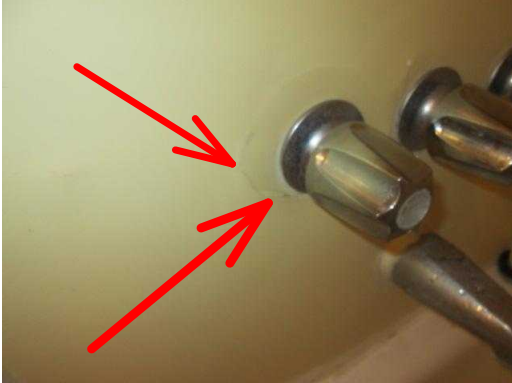
- 21. Unit #16 Bathroom Tub/Surround:** Tub faucet was actively drip leaking. Tub diverter was not 100 % functional. Some water comes out the shower spout when the tub is activated. Cracking was noted at the shower surround. A qualified and licensed contractor is recommended to evaluate and estimate repairs.

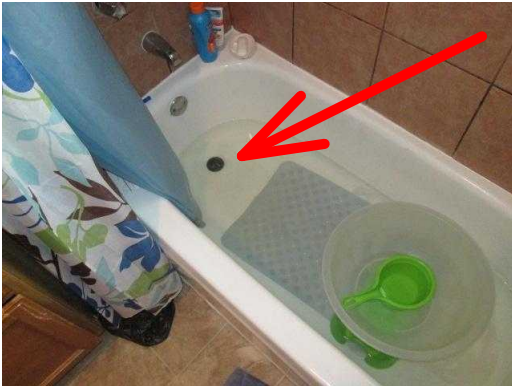
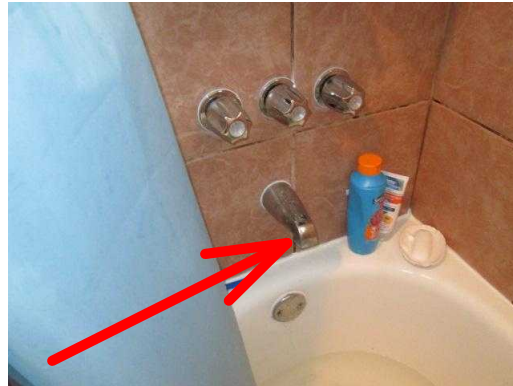
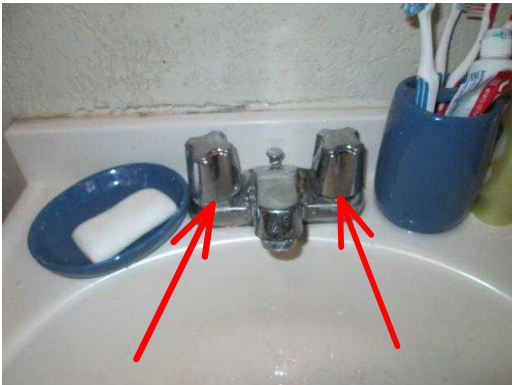
- 22. Unit #17 Bathroom Faucets/Traps:** A slow drain was noted at the tub. Leaking fixtures were noted in one or more areas (shower and sink faucet). A qualified licensed contractor is recommended to estimate repairs.

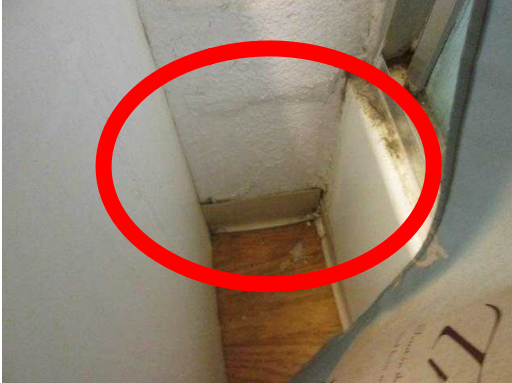
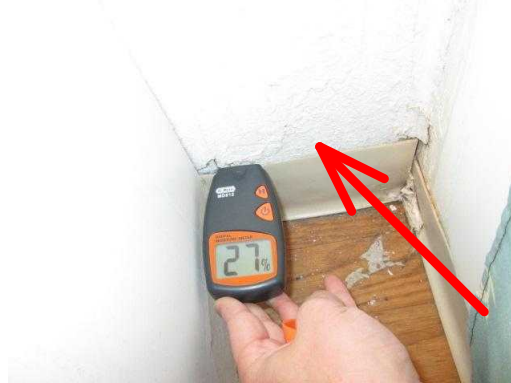
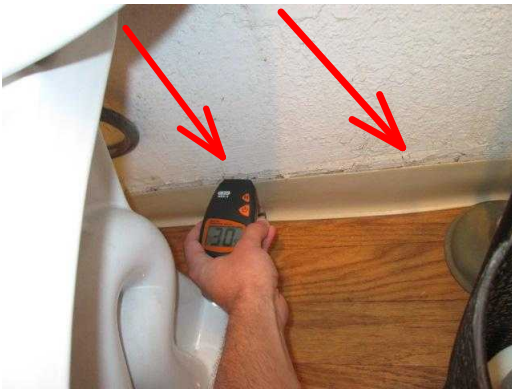
- 23. Unit #19 Bathroom Walls:** Water stains and damage were present in one or more areas. It is beyond the scope of this inspection to determine if the moisture penetration is active. Inquire with seller and licensed specialist if necessary.

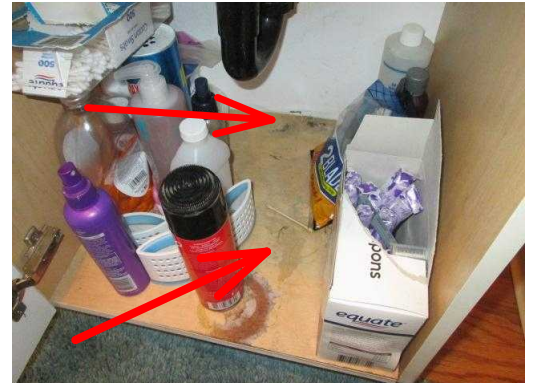
- 24. Unit #19 Bathroom Counter/Cabinet:** Water damage present under the counter. Unidentifiable biological substance is present and is a potential health concern (probably a mold or mildew). Further evaluation of the substance is recommended by a specialist. A moisture intrusion expert is also recommended.

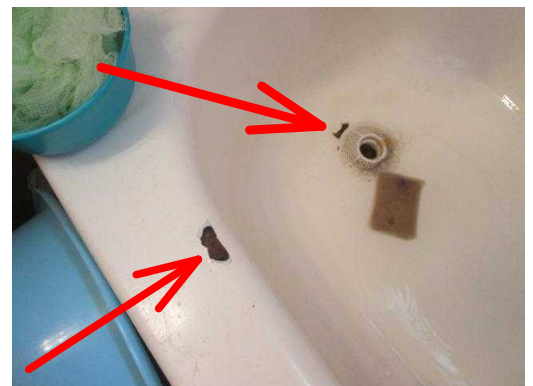
- 25. Unit #21 Bathroom Tub/Surround:** Chipped or damaged tub. A qualified contractor is recommended to evaluate and estimate repairs.

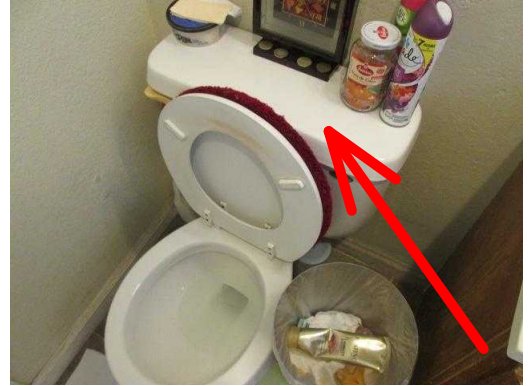
- 26. Unit #21 Bathroom Toilets:** The toilet was not properly operational. A qualified licensed contractor is recommended to evaluate and estimate repairs.

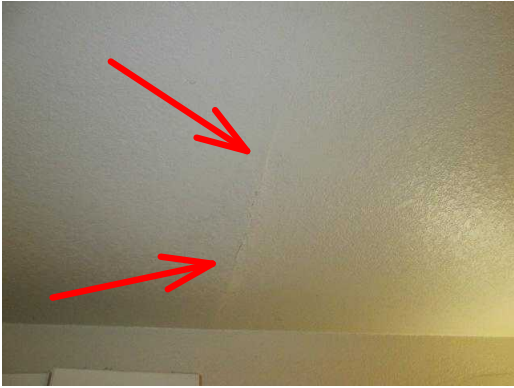
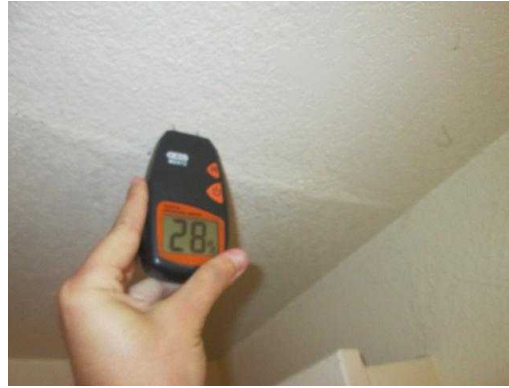
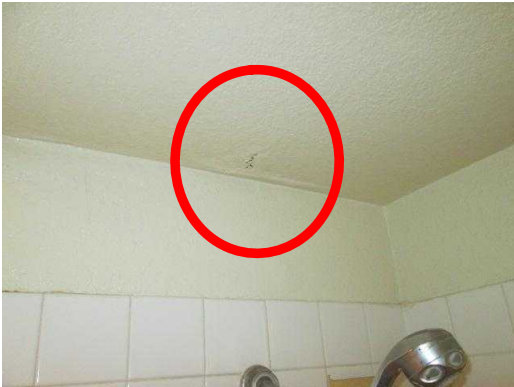
- 27. Unit #23 Bathroom Ceiling:** Soft spots and/or moisture damage were noted in one or more areas. Water stains and damage were present in one or more areas. It is beyond the scope of this inspection to determine if the moisture penetration is active. Inquire with seller and licensed specialist if necessary.

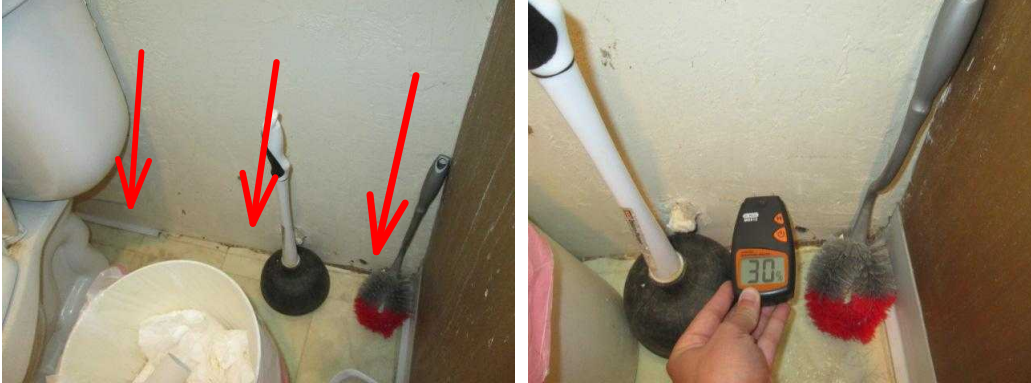
- 28. Unit #23 Bathroom Walls:** Water stains and damage were present in one or more areas. It is beyond the scope of this inspection to determine if the moisture penetration is active. Inquire with seller and licensed specialist if necessary.

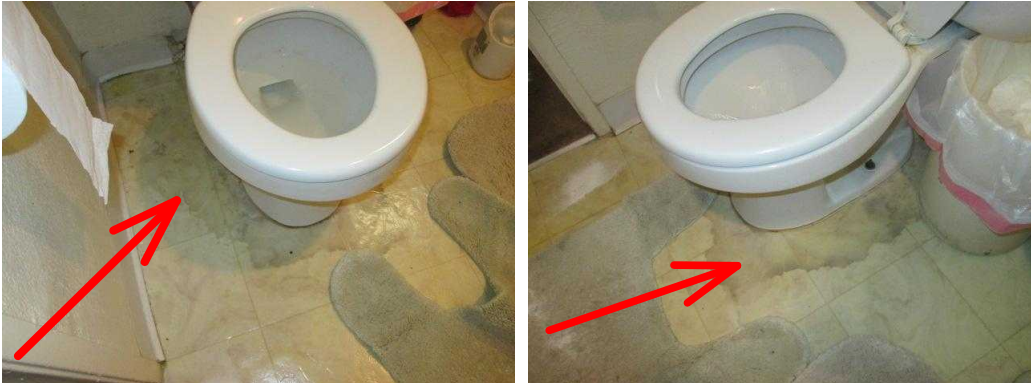
- 29. Unit #23 Bathroom Floor:** Flooring was discolored and or stained in one or more areas. Water stains and or damage were present in one or more areas. Evidence of water intrusion was noted. Hidden damage and or mold/mildew may be present. A qualified licensed contractor is recommended to evaluate and estimate repairs.

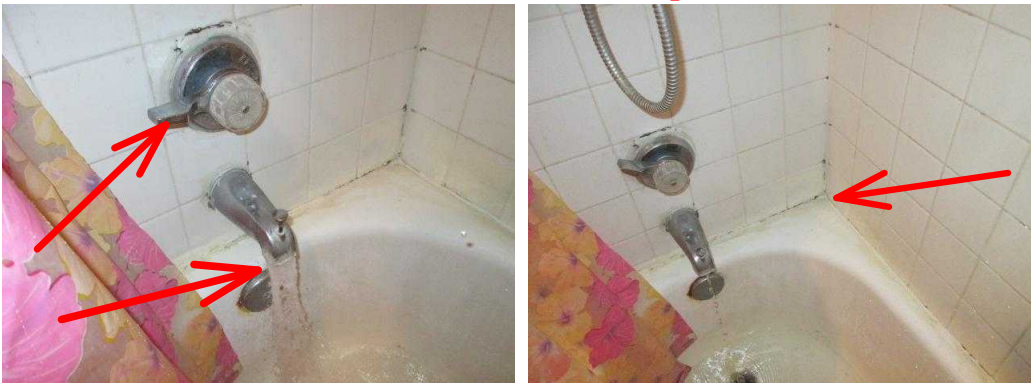
- 30. Unit #23 Bathroom Tub/Surround:** Damaged tiles were noted at the tub surround. The tub diverter was not functional. Water comes out the tub spout when the shower is activated. Replacement may be needed. A qualified licensed contractor is recommended to evaluate and estimate repairs.

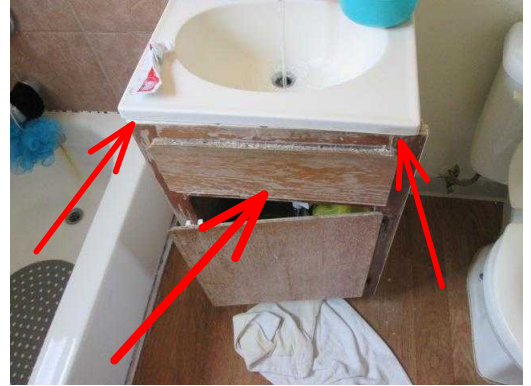
- 31. Unit #25 Bathroom Counter/Cabinet:** Cabinets have excessive moisture damage and the sink is loose at the countertop. A qualified licensed contractor is recommended to evaluate and estimate repairs.

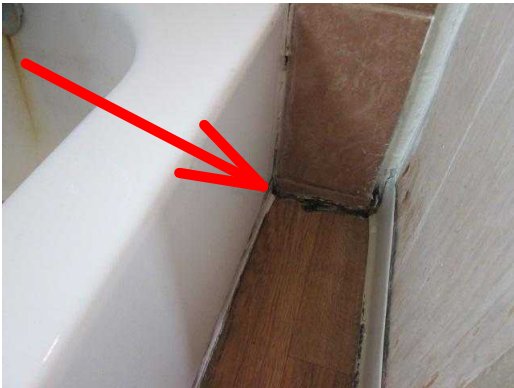
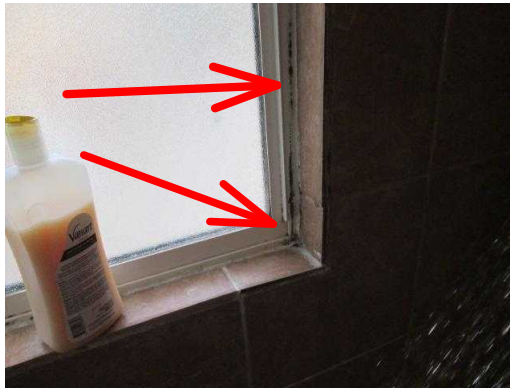
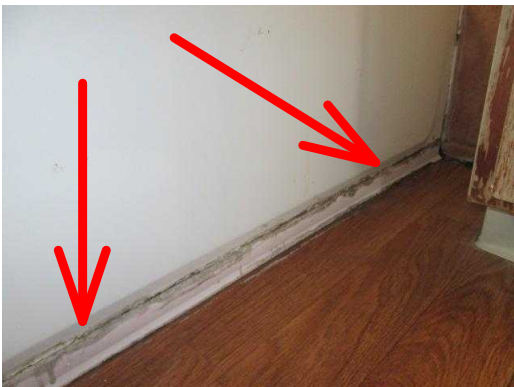
- 32. Unit #25 Bathroom Tub/Surround:** Grout was cracked or deteriorated at one or more areas. Correction is recommended. Unidentifiable biological substance is present and is a potential health concern (probably a mold or mildew). Further evaluation of the substance is recommended by a specialist. A moisture intrusion expert is also recommended.

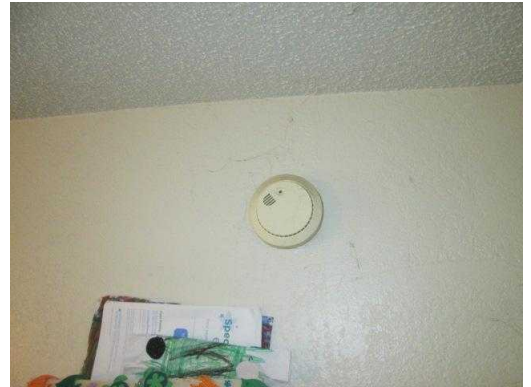
33. General Interior Room Notes Living Space Smoke

Detector(s): No detectors were found at one or more locations. A smoke detector is recommended for each hallway leading to a bedroom and one per bedroom. One or more smoke detectors did not appear to be operational. This is a safety item and correction is needed.

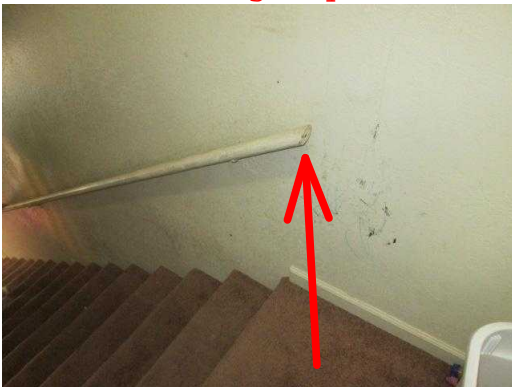
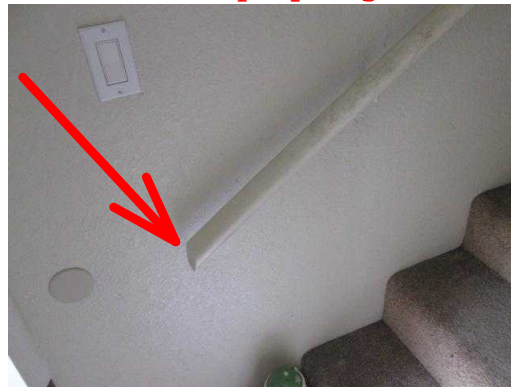
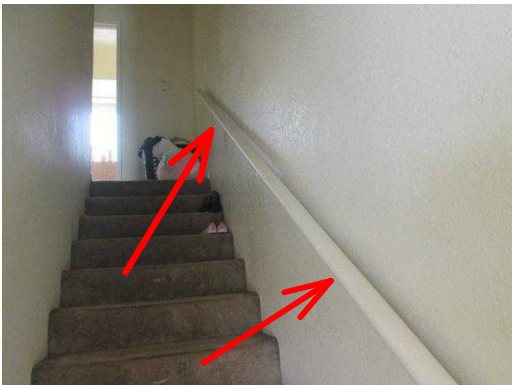
35. General Interior Room Notes Living Space Stairs and Railings:

Handrails were improper in one or more areas. The current building practice is that they should tie back into the wall for added safety. Loose handrails were noted in one or more areas. Recommend having a qualified contractor add proper guardrails where necessary.

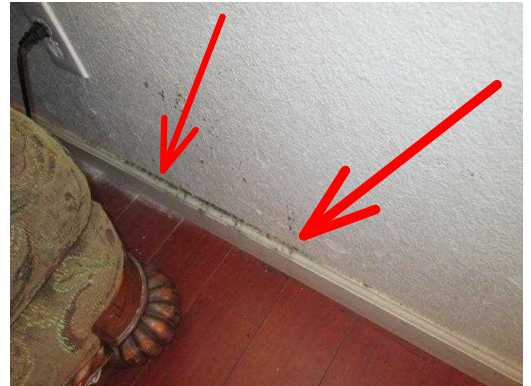
- 36. Unit #4 Living Space Walls:** Unidentifiable biological substance is present and is a potential health concern (probably a mold or mildew). Further evaluation of the substance is recommended by a specialist. A moisture intrusion expert is also recommended.

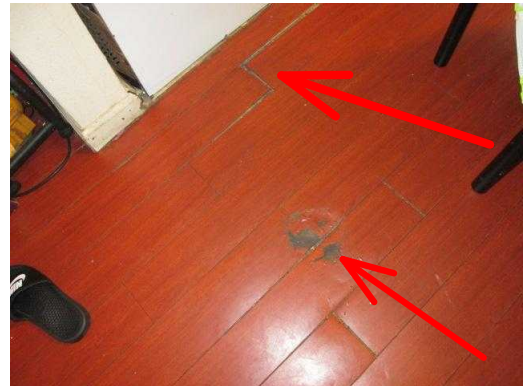
- 37. Unit #4 Living Space Floor:** Loose flooring was noted in one or more areas. Moisture damaged was noted in one or more areas. Hidden damage and or mold/mildew may be present. A qualified licensed contractor is recommended to evaluate and estimate repairs.

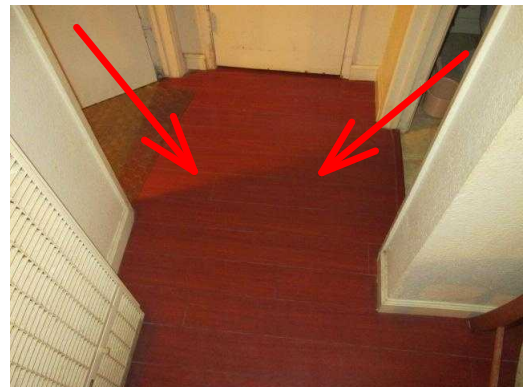
- 38. Unit #6 Living Space Floor:** Bubbling and loose floorboards were noted at the hallway. A qualified licensed contractor is recommended to evaluate and estimate repairs.

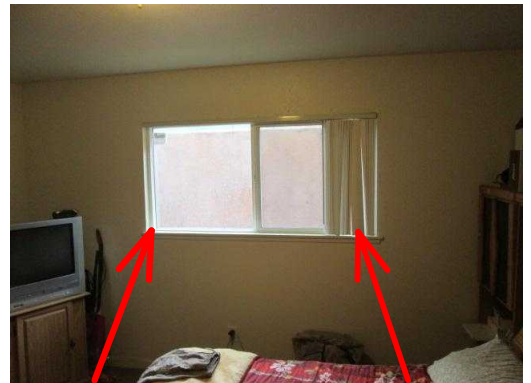
- 39. Unit #6 Living Space Windows:** Windows in the bedrooms do not meet the current fire escape requirements in one or more areas. This is a safety hazard. It could have been acceptable when it was built but upgrades are recommended for added safety.

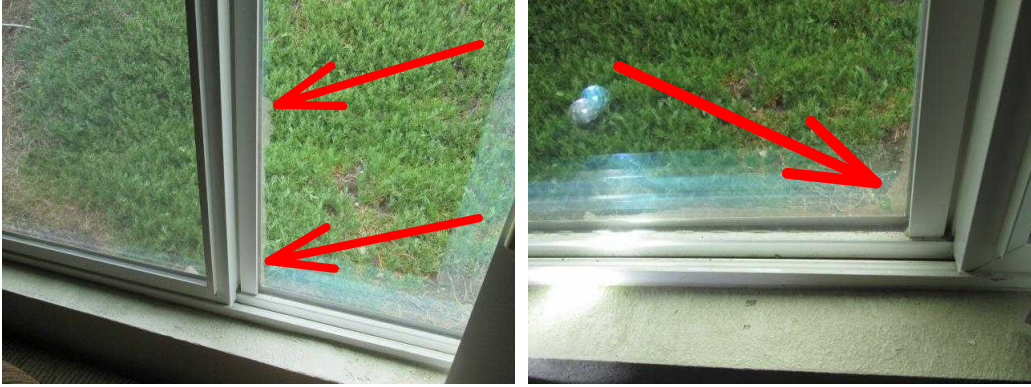
- 40. Unit #16 Living Space Windows:** Moisture and or discoloration was noted to one or more windows. This is usually due to a damaged seal. A qualified licensed contractor is recommended to evaluate and estimate repairs.

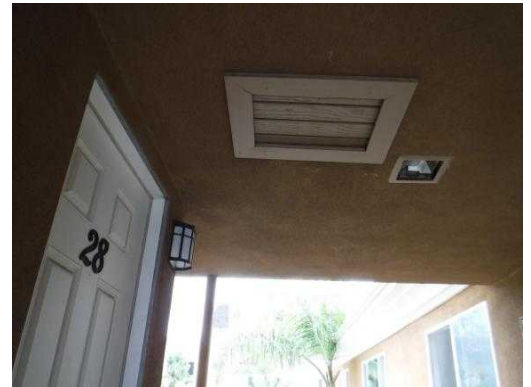
- 41. Attic Access:** Access is too small based on today's standards. Correction is recommended. No access was noted to one building. Be advised that because we could not enter the attic, hidden problems may exist that are not documented in this report. Access and further evaluation is recommended.

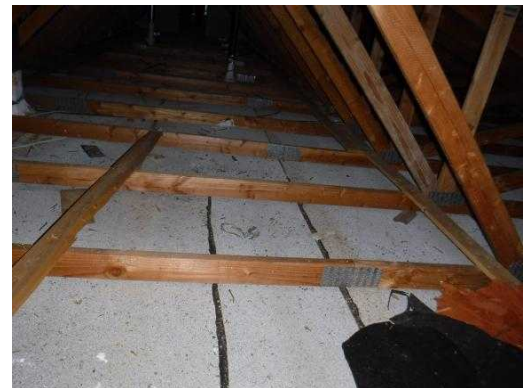
- 42. Attic Insulation:** No insulation present in one or more areas. A qualified licensed contractor is recommended to evaluate and estimate repairs.

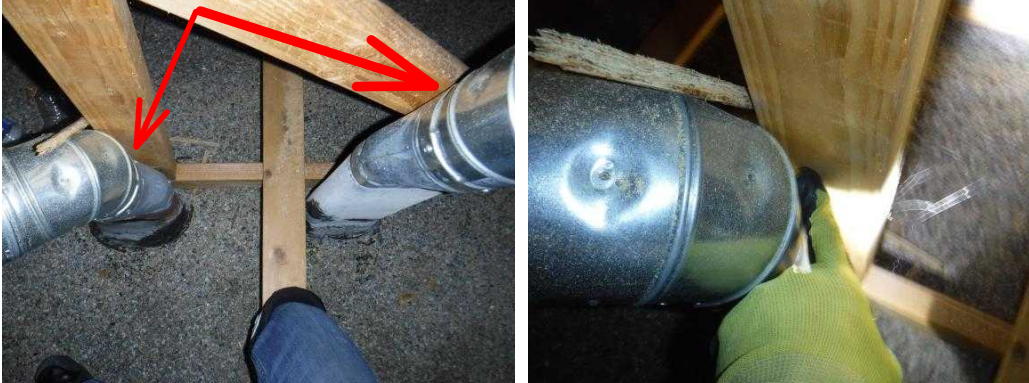
Heater Vents: (continued)

- 43. Attic Heater Vents:** Improper clearance to combustibles was noted at several vent pipes. This is a fire hazard and correction is recommended.
