Aztec Property Inspections
3655 Cowley Way
San Diego, CA 92117
(858) 245-9329

777 Clairemont Ave
San Diego, CA 92111

Jeff Smith
Home Inspection Sample.inspx

Definitions

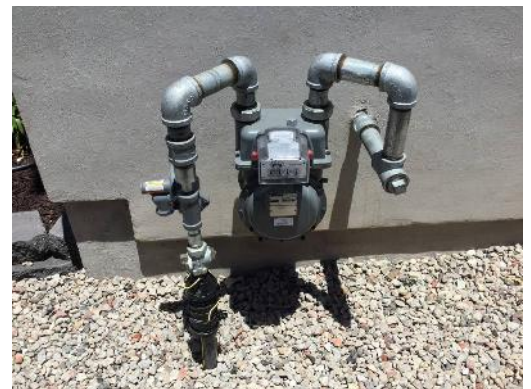
Gas Meter:

8. Acceptable

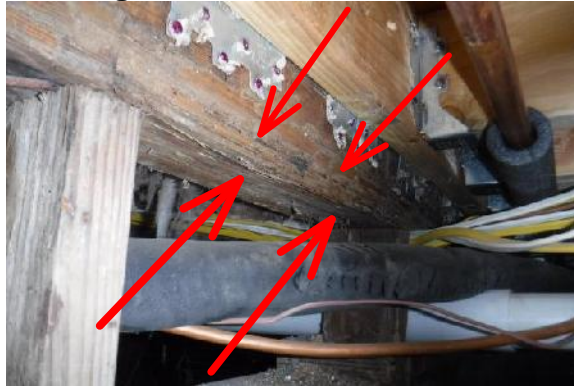
Framing:

9. Marginal

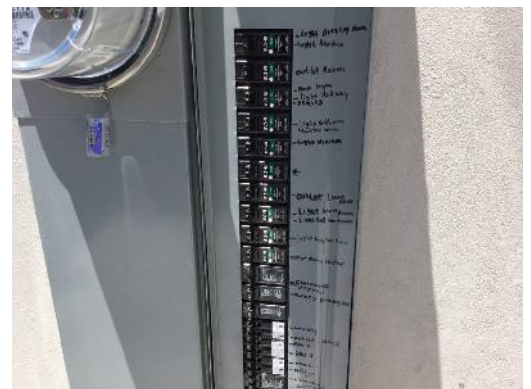
Condition:

3. Acceptable

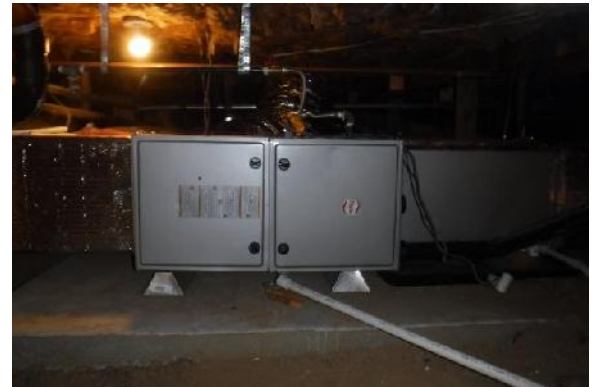
1. Acceptable

Operation: The local utility company is recommended for a complimentary safety inspection before the close of the contingency period.

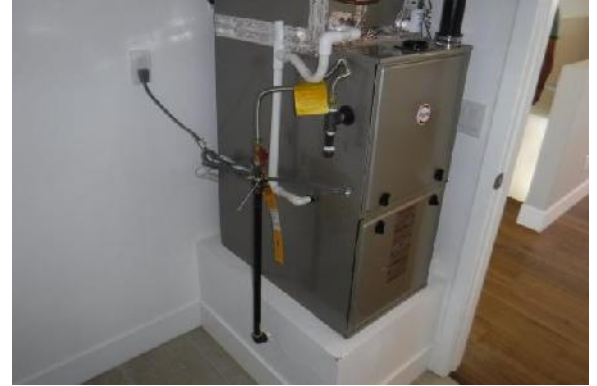
8. Acceptable Operation:

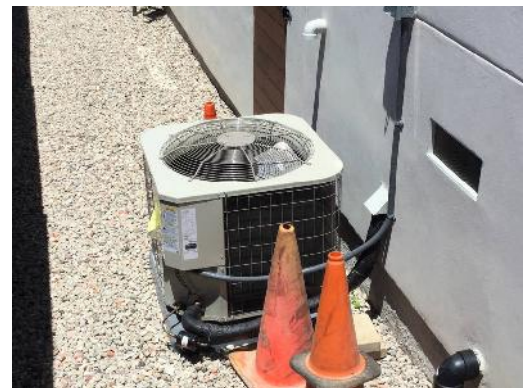
1. Acceptable Operation: (3 Ton)

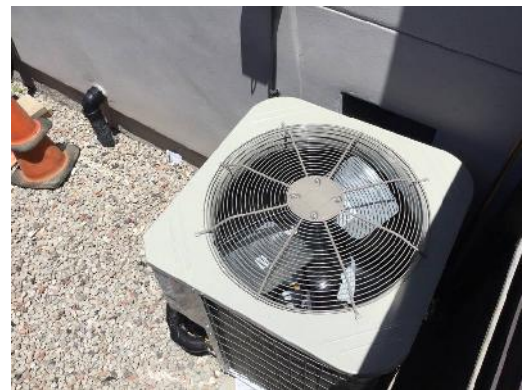
Operation: (4 Ton)

7. Acceptable
